# **Ouleout Creek Geomorphic Assessment, Nutrient Load Estimation, and Remediation Recommendations**

**November 2023**

**Delaware County Soil and Water Conservation District**

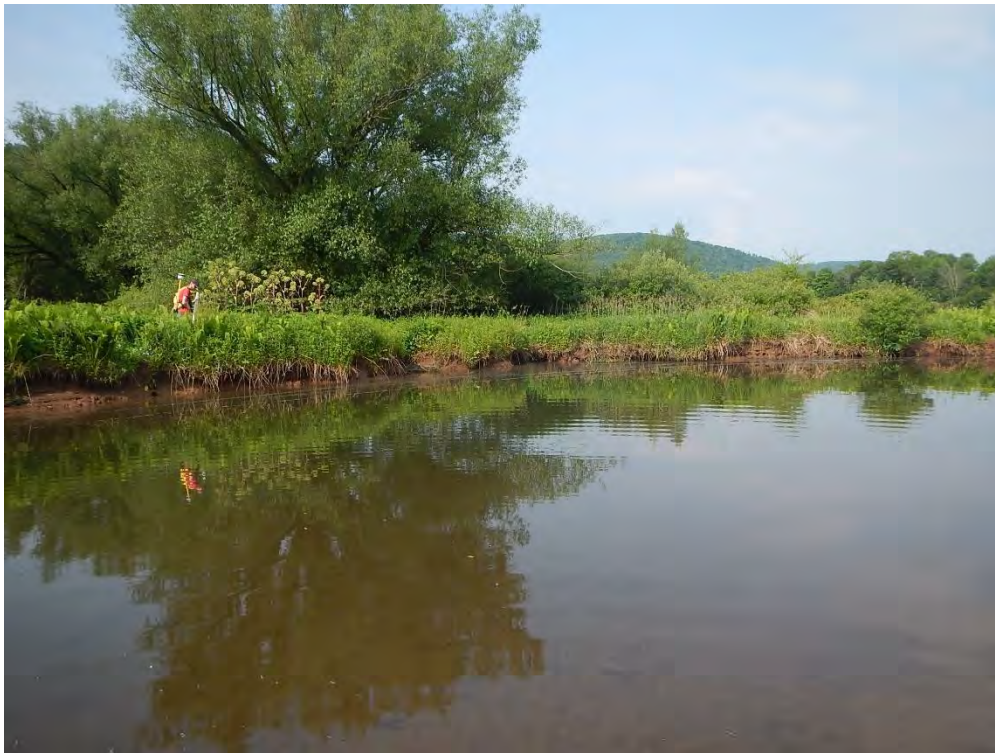
**Site 1-a: Erosion along the left bank. Note that the bank vegetation is comprised predominately of herbaceous plants and shrubs. Photo taken looking downstream at STA ~379+00.**

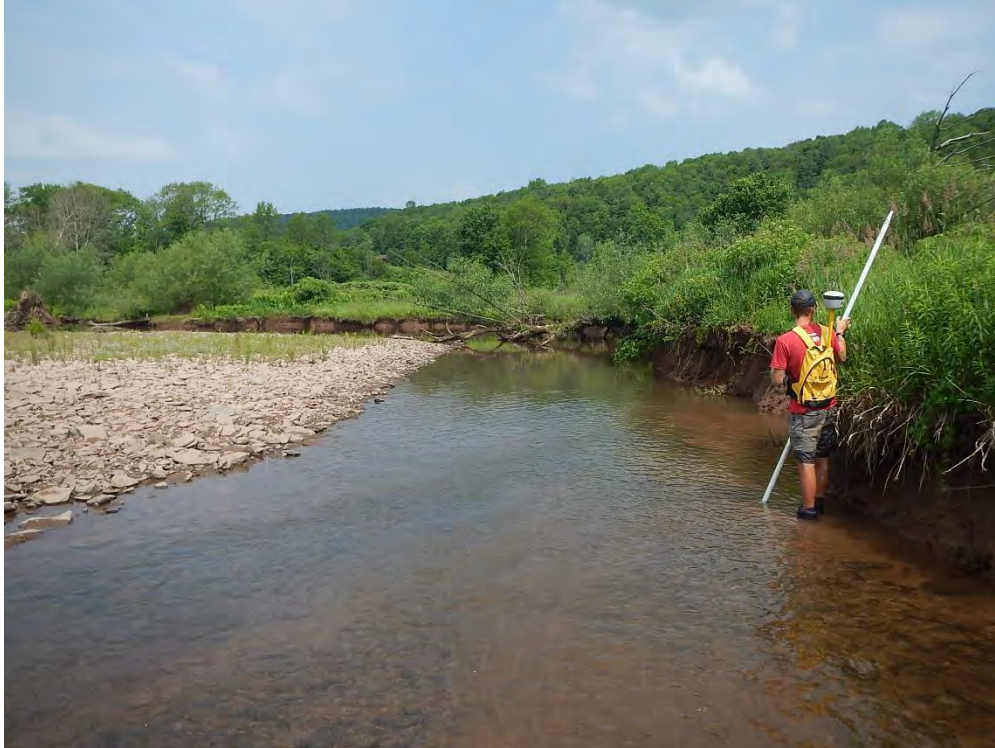
**Site 1-b: Erosion along the right bank with an aggrading mid-channel bar along the left bank. Photo taken looking downstream at STA ~383+00.**

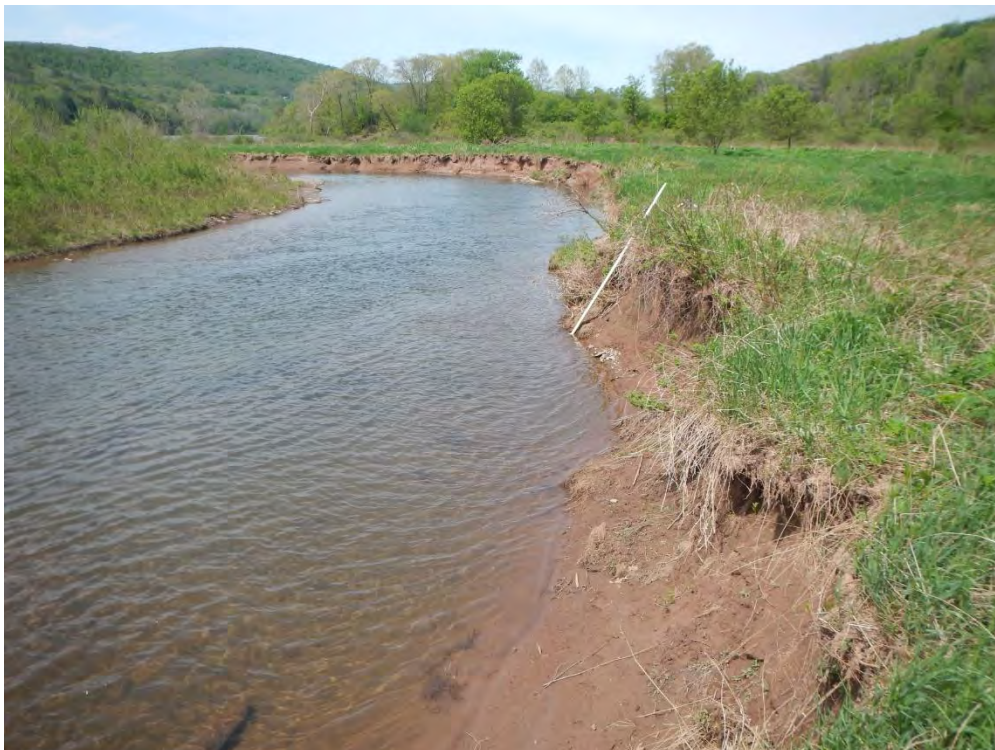
**Site 2-a: Erosion along the right bank on a sharp bend. Note the shallow rooting depth and lack of riparian forest buffer. Photo taken looking downstream at STA ~389+00.**

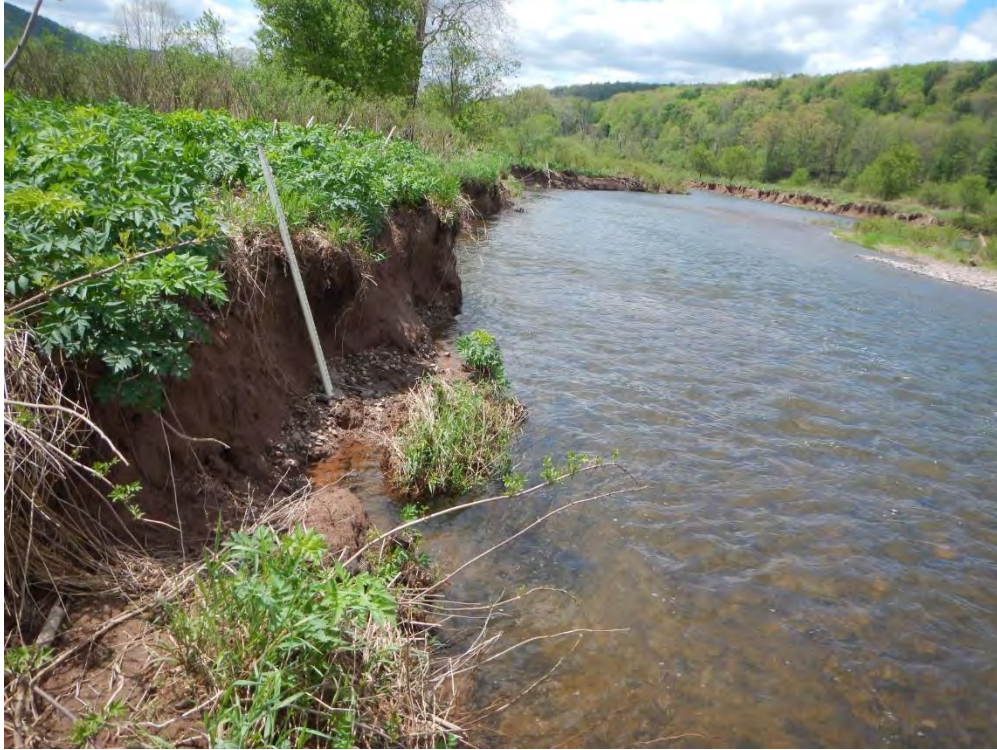
**Site 2-a: Erosion along the left bank in the foreground and erosion along the right bank in the background. Photo taken looking downstream at STA ~392+00.**

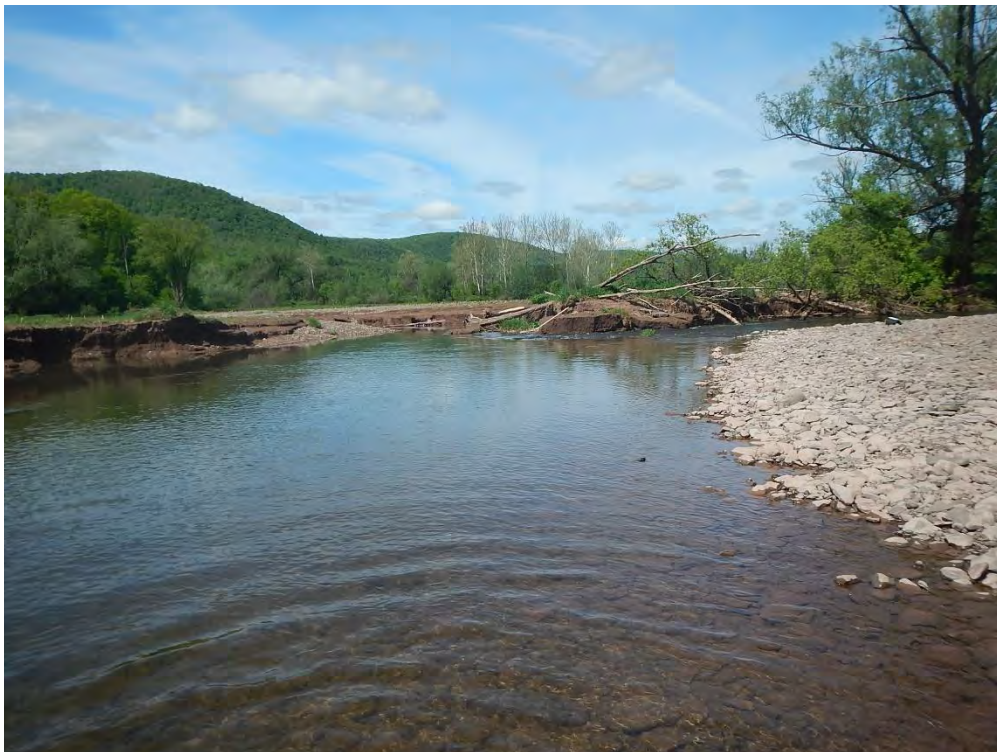
**Site 2-b: Erosion along the left bank with an aggrading point bar on the right bank. Photo taken looking downstream at STA ~406+00.**

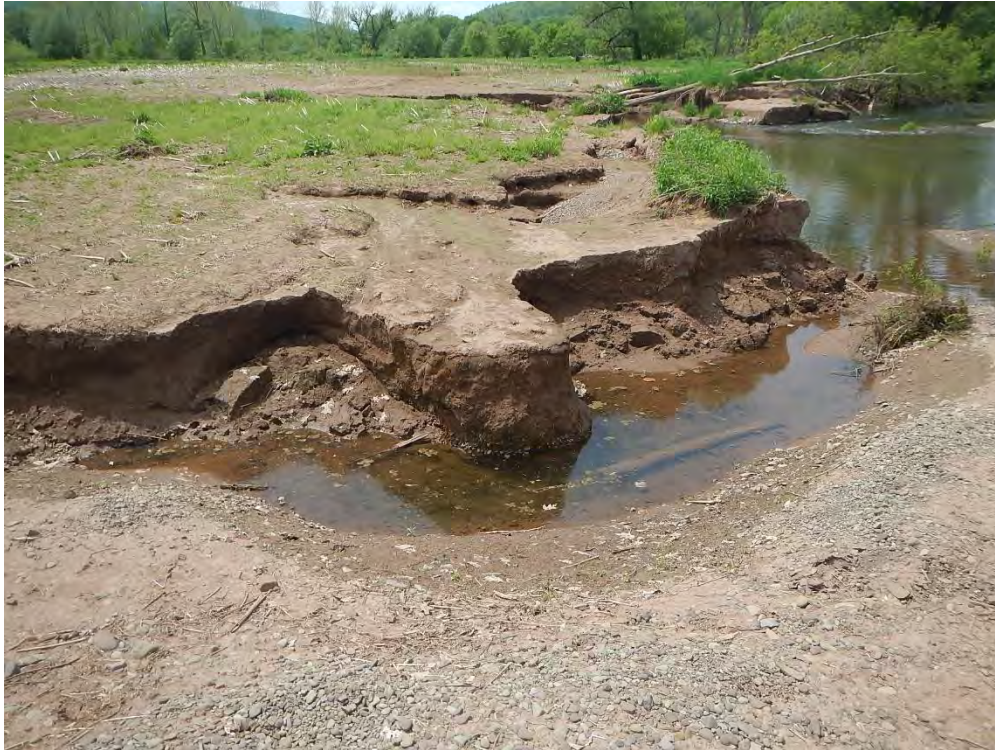
**Site 2-b: Erosion along an agricultural field on the left bank. Note the lack of established vegetation on the streambank. Photo taken looking downstream at STA ~406+00.**

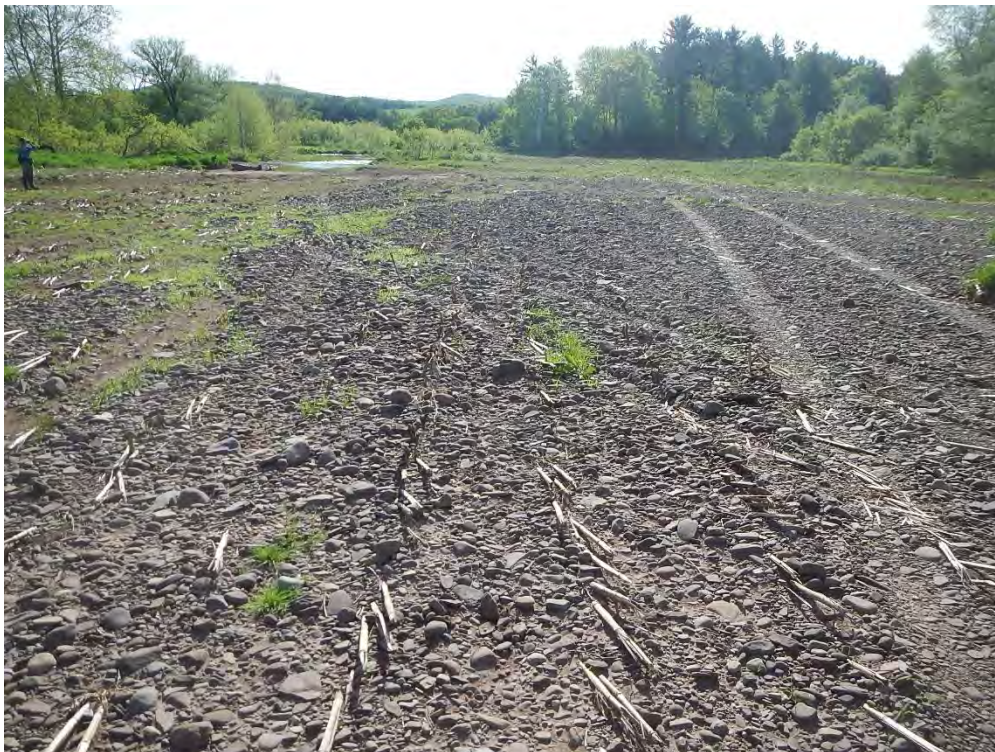
**Site 2-b: Deposit of cobble material in an agricultural field on the left bank. Photo taken looking upstream at STA ~405+50.**

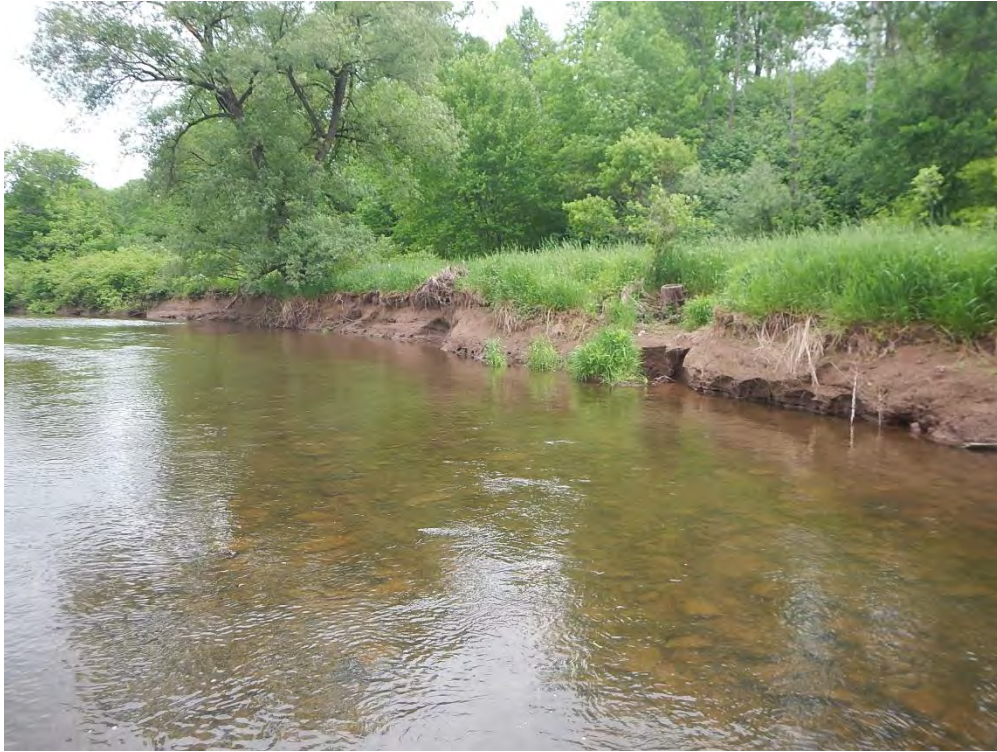
**Site 4-a: Erosion along the left bank. Note the shallow rooting depth and lack of riparian forest buffer on the bank. Photo taken looking upstream at STA ~466+00.**

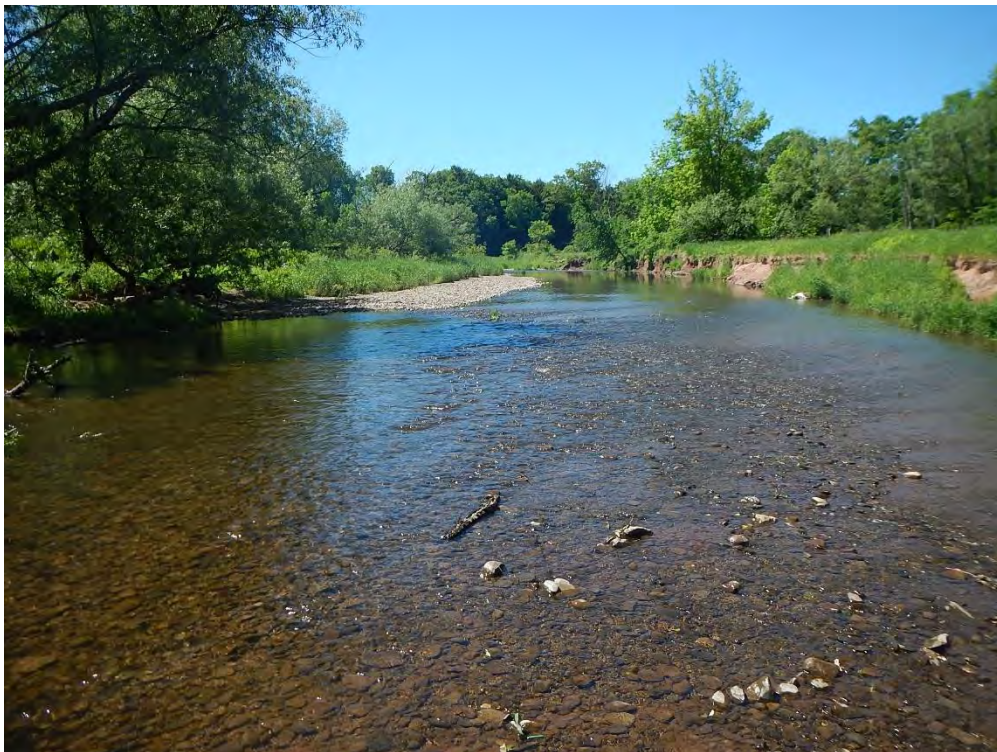
**Site 4-a: Transverse bar directing streamflow into the eroding right bank along an agricultural field. Photo taken looking downstream at STA ~475+00.**

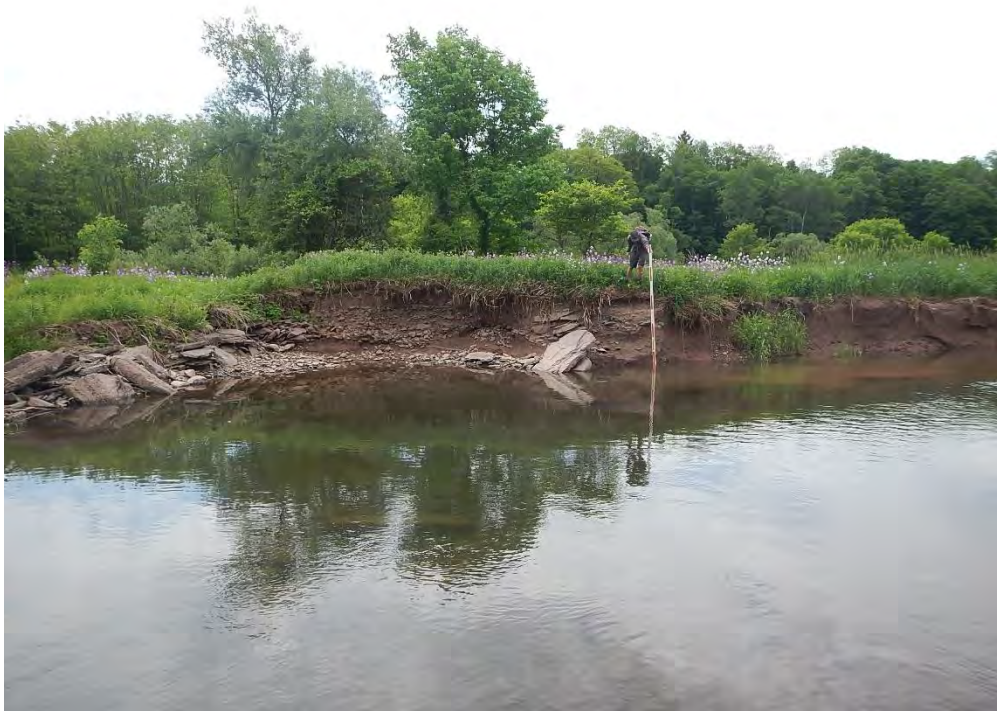
**Site 4-b: Erosion along the left bank. Note the lack of riparian forest buffer in the old field. Photo taken looking across the channel at STA ~507+00.**

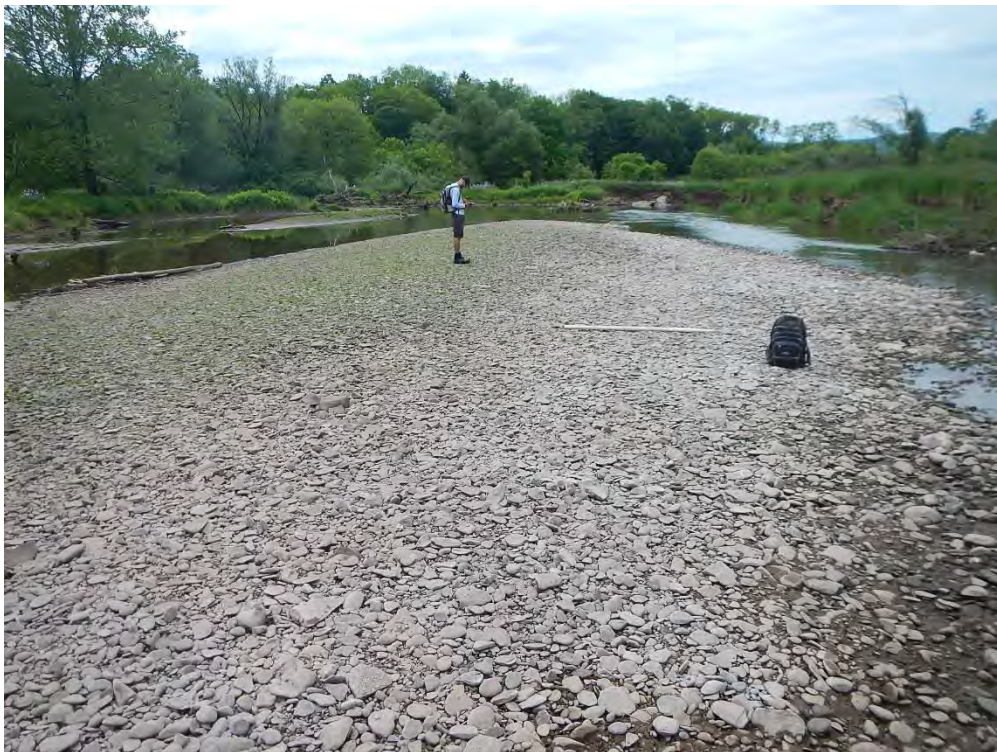
**Site 4-b: Excessive depositional feature in the channel with erosion along the right bank. Photo taken looking downstream at STA ~511+00.**

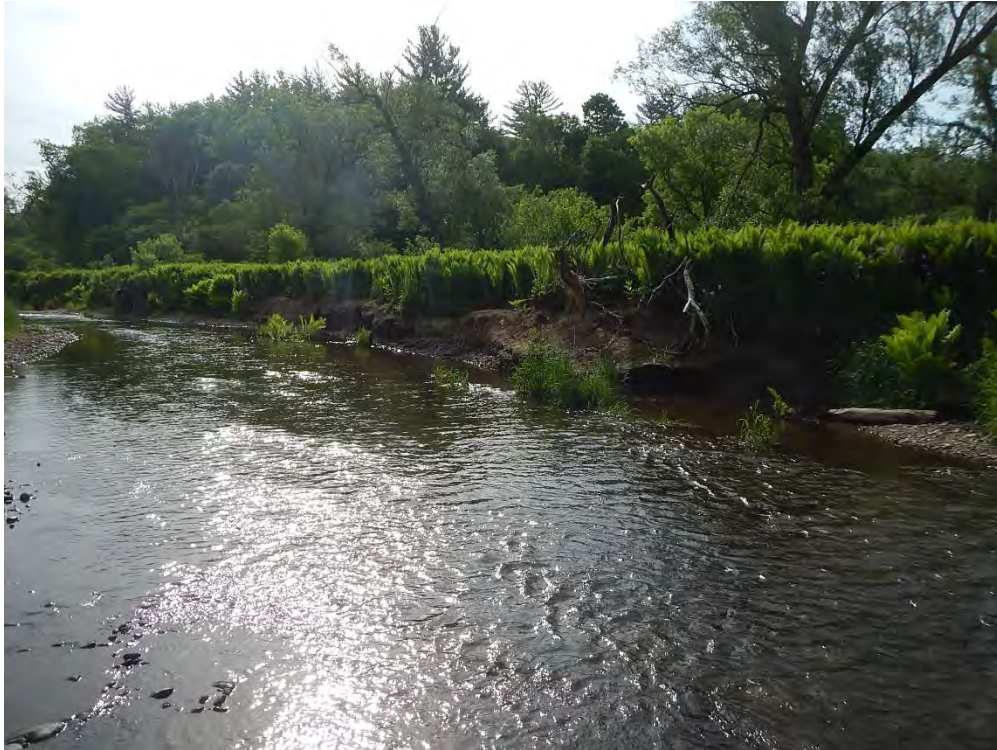
**Site 5-a: Erosion along the left bank. Photo taken looking upstream at STA ~530+00.**

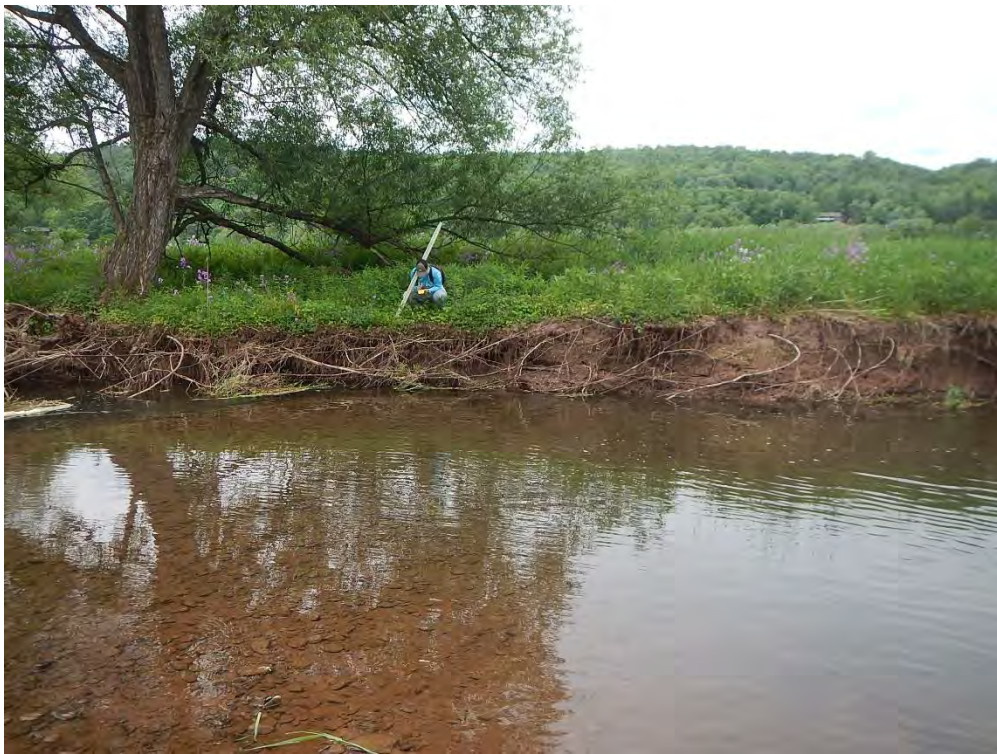
**Site 5-b: Erosion along the right bank. Photo taken looking across the channel at STA ~549+50.**

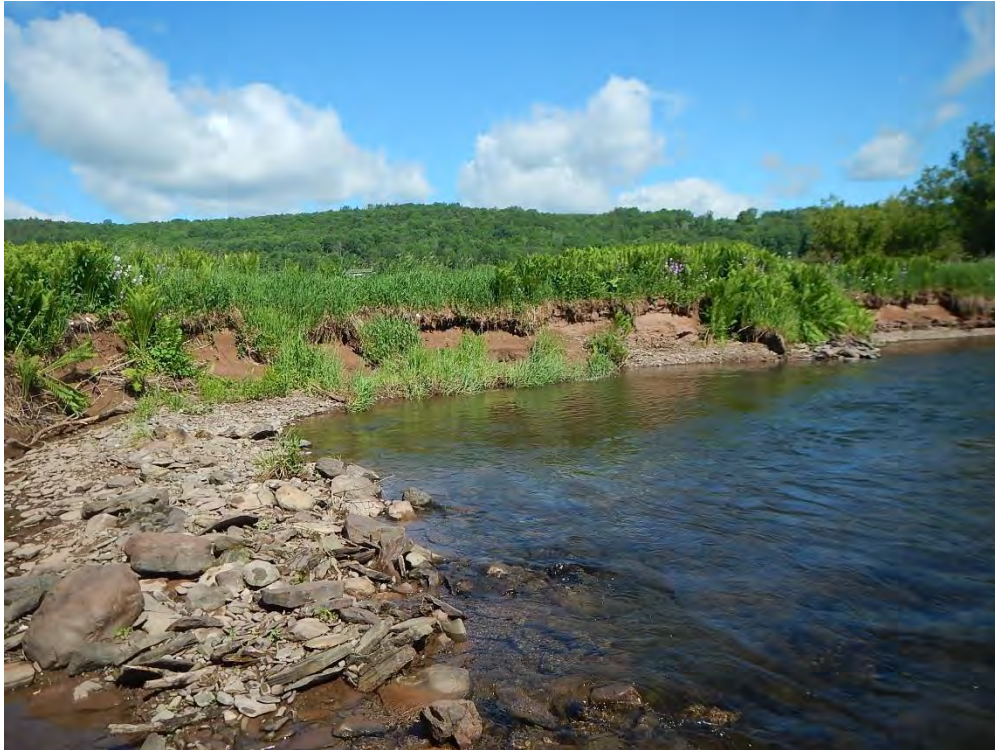
**Site 5-c: Erosion along the right bank of an agricultural field. Note the lack of riparian forest buffer on the bank. Photo taken looking upstream at STA ~560+00.**

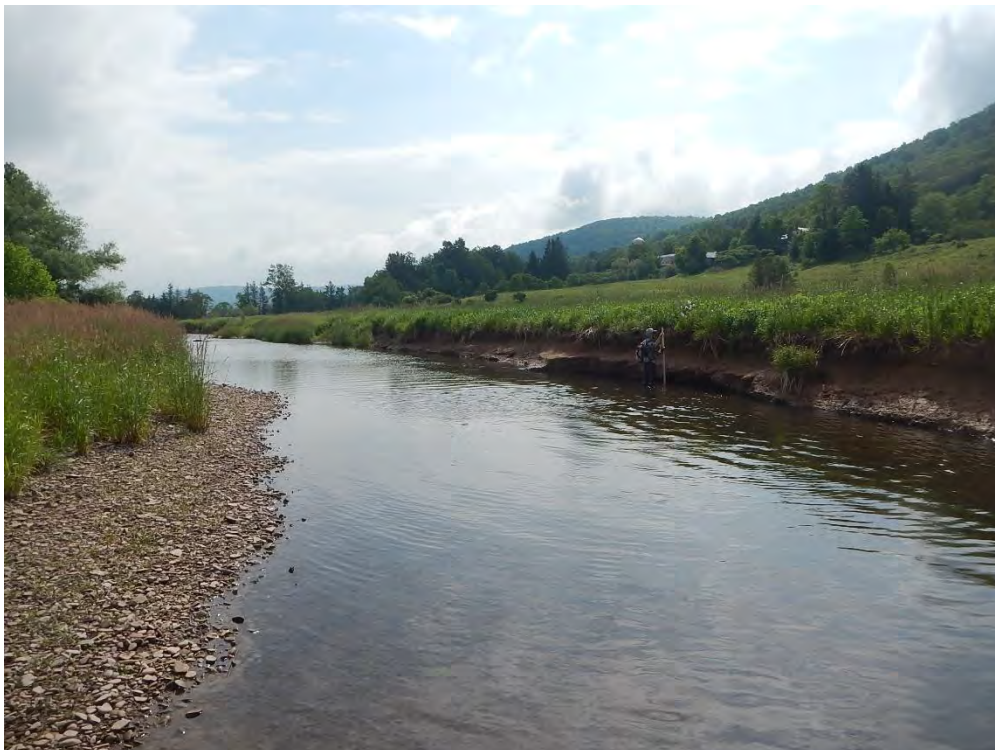
**Site 6-a: Erosion along the left bank of an inactive agricultural field. Note the lack of riparian forest buffer on the right bank. Photo taken looking upstream at STA ~580+00.**

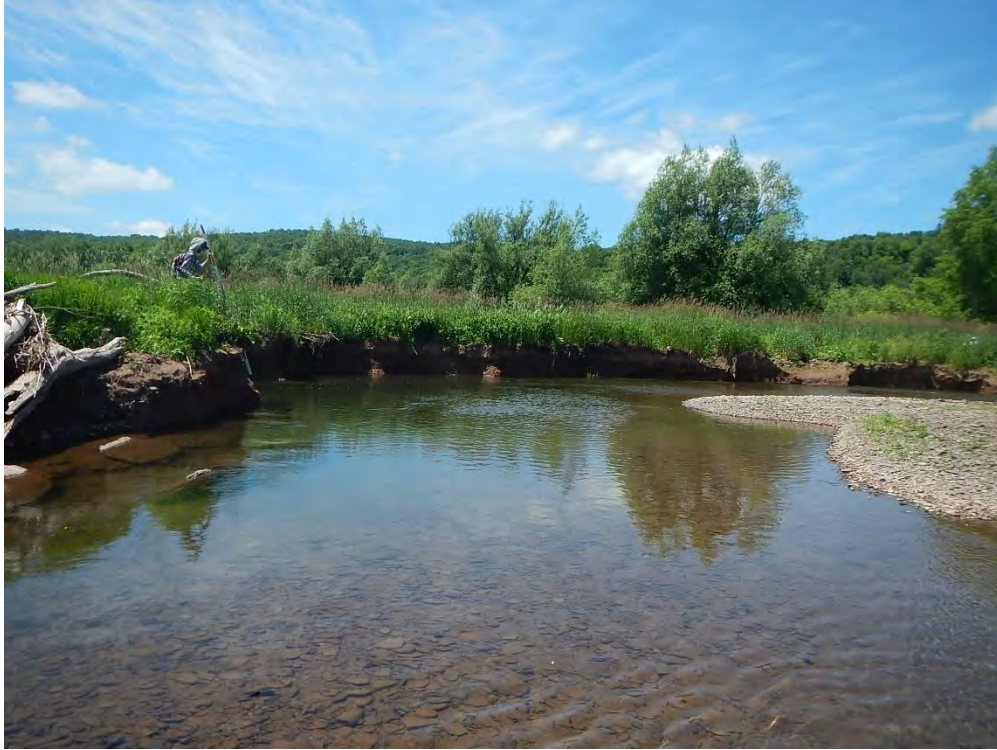
**Site 6-b: Erosion along the right bank of an old field. Note the sharp bend in the channel with flow to impinging on the right bank. Photo taken looking upstream at STA ~591+00.**

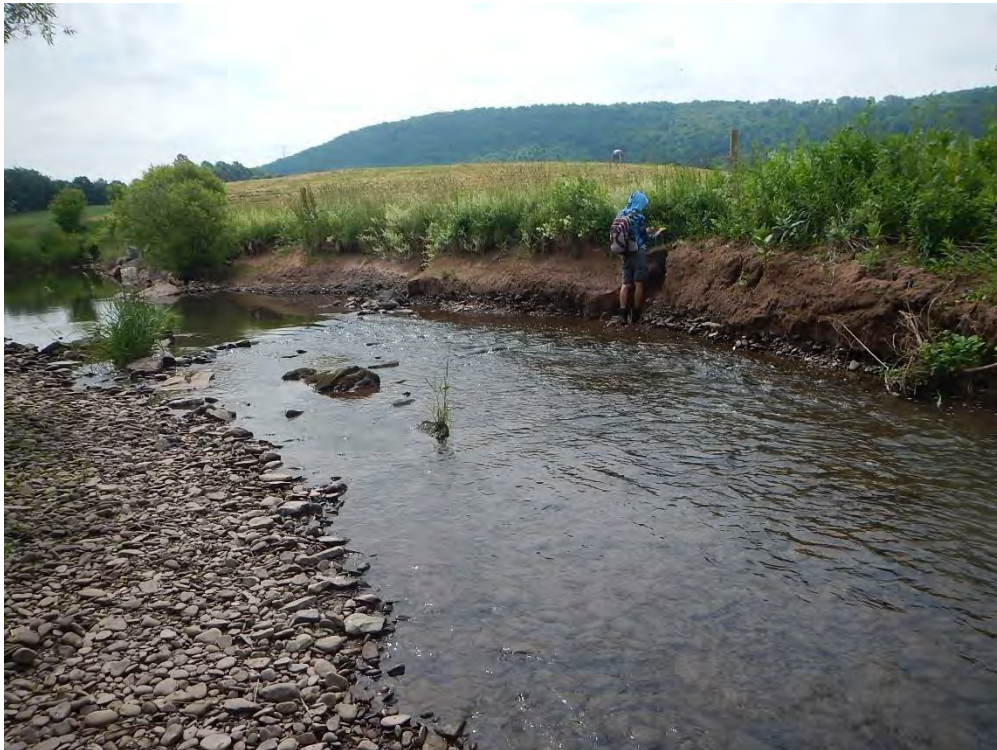
**Site 8-a: Erosion along the left bank of an agricultural field. Photo taken looking upstream at STA ~687+00.**

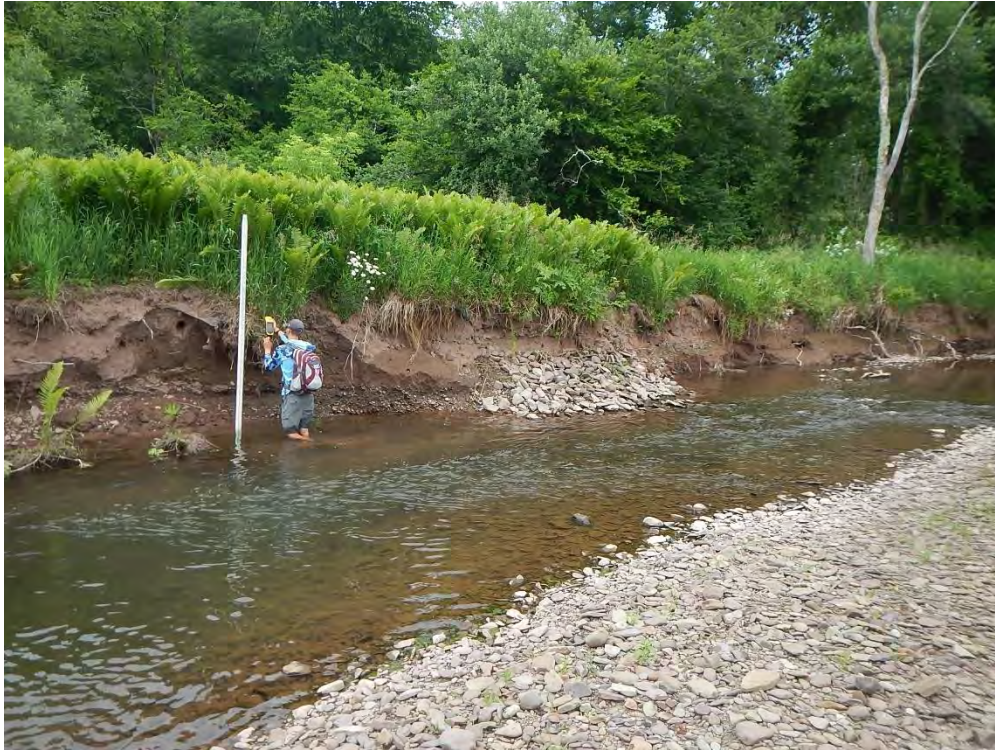
**Site 8-b: Erosion along the right bank. Note the shallow rooting depth of the herbaceous vegetation on the bank. Photo taken looking upstream at STA ~706+50.**

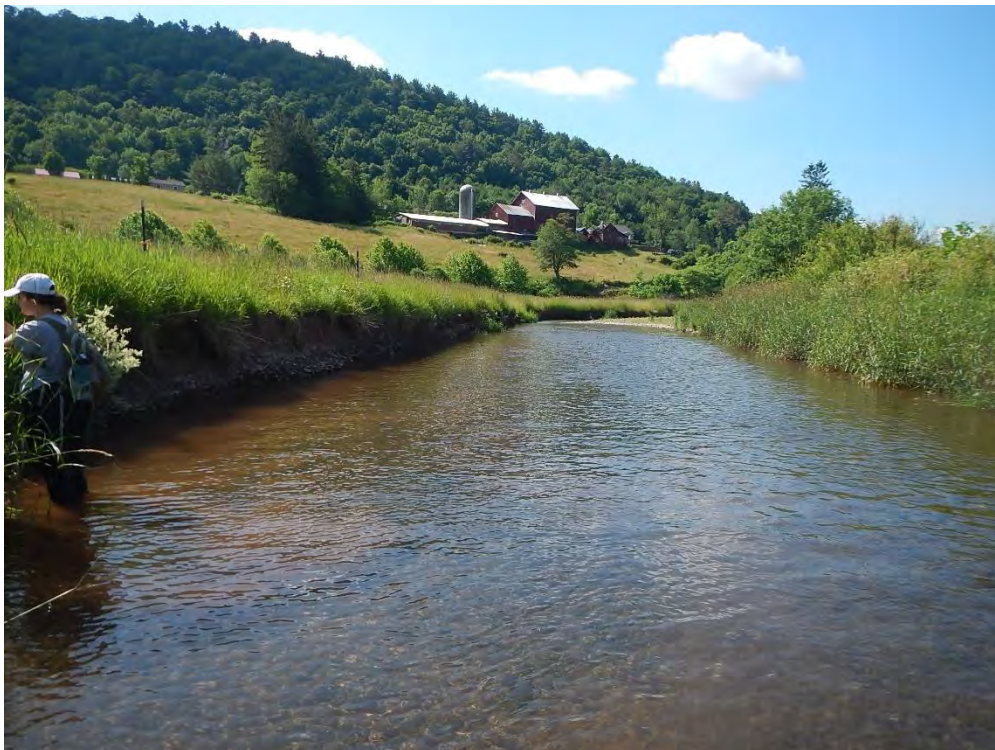
**Site 9-a: Erosion along an agricultural field on the left bank. Photo taken before stabilization project was completed. Photo taken looking downstream at STA ~774+00.**

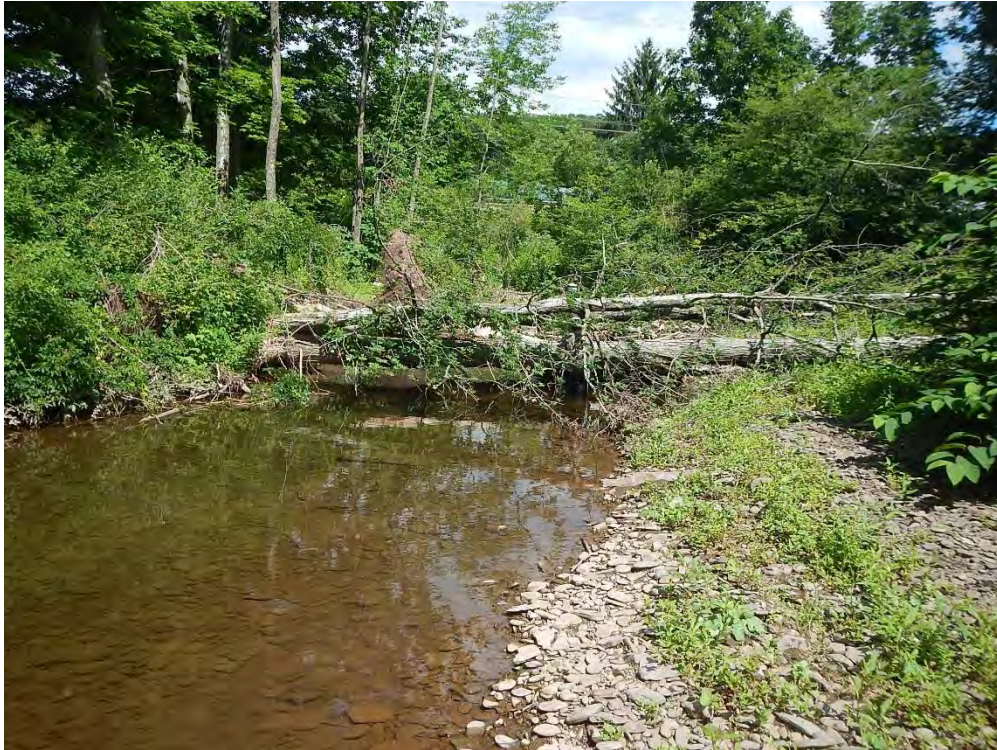
**Site 10-a: Erosion along the right bank with trees cantilevered across the channel and an aggrading point bar on left bank. Photo taken looking upstream at STA ~833+00.**

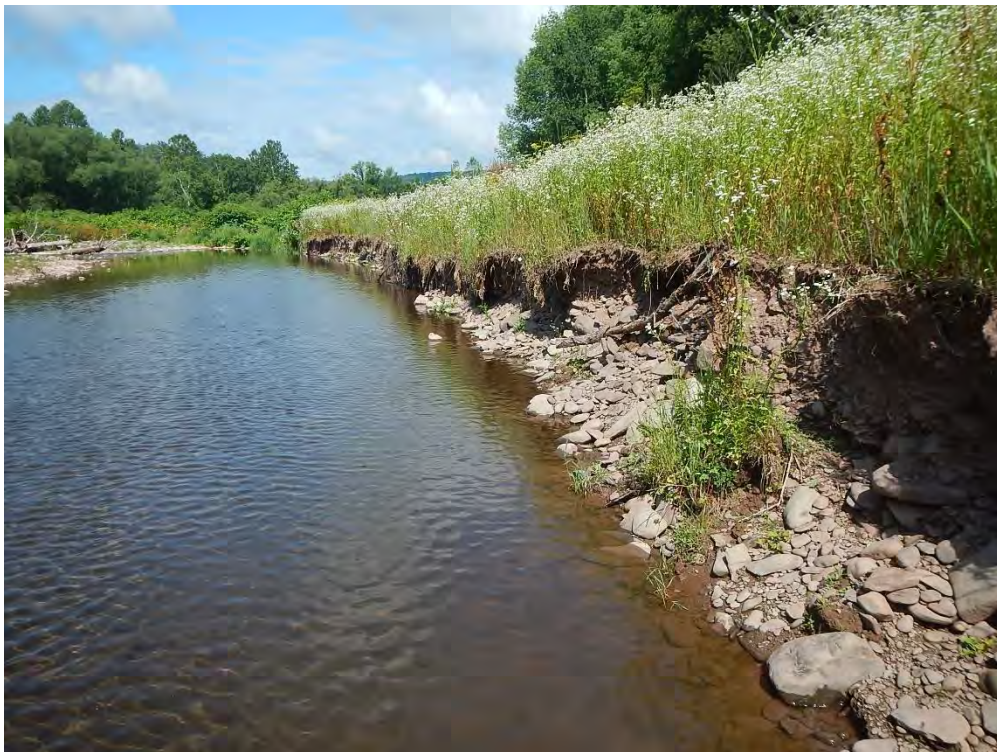
**Site 11-a: Erosion along the right bank of an old field. Note the unconsolidated material that the bank is comprised of. Photo taken looking downstream at STA ~907+50.**

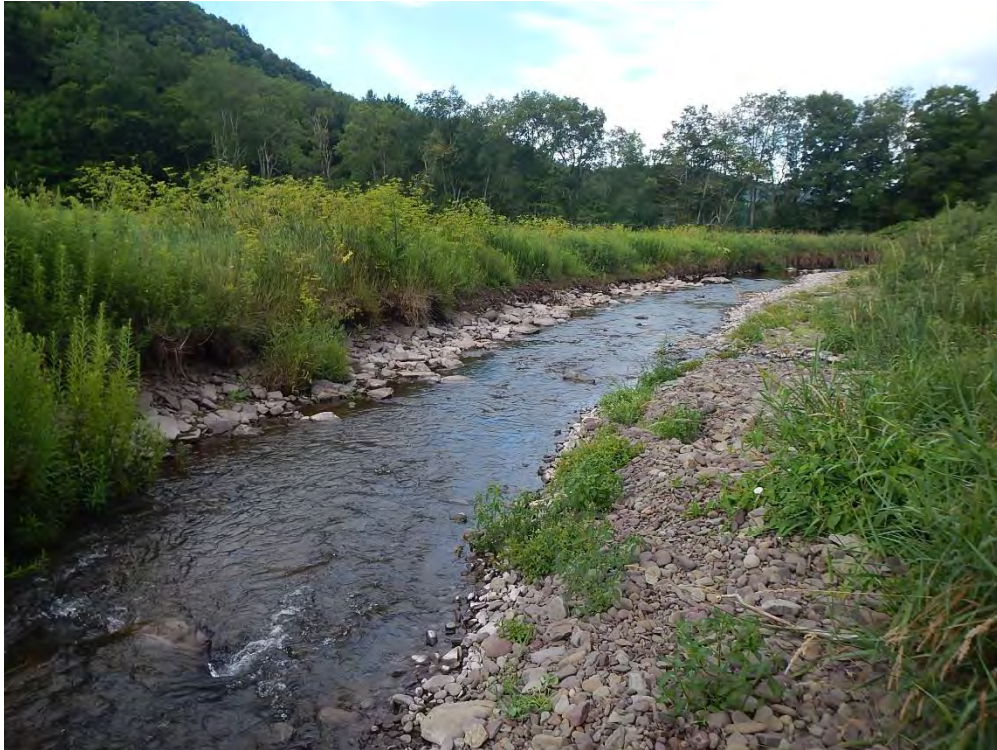
**Site 14-a: Erosion along the left bank of a hay field with an aggrading point bar on the right bank. Photo taken looking downstream at STA ~1020+00.**

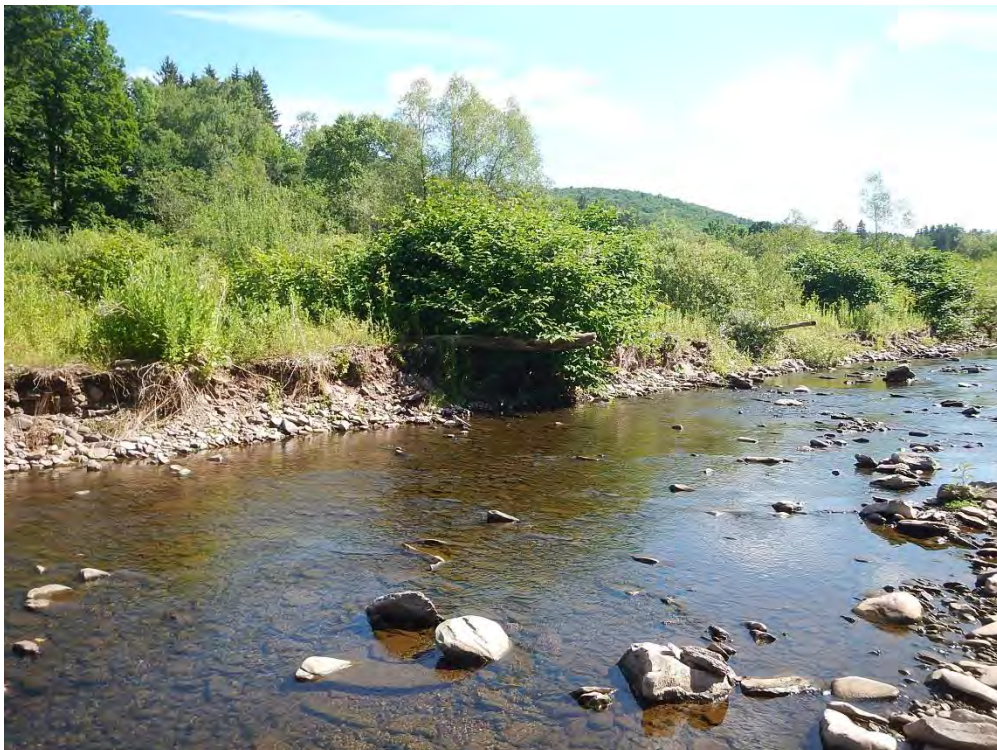
**Site 14-b: Erosion along the right bank. Photo taken looking upstream at STA ~1046+00.**

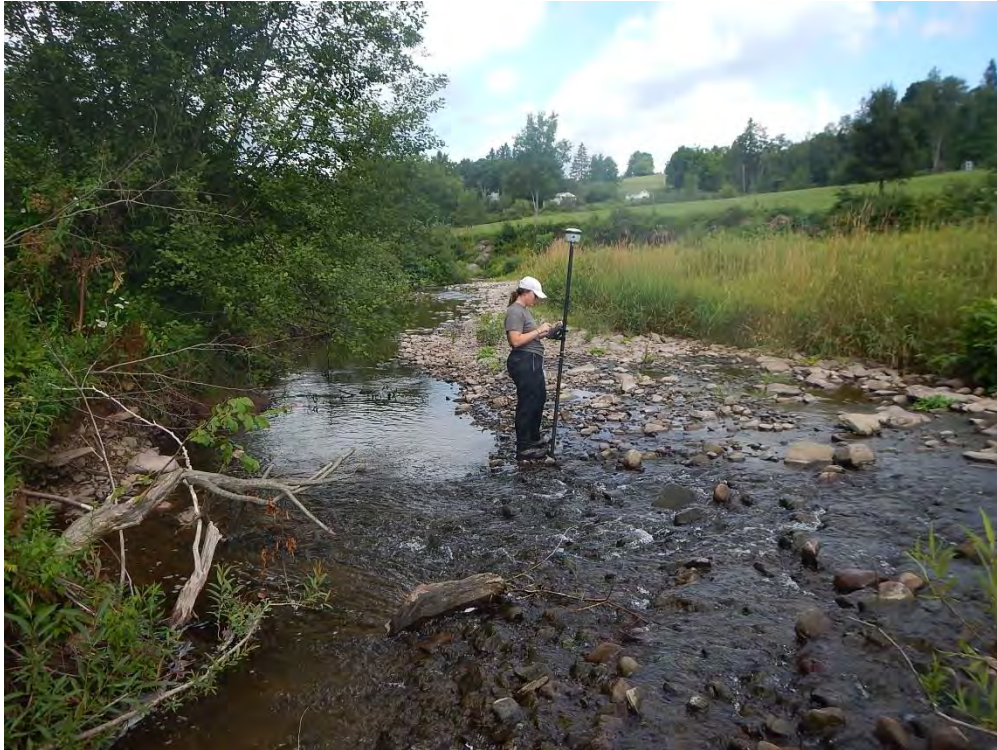
**Site 15-a: Transverse bar directing flow into eroding left bank. Photo taken looking downstream at STA ~1060+00.**

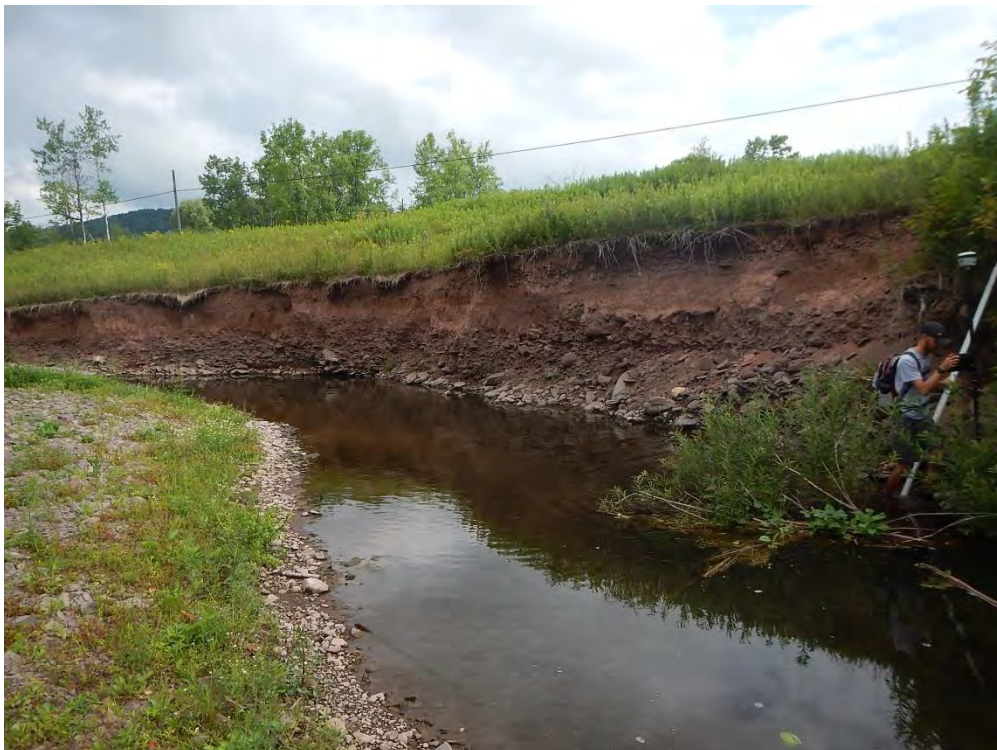
**Site 15-b: Erosion along the right bank. Note the shallow rooting depth of the vegetation on the bank. Photo taken looking downstream at STA ~1102+00.**
