Estimating Nutrient Loads from Two Streambank Erosion Sites on the West Branch Delaware River, Delaware County, New York

October 2021

**Delaware County Soil and Water Conservation District
44 West Street
Walton, NY 13856**

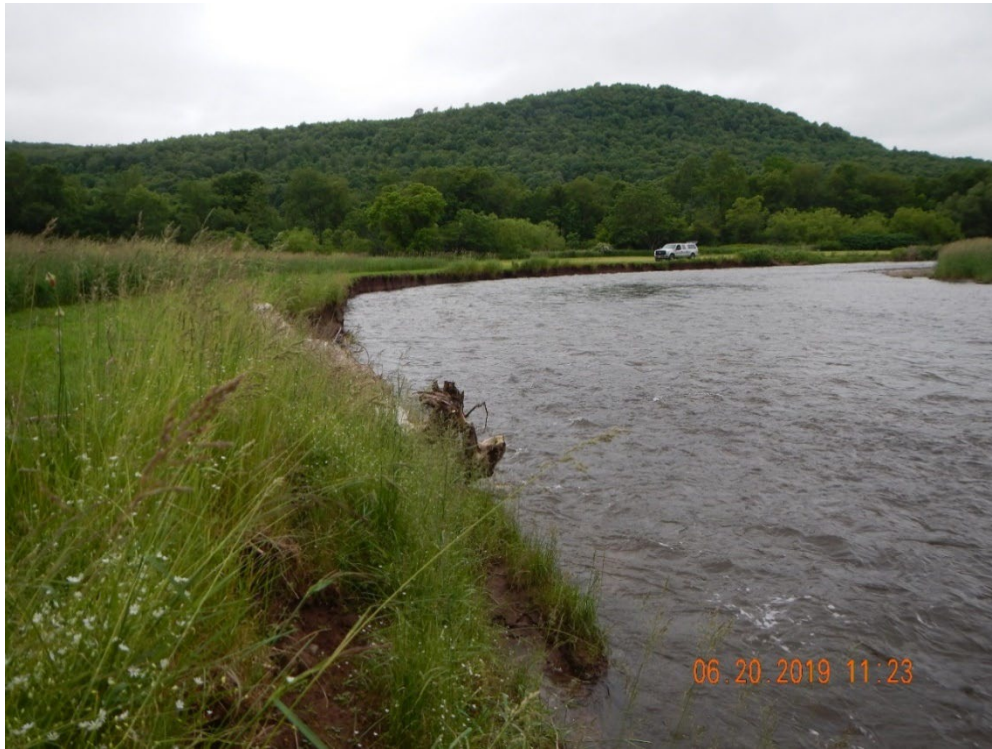
Figure 2: Photograph of streambank erosion at Birdsong Farm in 2019 (looking upstream).

This study evaluated streambank erosion that occurred between 2009 and 2019 from two sites that are 2.3 km (1.4 miles) apart on the West Branch Delaware River (Figure 1). Birdsong farm is located 2.4 km (1.5 miles) north of Delancey, NY; the 283 m (929 LF) of active streambank erosion that was investigated occurred at a hay field without riparian forest tree cover. Erosion at Birdsong farm is driven by extreme near-bank stress due to increasing deposition around an in-stream island opposite the eroding right streambank.

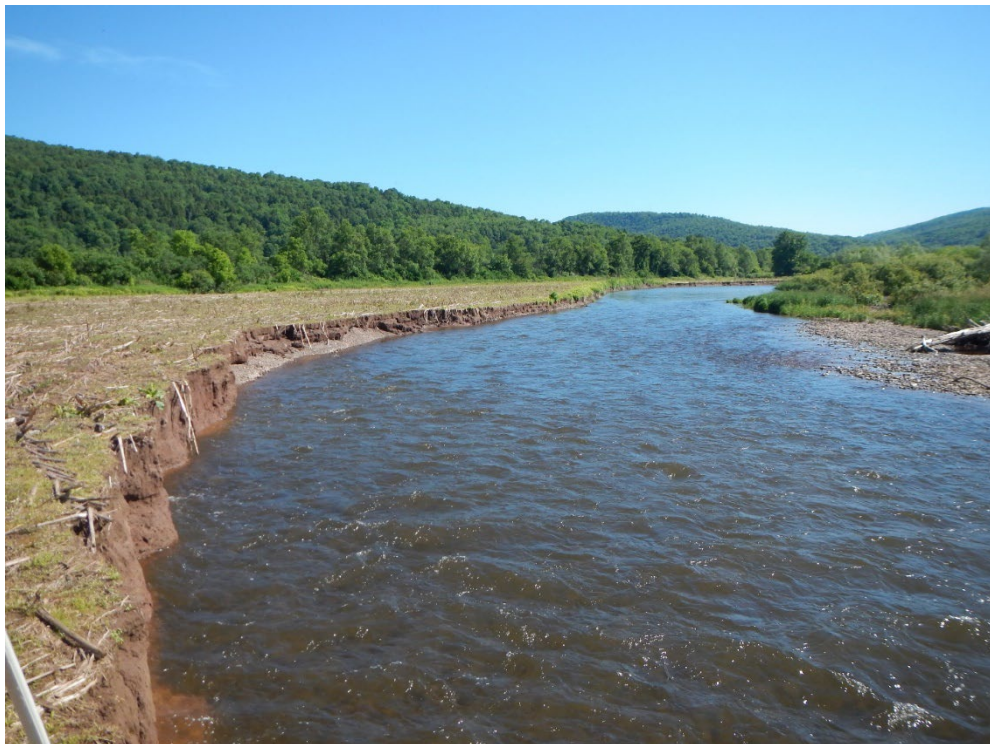
Figure 3: Photograph of streambank erosion at River Haven Farm in 2019 (looking upstream).

River Haven Farm experienced similar streambank erosion issues just upstream of the hamlet of Delancey, NY. The right streambank had 404 m (1,326 LF) of active erosion with a left bank section of 84 m (275 LF) that had eroded. The land use consisted of 380 m of continuous corn (right bank), 24 m of wetland (right bank), and 84 m of hay field (left bank). Neither bank had riparian forest tree cover. A tributary known as Bagley Brook meets the WBDR directly across from the eroding continuous corn field where it has built a delta bar. The delta bar has grown in size between 2009 and 2019. Consequently, the river's hydraulics have been altered in a way that has caused excessive erosion to continue. Presence of this growing delta bar has resulted in the near-bank stress rating on these eroding streambanks to be assessed as extreme.

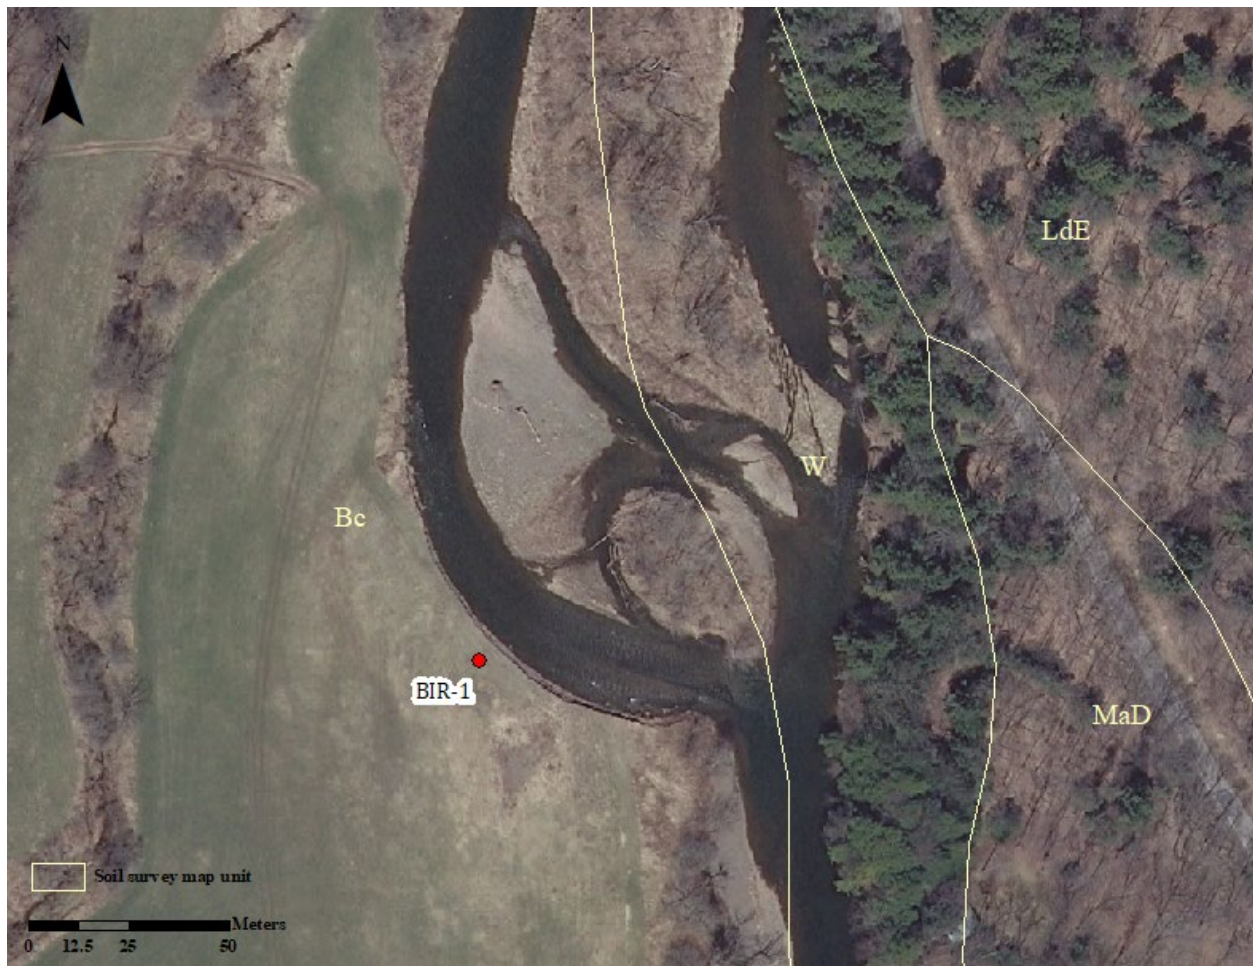
Figure 5: Soil survey map showing soil map units and location of study plot (superimposed on 2009 orthoimagery) at Birdsong Farm. The label identifies the plot with a three-letter prefix “BIR” for Birdsong.

Streambank erosion at Birdsong Farm occurred within a single Barbour loam map unit. As such, the study area was initially considered a single plot (Table 1 and Figure 5).

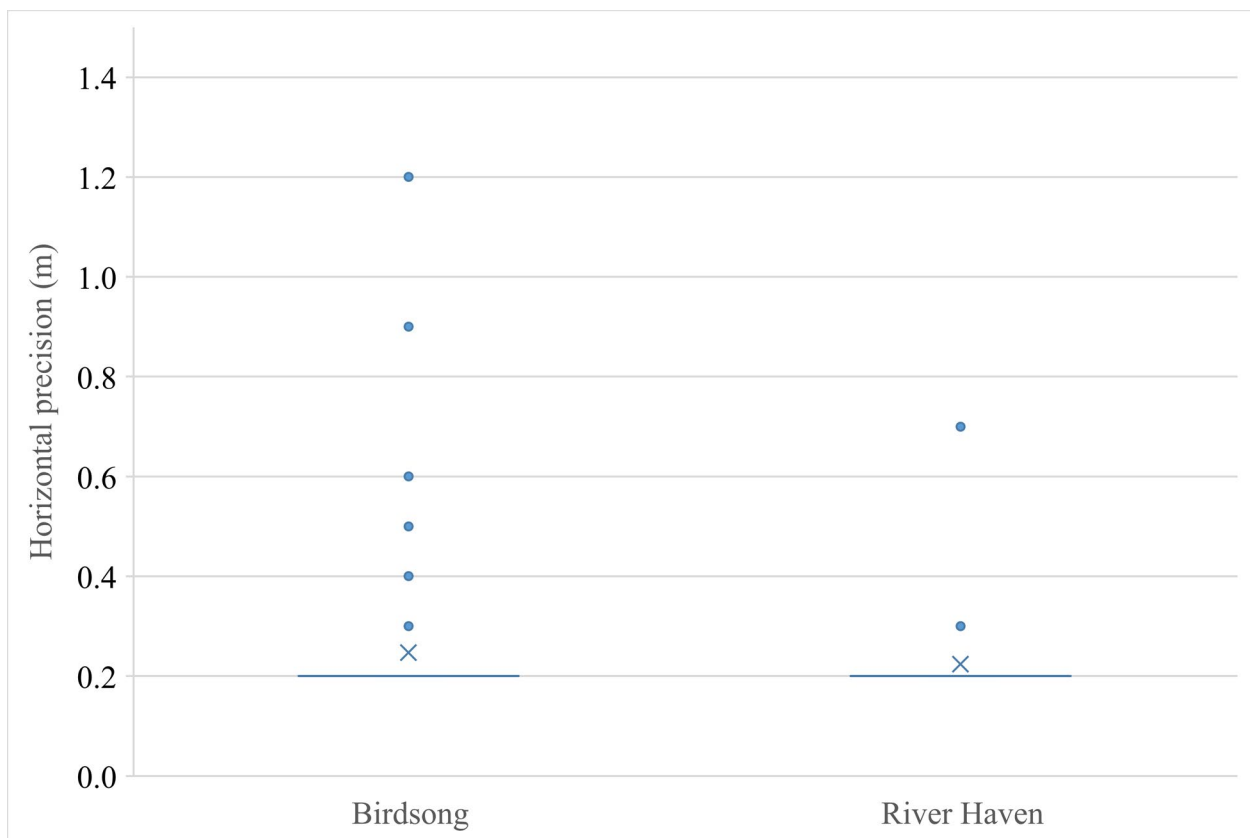
Figure 6: Boxplot of GPS point horizontal precision at Birdsong and River Haven locations.

Horizontal precision of points recorded at Birdsong and River Haven was very similar to that of the control points on the County Highway 2 bridge. The median horizontal precision of points at each location was 0.2 m. Precision was so consistent that first and third quartile values were also 0.2 m for points at each location. Six points at Birdsong Farm had horizontal precision values that were considered outliers, ranging from 0.3 m to 1.2 m (Figure 6). Three points at River Haven had horizontal precision values that were considered outliers. These precision values ranged from 0.3 m to 1.8 m (Figure 6). GPS points with horizontal precision values considered to be outliers were removed from the erosion delineation process and subsequent area calculations.

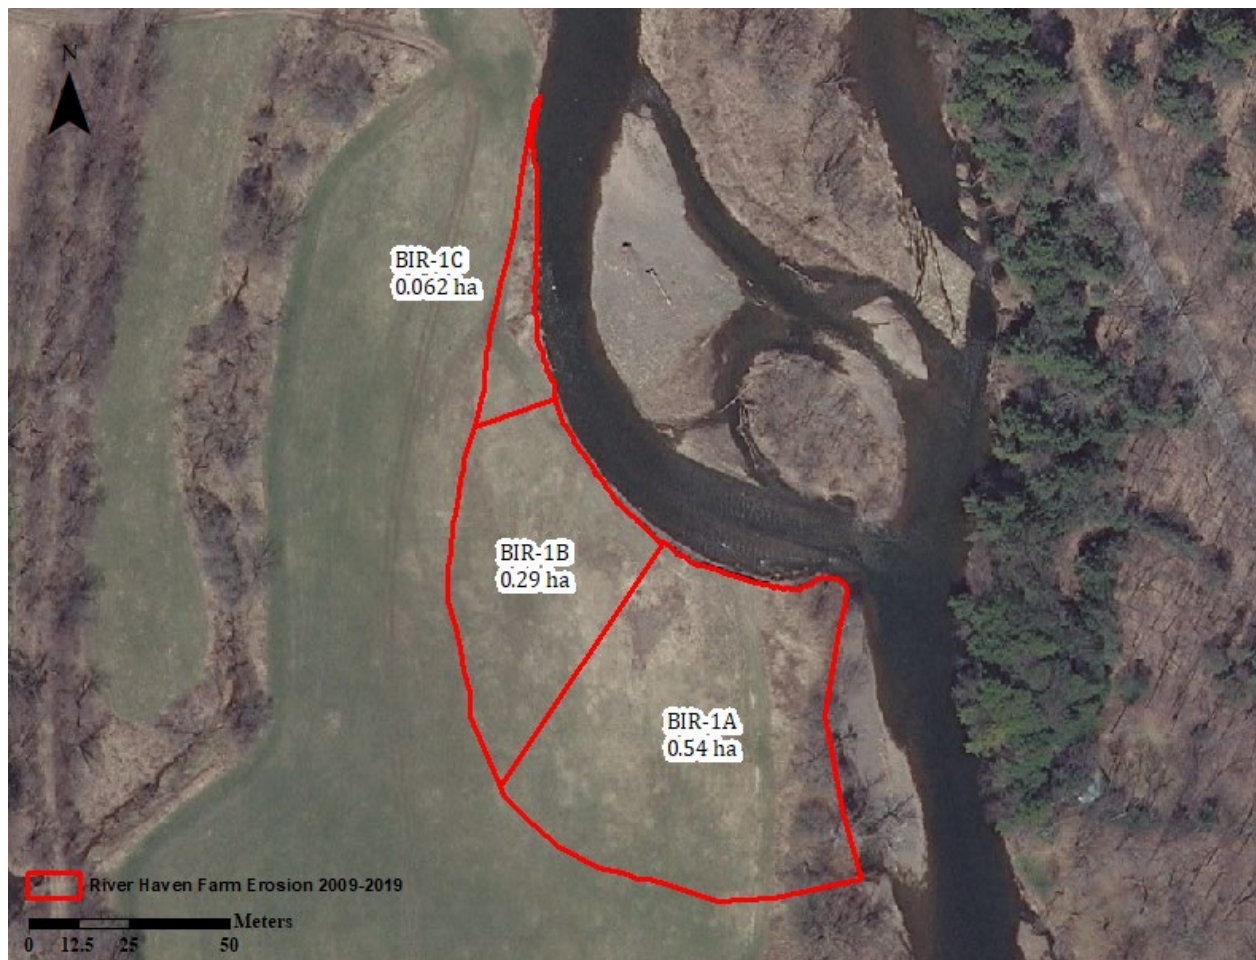
Figure 8: Superimposition of 2019 erosion extents on 2009 orthoimagery at Birdsong Farm, with plot identification.

Birdsong Farm plots yielded weighted average bank heights that ranged from 1.2 m to 1.4 m (Table 3). Total combined eroded lengths for these continuous plots was 278 m. Eroded area of Birdsong plots totaled 8,900 m², or 0.89 hectares (2.2 acres; Figure 8). Total eroded volume of these plots between 2009 and 2019 was approximately 12,000 m³, or roughly 995 16 yd³ dump truck loads.

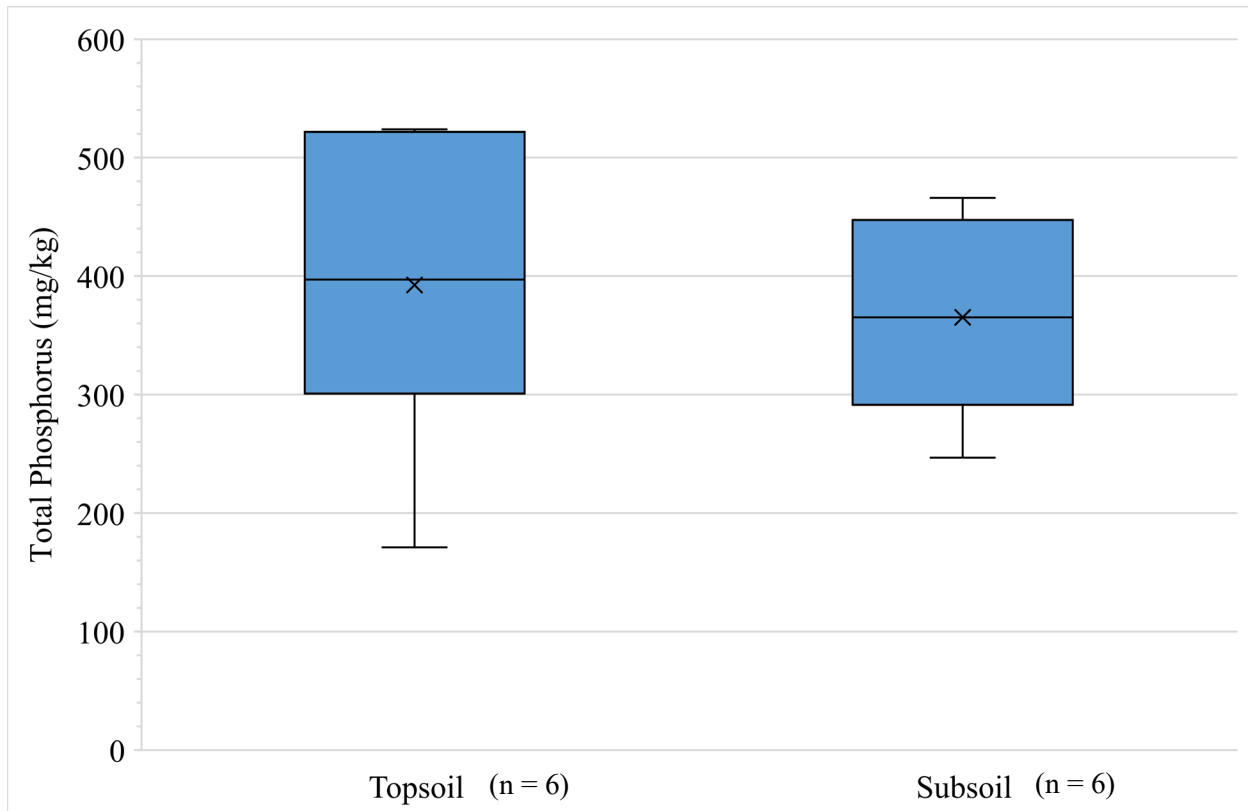
Figure 11: Boxplot of total phosphorus concentrations for topsoil and subsoil of study plots.

Twelve total composite soil samples were analyzed for TN and TP constituents; six being topsoil and six being subsoil samples. Topsoil TP concentrations ranged from 171 mg/kg to 524 mg/kg with a mean of 392 mg/kg and standard deviation of 134 mg/kg (Figure 11). Subsoil TP concentrations spanned a range of 247 mg/kg to 466 mg/kg with a mean of 365 mg/kg and a standard deviation of 86 mg/kg.

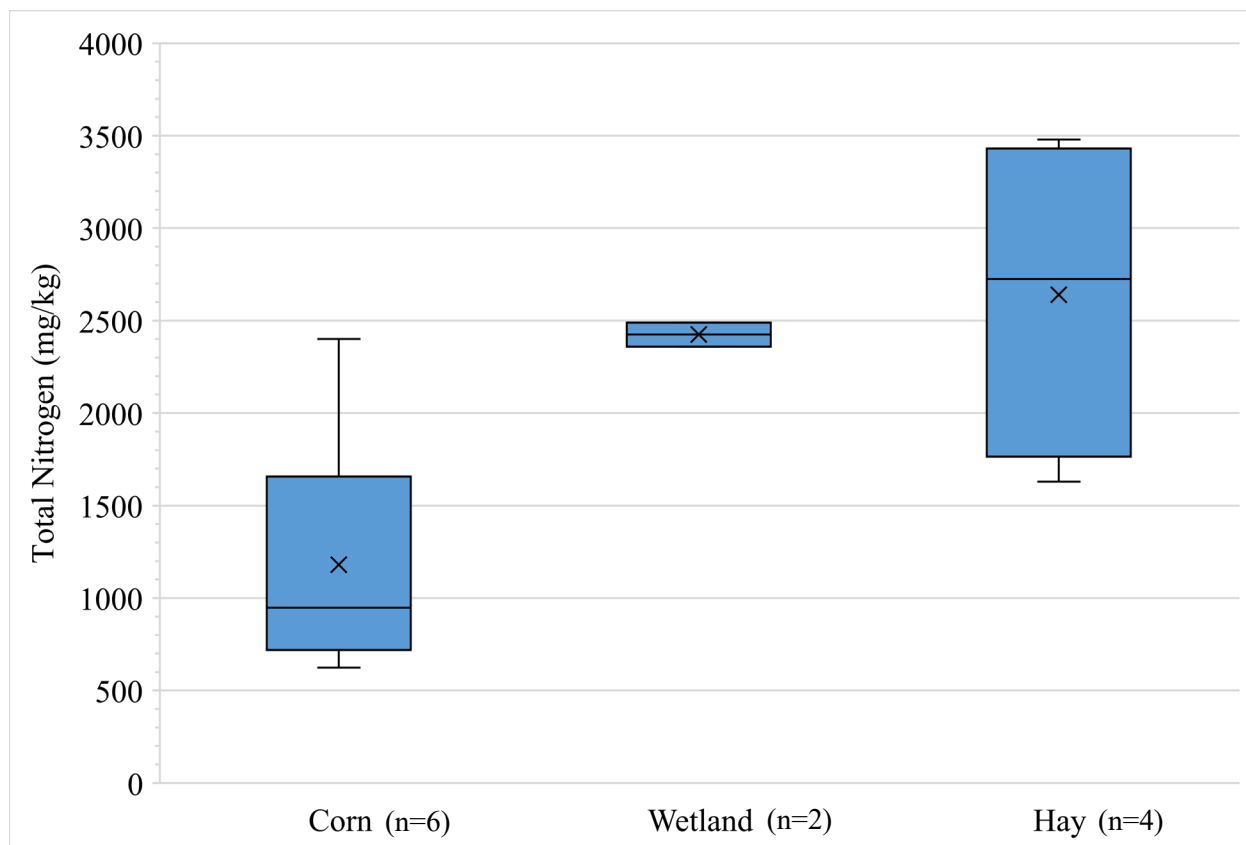
Figure 14: Boxplot of total nitrogen concentrations by land use.

The highest average TN concentration was found in hay streambanks with 2640 mg/kg though hay banks also had the greatest range of concentrations (Figure 14). Corn streambank samples produced the lowest average TN and lowest single sample TN concentrations of 1180 mg/kg and 624 mg/kg, respectively.
