# **Ouleout Creek Geomorphic Assessment, Nutrient Load Estimation, and Remediation Recommendations**

**November 2023**

**Delaware County Soil and Water Conservation District**

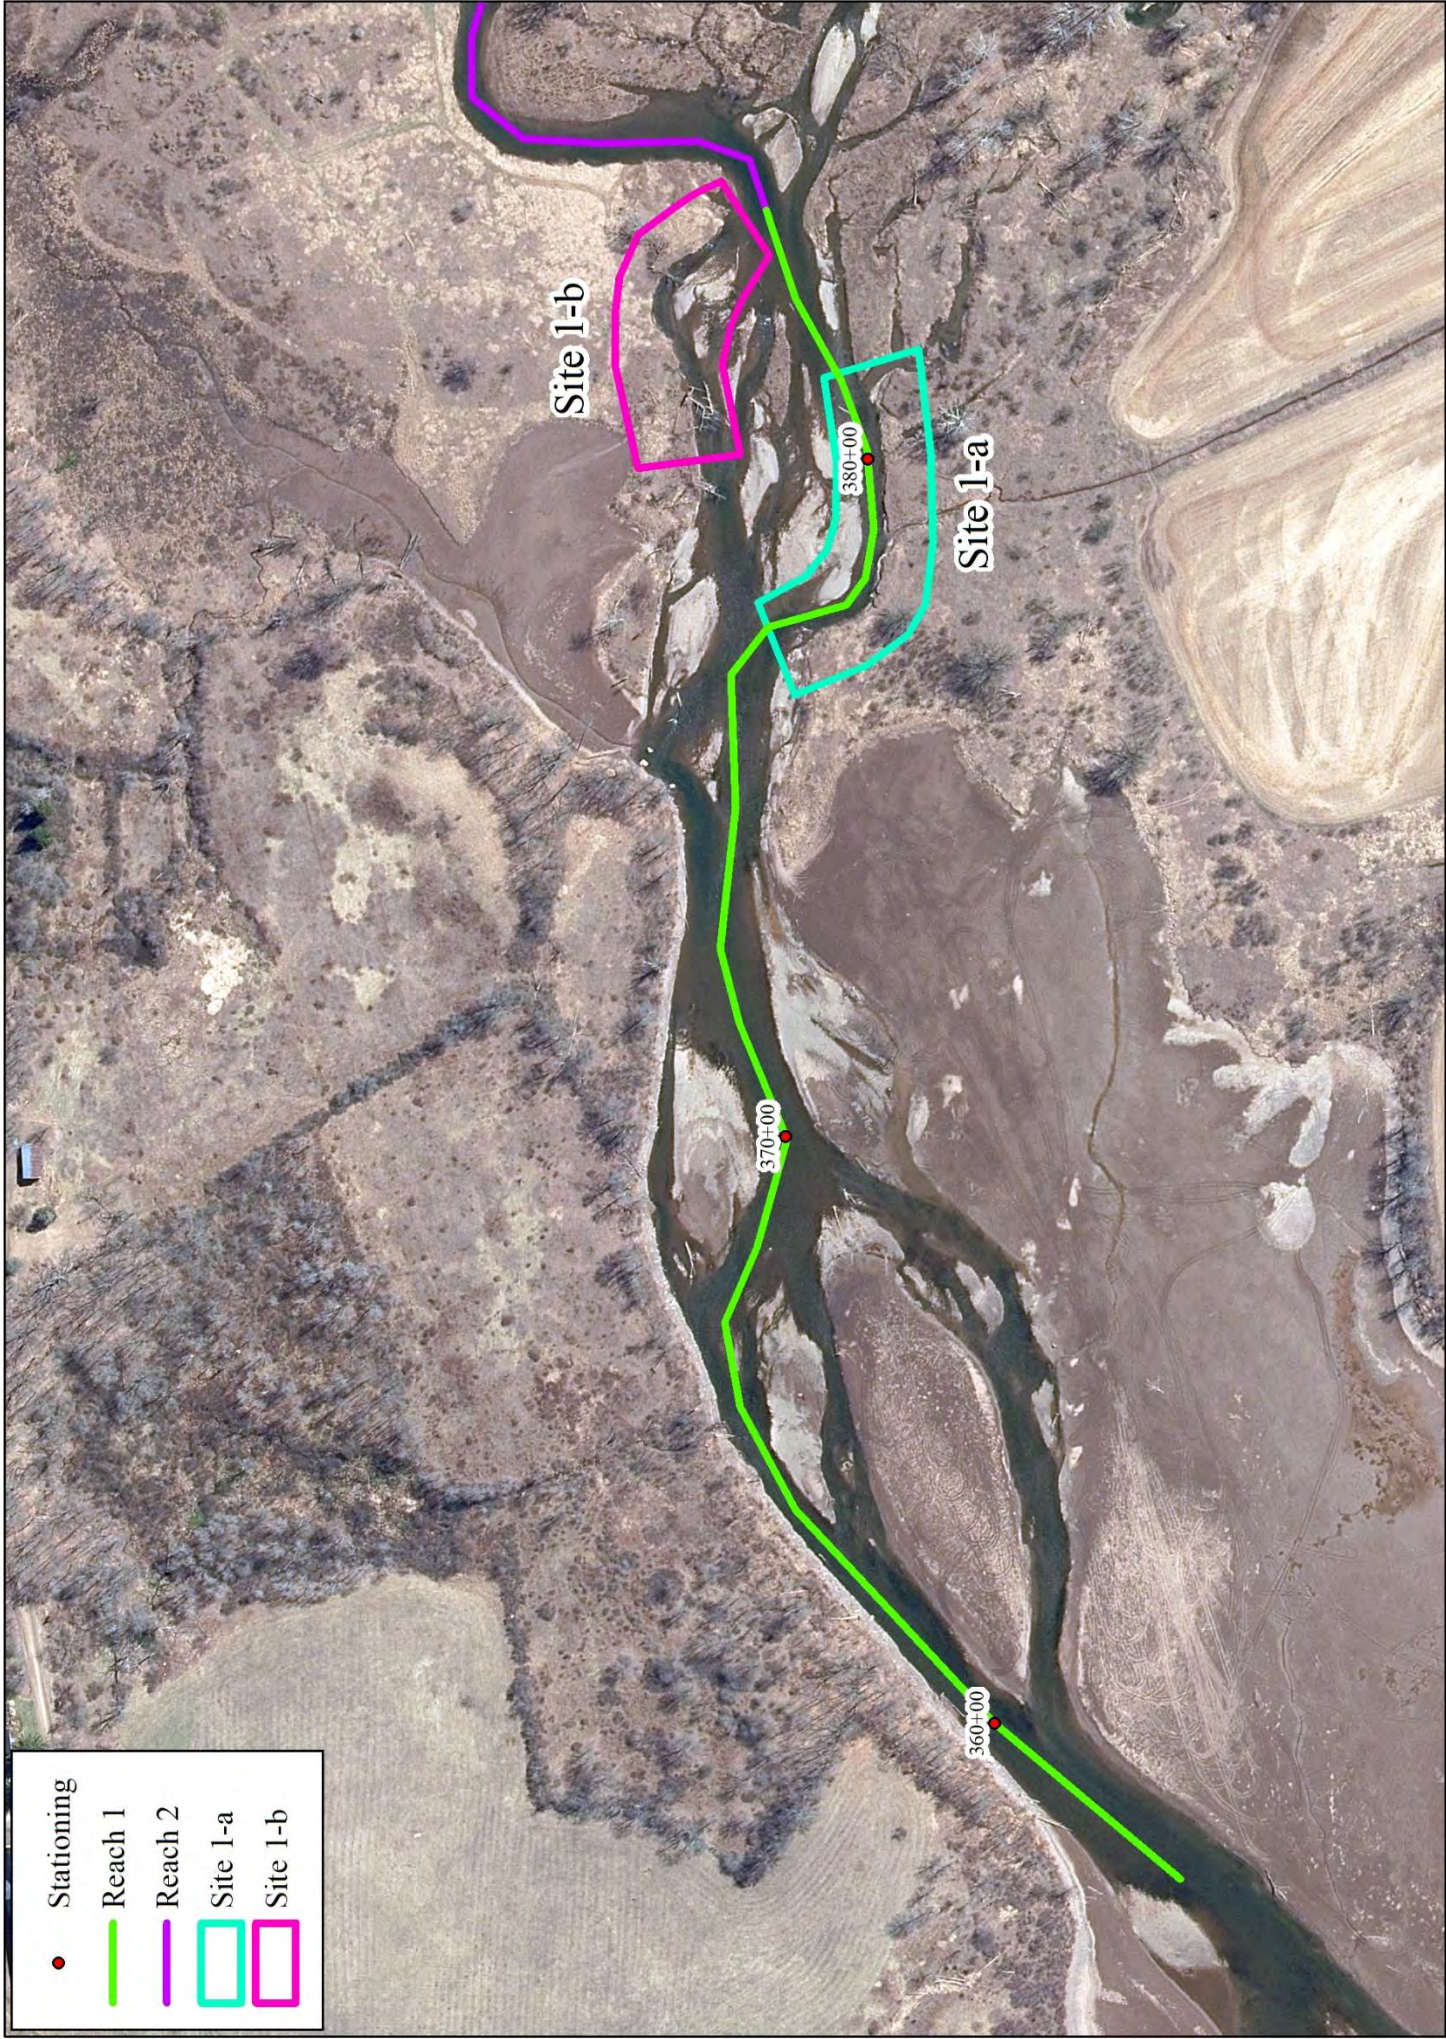
Figure 25: Reach 1 Map

In the assessed portion of the reach, 42.5% of the banks were actively eroding at the time of assessment and it is estimated that 300 yd<sup>3</sup> of sediment erodes annually from the streambanks in the reach. In addition, 820 lb of TN and 460 lb of TP are estimated to erode annually from the streambanks in the reach. This reach ranked 7th among reaches for the volume of eroded sediment, 6th for the mass of eroded TN, and 3rd for the mass of eroded TP. The two sites of substantial erosion in the reach can be viewed on the reach map in **Figure 25**.

It is estimated that 170 yd<sup>3</sup> of sediment has eroded annually from Site 1-b. This site accounted for 56% of the eroded volume of sediment in the reach and 3.0% of the eroded volume of sediment along the main stem of the Ouleout. This eroded volume equates to 190 tons of sediment. It is estimated that 260 lb of TP and 460 lb of TN have eroded annually from the site. This site accounted for 56% of the eroded TP in Reach 1 and 6.7% of the eroded TP along the main stem of the Ouleout. Additionally, this site accounted for 56% of the eroded TN in Reach 1 and 4.0% of the eroded TN along the main stem of the Ouleout. Of the sites of substantial erosion along the main stem of the Ouleout, this site ranked 8th for the volume of eroded sediment, 6th for the mass of eroded TN, and 4th for the mass of eroded TP.

The channel is over widened in this section with several excessive sediment depositions in the channel. The oversized cobble bars direct the stream into the right bank further exacerbating the erosion. Similar to what was previously discussed regarding Site 1-a, this site is in the area where the stream channel is seasonally inundated by East Sidney Lake. Because of this, the same problems regarding remediation with Site 1-a are relevant to this site. The streambank would need to be stabilized with revetment. It is unlikely shifting or realigning the channel would be a feasible solution due to the effect of the Lake, the multiple excessive sediment depositions, and the natural deltaic cycle of sediment deposition and transport at the site. A riparian forest buffer could be planted on the streambank but the trees may have added difficulty becoming established due to the Lake's varying water level. A few mature sycamores and willows are scattered along the right bank floodplain indicating that these tree species could be used for a buffer at this site.

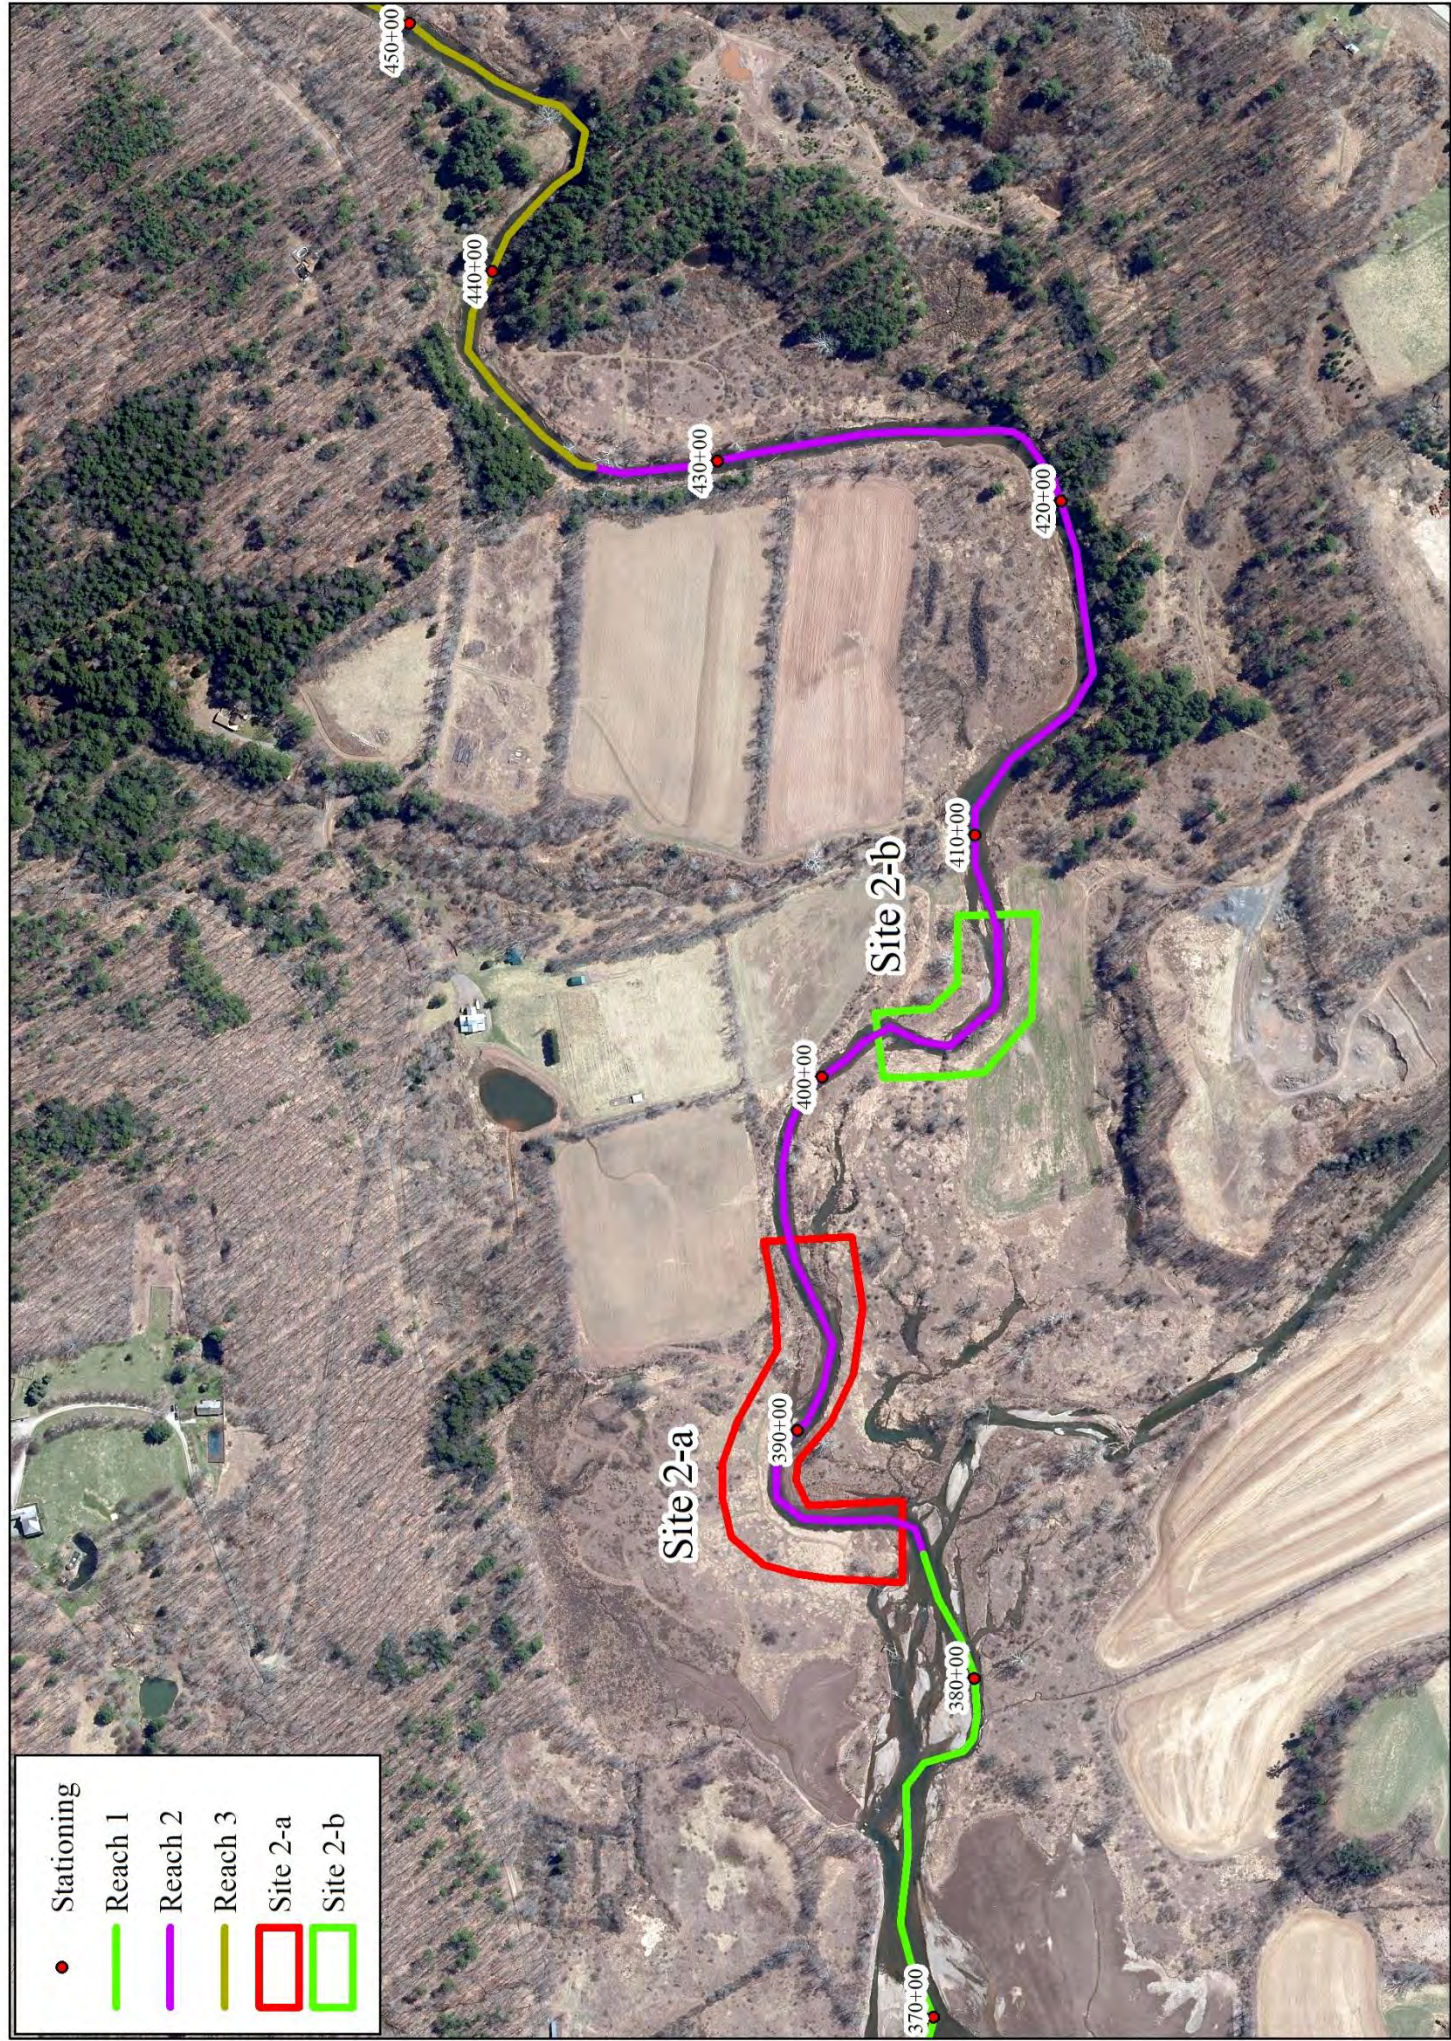
Figure 26: Reach 2 Map

In the reach, 42% of the banks were actively eroding at the time of assessment and it is estimated that 720 yd<sup>3</sup> of sediment erodes annually from the streambanks. In addition, 1,400 lb of TN and 720 lb of TP are estimated to erode annually from the streambanks in the reach. This reach ranked 2nd among reaches for the volume of eroded sediment, 2nd for the mass of eroded TN, and 1st for the mass of eroded TP. The two sites of substantial erosion in the reach can be viewed on the reach map in **Figure 26**.

At the time of assessment, the right bank of the Ouleout was actively eroding at several locations from STA 394+00 ft to STA 403+00 ft. The majority of this erosion was along the base of a terrace with agricultural fields at the top of the hillslope. An undersized riparian buffer separated the edge of the hillslope from the fields. Glacial till was observed intermittently throughout the toe of the hillslope. The erosion totaled to a length of 879 ft, had a maximum height of 7.8 ft, and it is estimated that 21 yd<sup>3</sup> of sediment erodes annually from the erosion segments. This erosion has the potential to increase in severity if the flow further impinges upon the base of the hillslope.

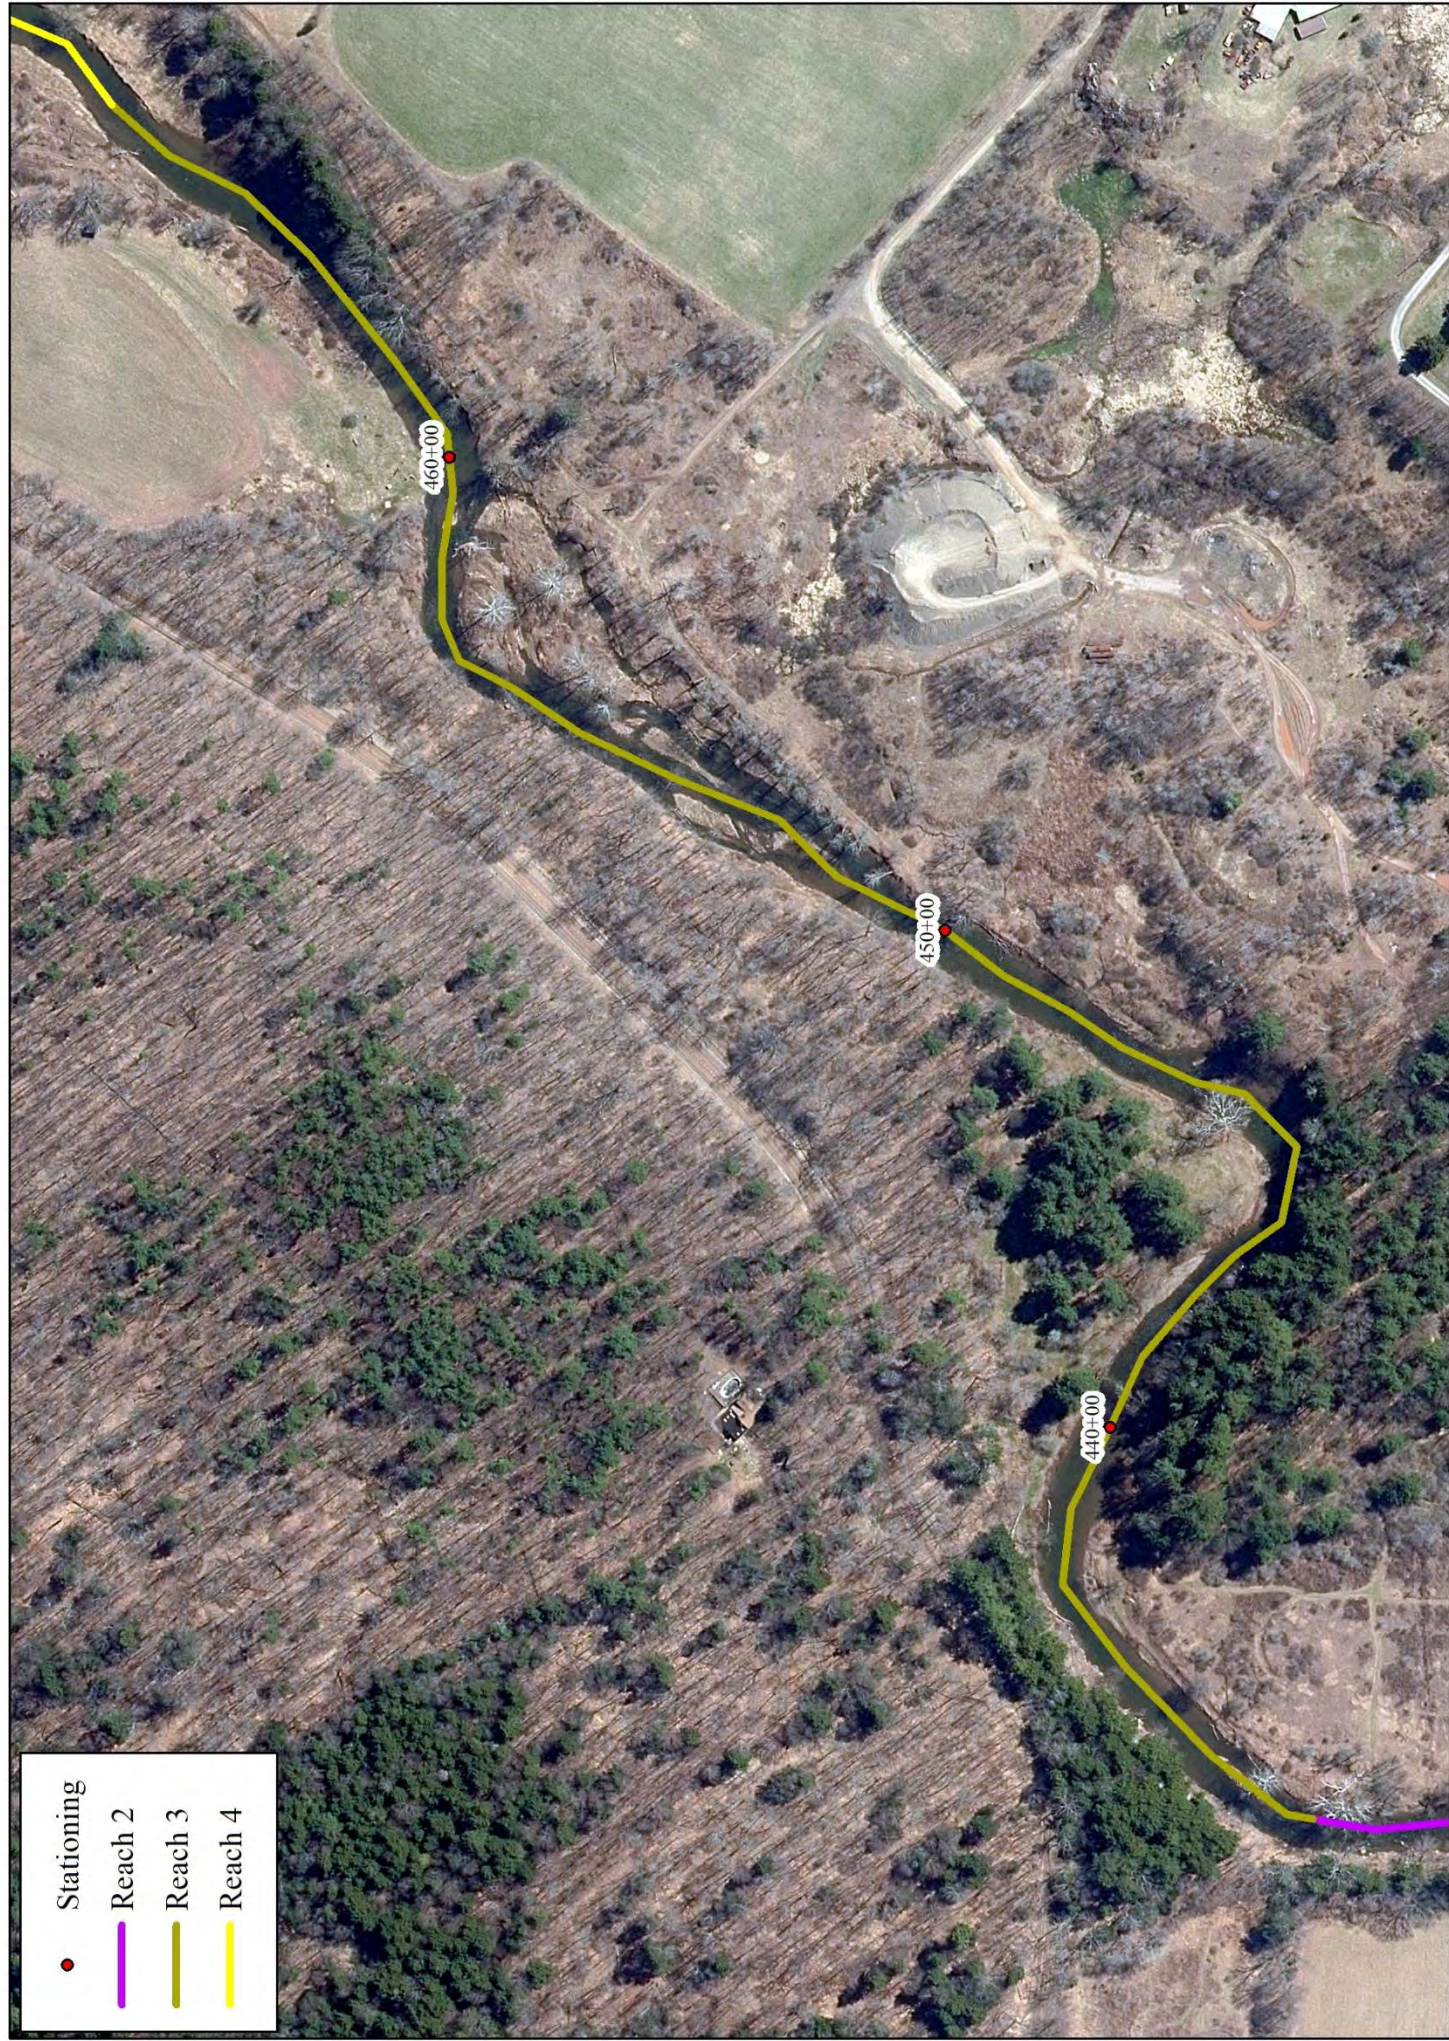
Figure 27: Reach 3 Map

In the reach, 43% of the banks were actively eroding and it is estimated that 47 yd<sup>3</sup> of sediment erodes annually from the reach. In addition, 99 lb of TN and 22 lb of TP are estimated to erode annually from the streambanks in the reach. This reach ranked 21st among reaches for the volume of eroded sediment, 21st for the mass of eroded TN, and 18th for the mass of eroded TP. The reach's location can be viewed on the reach map in **Figure 27**. While a large percentage of banks were eroding in the reach, their erosion rates were low and they were not a large source of sediment or nutrients.

No notable concerns were identified in Reach 3 regarding stream related issues that needed to be addressed.

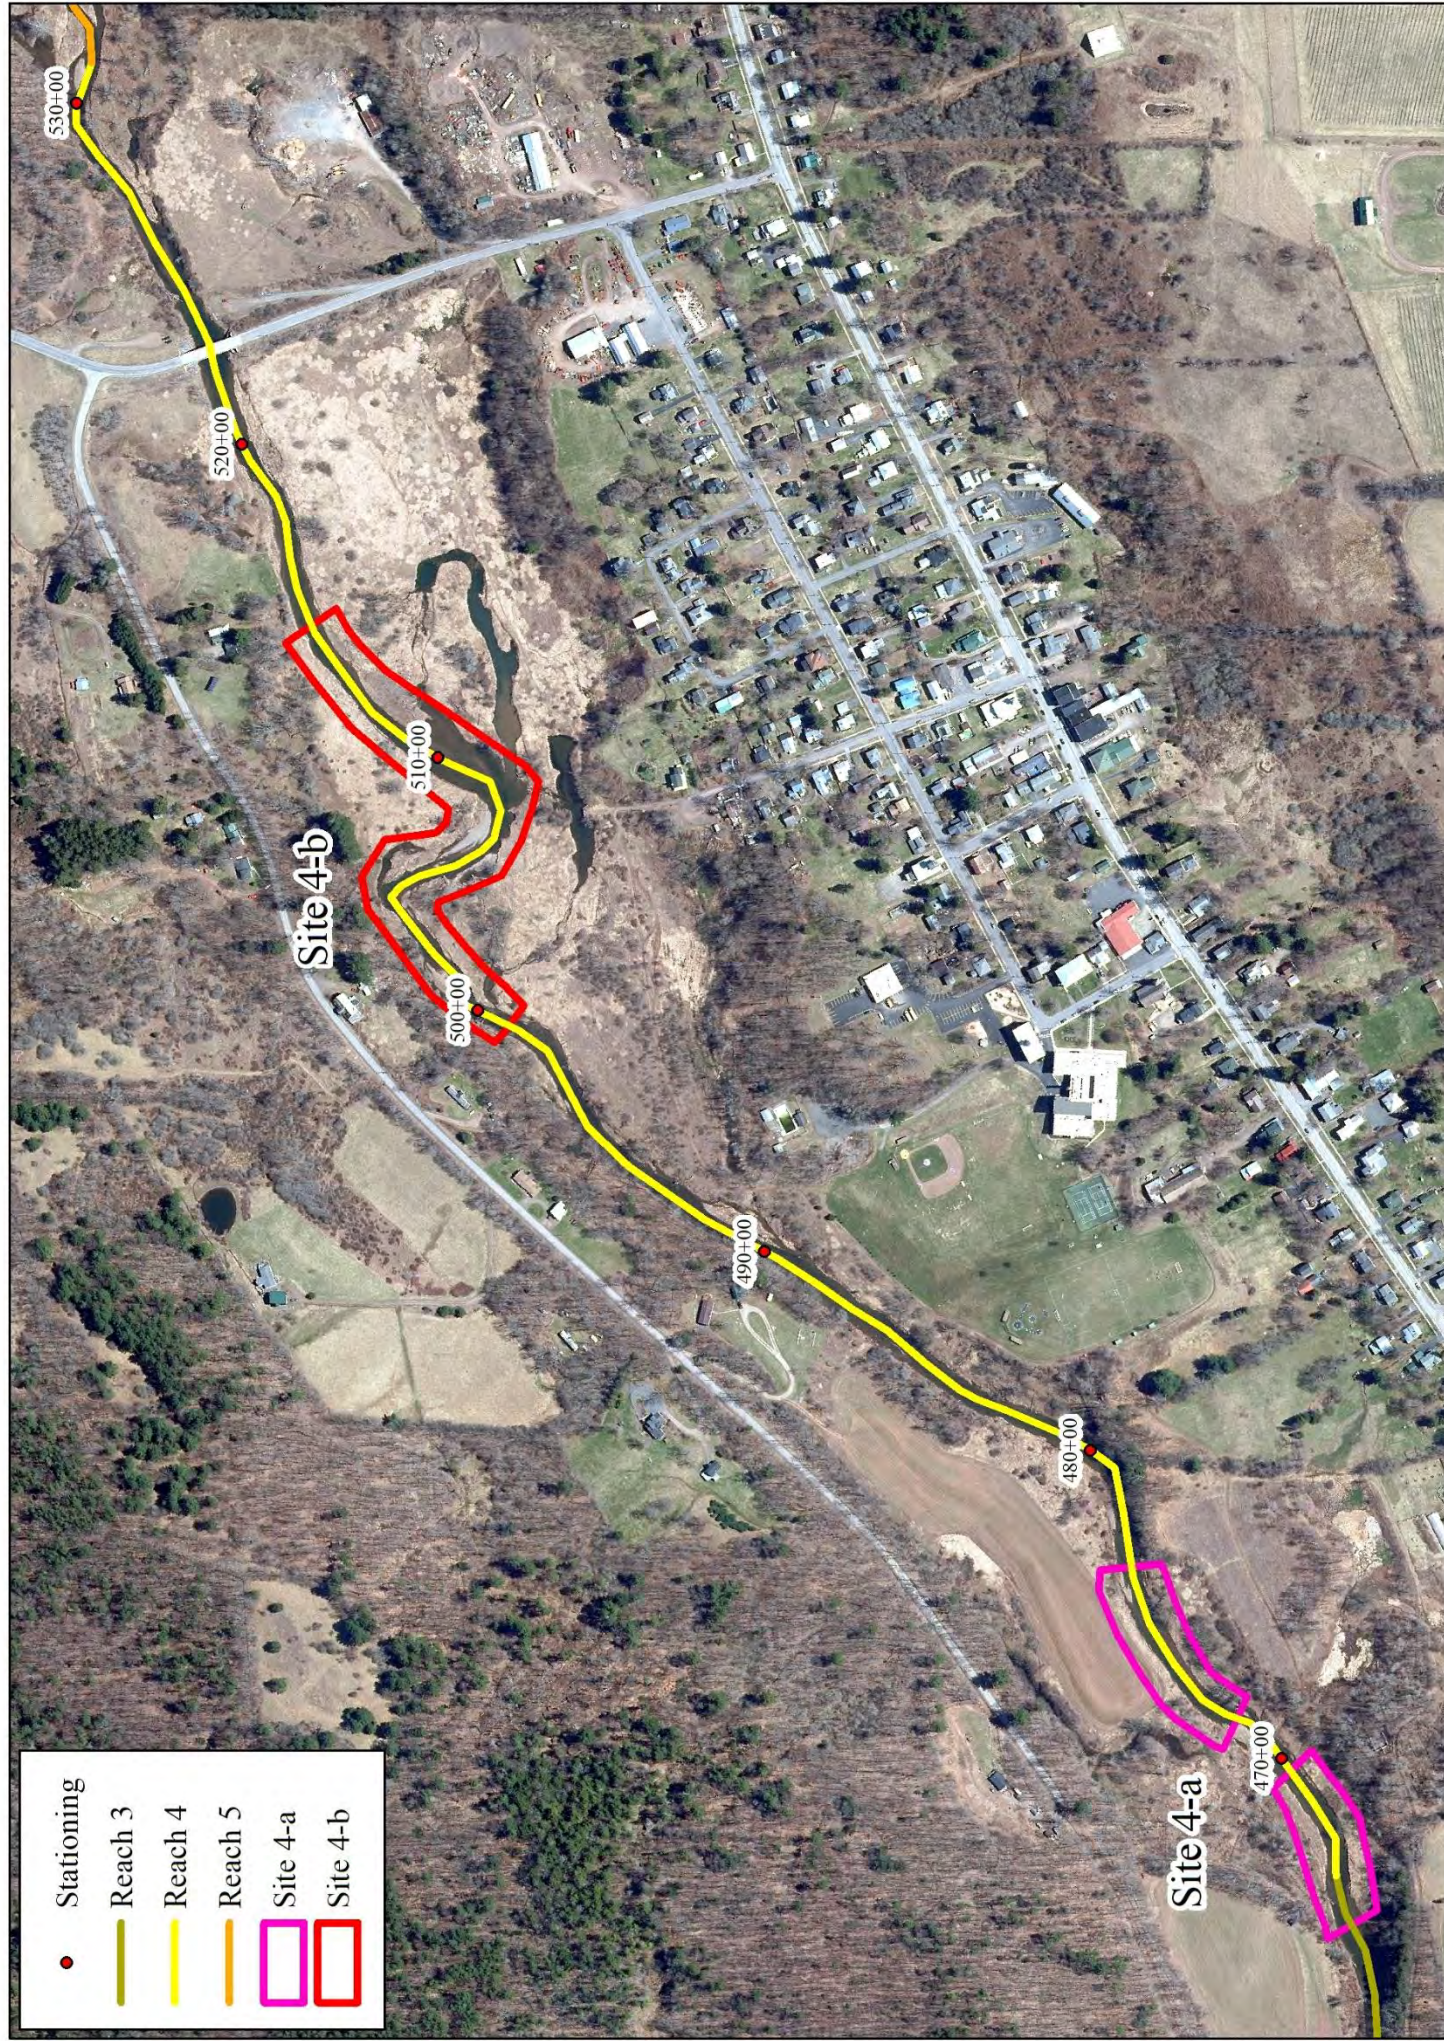
Figure 28: Reach 4 Map

In the reach, 28% of the banks were actively eroding and it is estimated that 1,100 yd<sup>3</sup> of sediment erodes annually from the reach. In addition, 1,700 lb of TN and 640 lb of TP are estimated to erode annually from the streambanks in the reach. This reach ranked 1st among reaches for the volume of eroded sediment, 1st for the mass of eroded TN, and 2nd for the mass of eroded TP. The two sites of substantial erosion in the reach can be viewed on the reach map in **Figure 28**.

This site of substantial erosion in Reach 4 consisted of several erosion segments along both banks from STA 500+00 ft to STA 514+00 ft. The erosion totaled 1,181 ft in length with an average height of 4.7 ft. The stream at this site was eroding into fields that were once used for agriculture historically but have since been abandoned. Since abandonment, the stream has shifted dramatically in this section due to the easily erodible soil and the lack of a riparian buffer to anchor the soil in place. This shifting caused several backwater oxbows to form over time due to the stream avulsing and forming new channels. The major cause of erosion in this section was a downstream meander migrating into the left bank as well as a bend in the channel migrating into the right bank. Historically, a bridge crossed the channel at this site immediately upstream of the left bank erosion. The bridge no longer exists, however, some of the revetment from the bridge is still present in the channel at this site. The revetment, in the form of large boulders, protrudes into the channel and could be contributing to the instability along the left bank by diverting flow into the left bank.

It is estimated that 860 yd<sup>3</sup> of sediment has eroded annually from Site 4-b. This site accounted for 76% of the eroded volume of sediment in the reach and 16% of the eroded volume of sediment along the main stem of the Ouleout. This eroded volume equates to 970 tons of sediment. It is estimated that 440 lb of TP and 1,200 lb of TN have eroded annually from the site. This site accounted for 68% of the eroded TP in Reach 4 and 11% of the eroded TP along the main stem of the Ouleout. Additionally, this site accounted for 68% of the eroded TN in Reach 4 and 10% of the eroded TN along the main stem of the Ouleout. Of the sites of substantial erosion along the main stem of the Ouleout, this site ranked 1st for the volume of eroded sediment, 1st for the mass of eroded TN, and 2nd for the mass of eroded TP.

An extensive stream stabilization project would need to occur at this site in order to remediate the erosion. The streambank would need to be stabilized with revetment in the form of rock or root wads to prevent further erosion along the streambanks. The channel planform would also need to be realigned so that the majority of flow does not impinge upon the streambank. The sinuosity of the channel would also need to be adjusted to a normal range. The channel is overwidened in some sections as well as pinched by excessive depositions in other sections. The channel would need to be resized to appropriate bankfull dimensions to prevent future excessive depositional features from forming. The current excessive depositional features would need to be resized and graded to appropriate dimensions. The old bridge revetment would need to be removed from the channel as well. The upstream end of the backwater oxbows would need to be plugged in order to prevent the stream from avulsing back into them. The downstream end of the backwater oxbows should be left in their current state to act as a wetland habitat. The final step would be to establish a riparian forest buffer to help stabilize the streambanks.

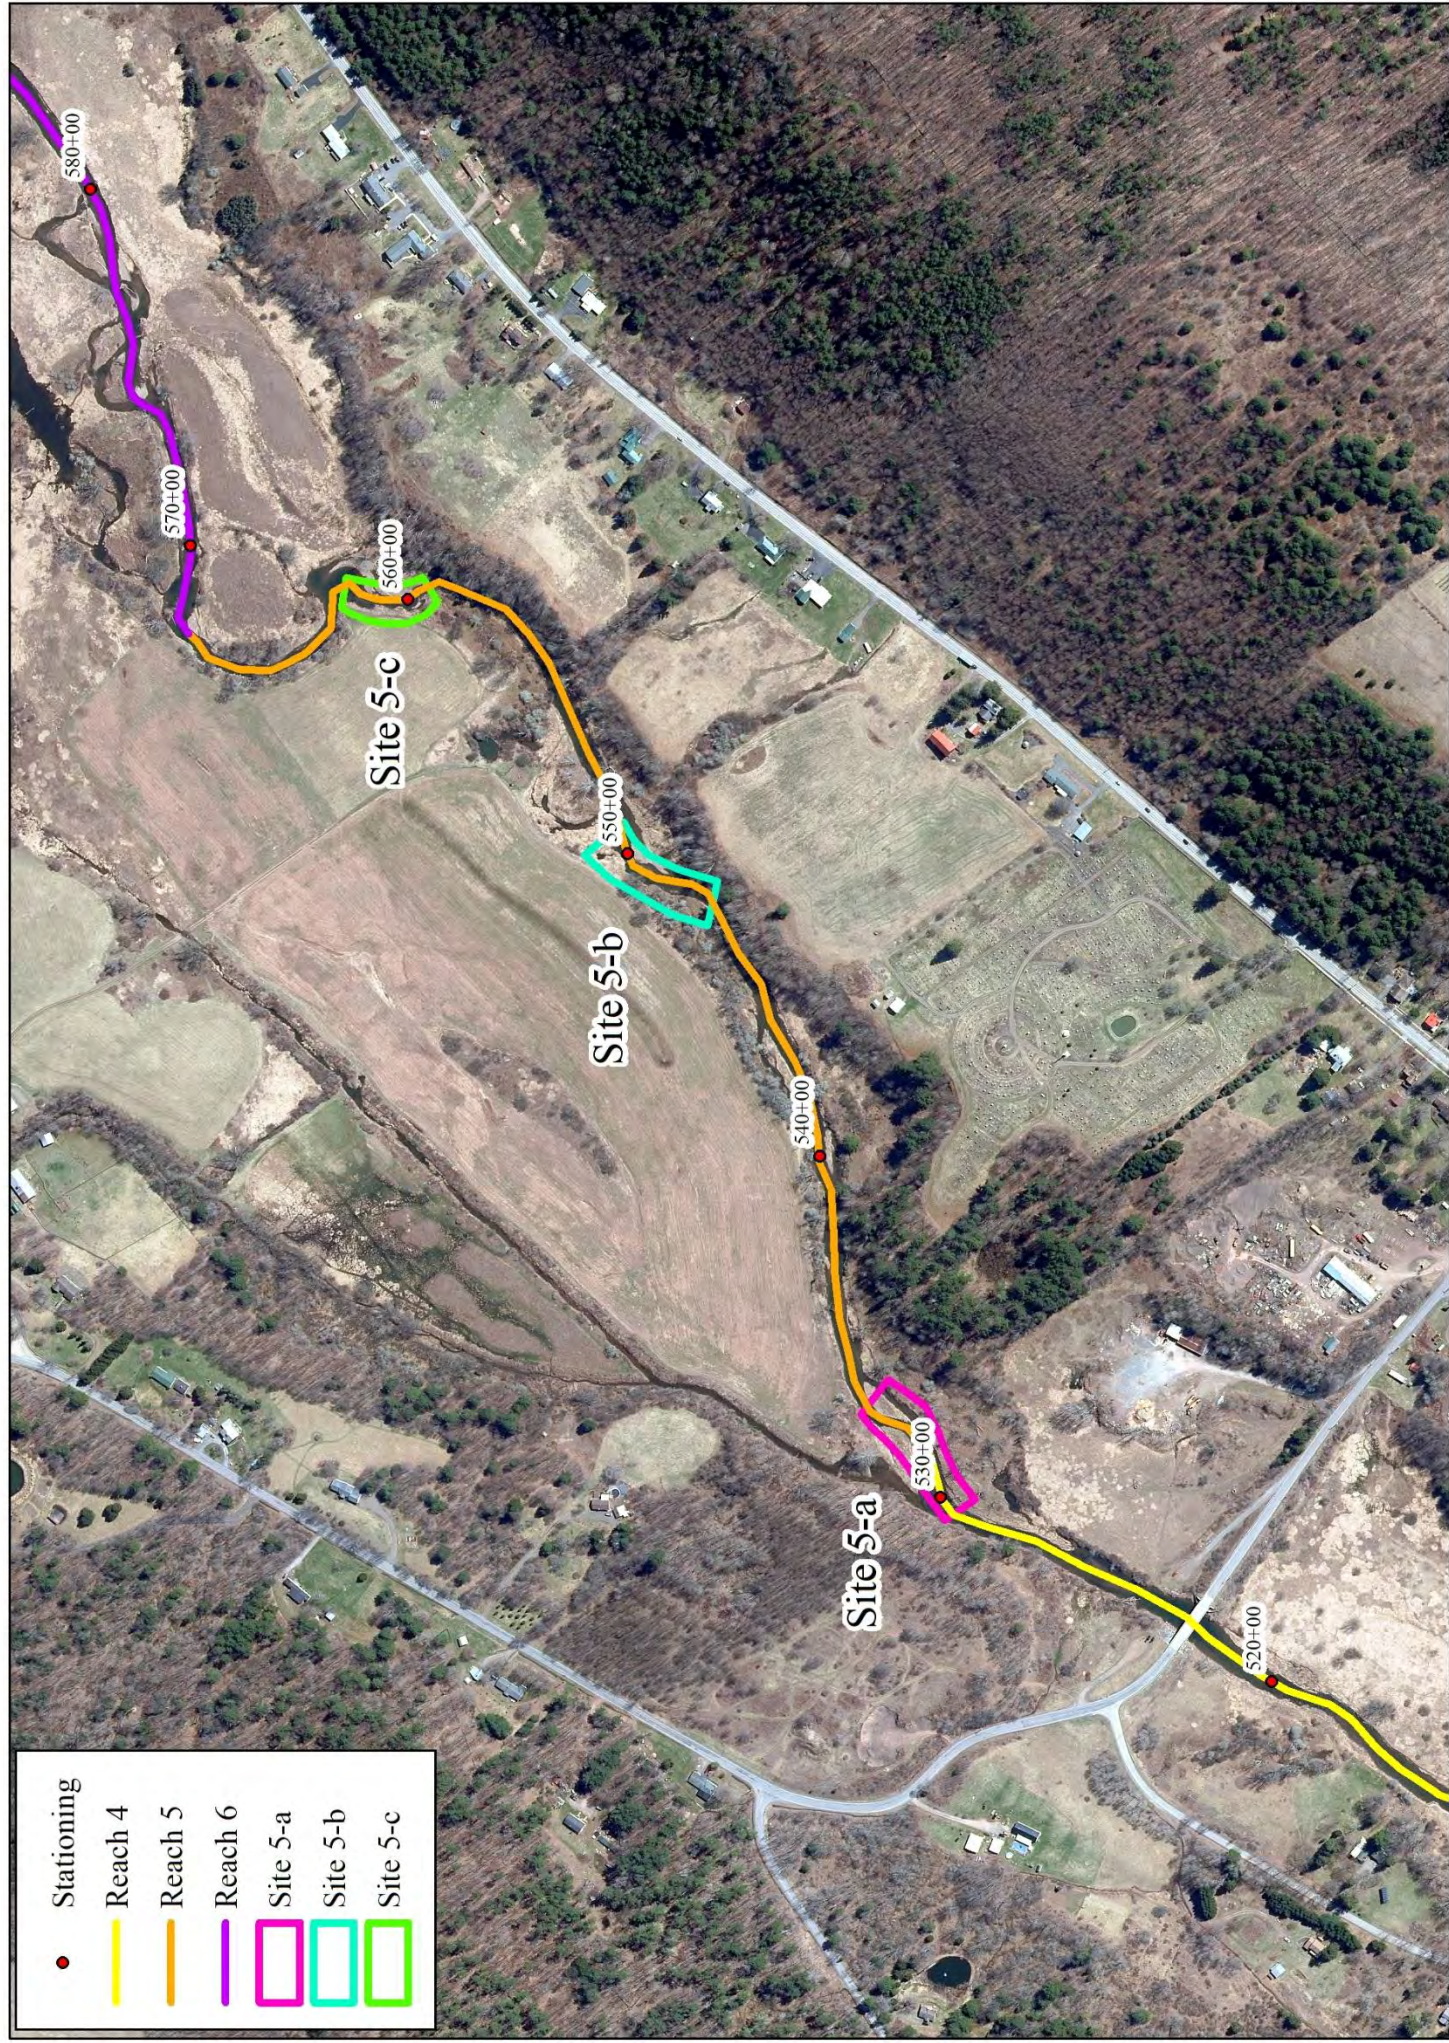
Figure 29: Reach 5 Map

There were several lengths of erosion along the right bank from STA 533+00 ft to STA 540+50 ft. These erosion segments were not great enough in terms of the amount of eroded material to be classified as an area of substantial erosion, but are still notable. The erosion segments were along an agricultural field only being separated from the field by a small strip of herbaceous plants and shrubs. The erosion segments totaled to a length of 579 ft and had an average height of 3.5 ft. It is estimated that 20 yd<sup>3</sup> of sediment had eroded annually from the erosion segments. The erosion segments should be monitored in the future as there is potential for the erosion to increase in severity due to the lack of an adequate riparian buffer between the stream channel and the agricultural field.

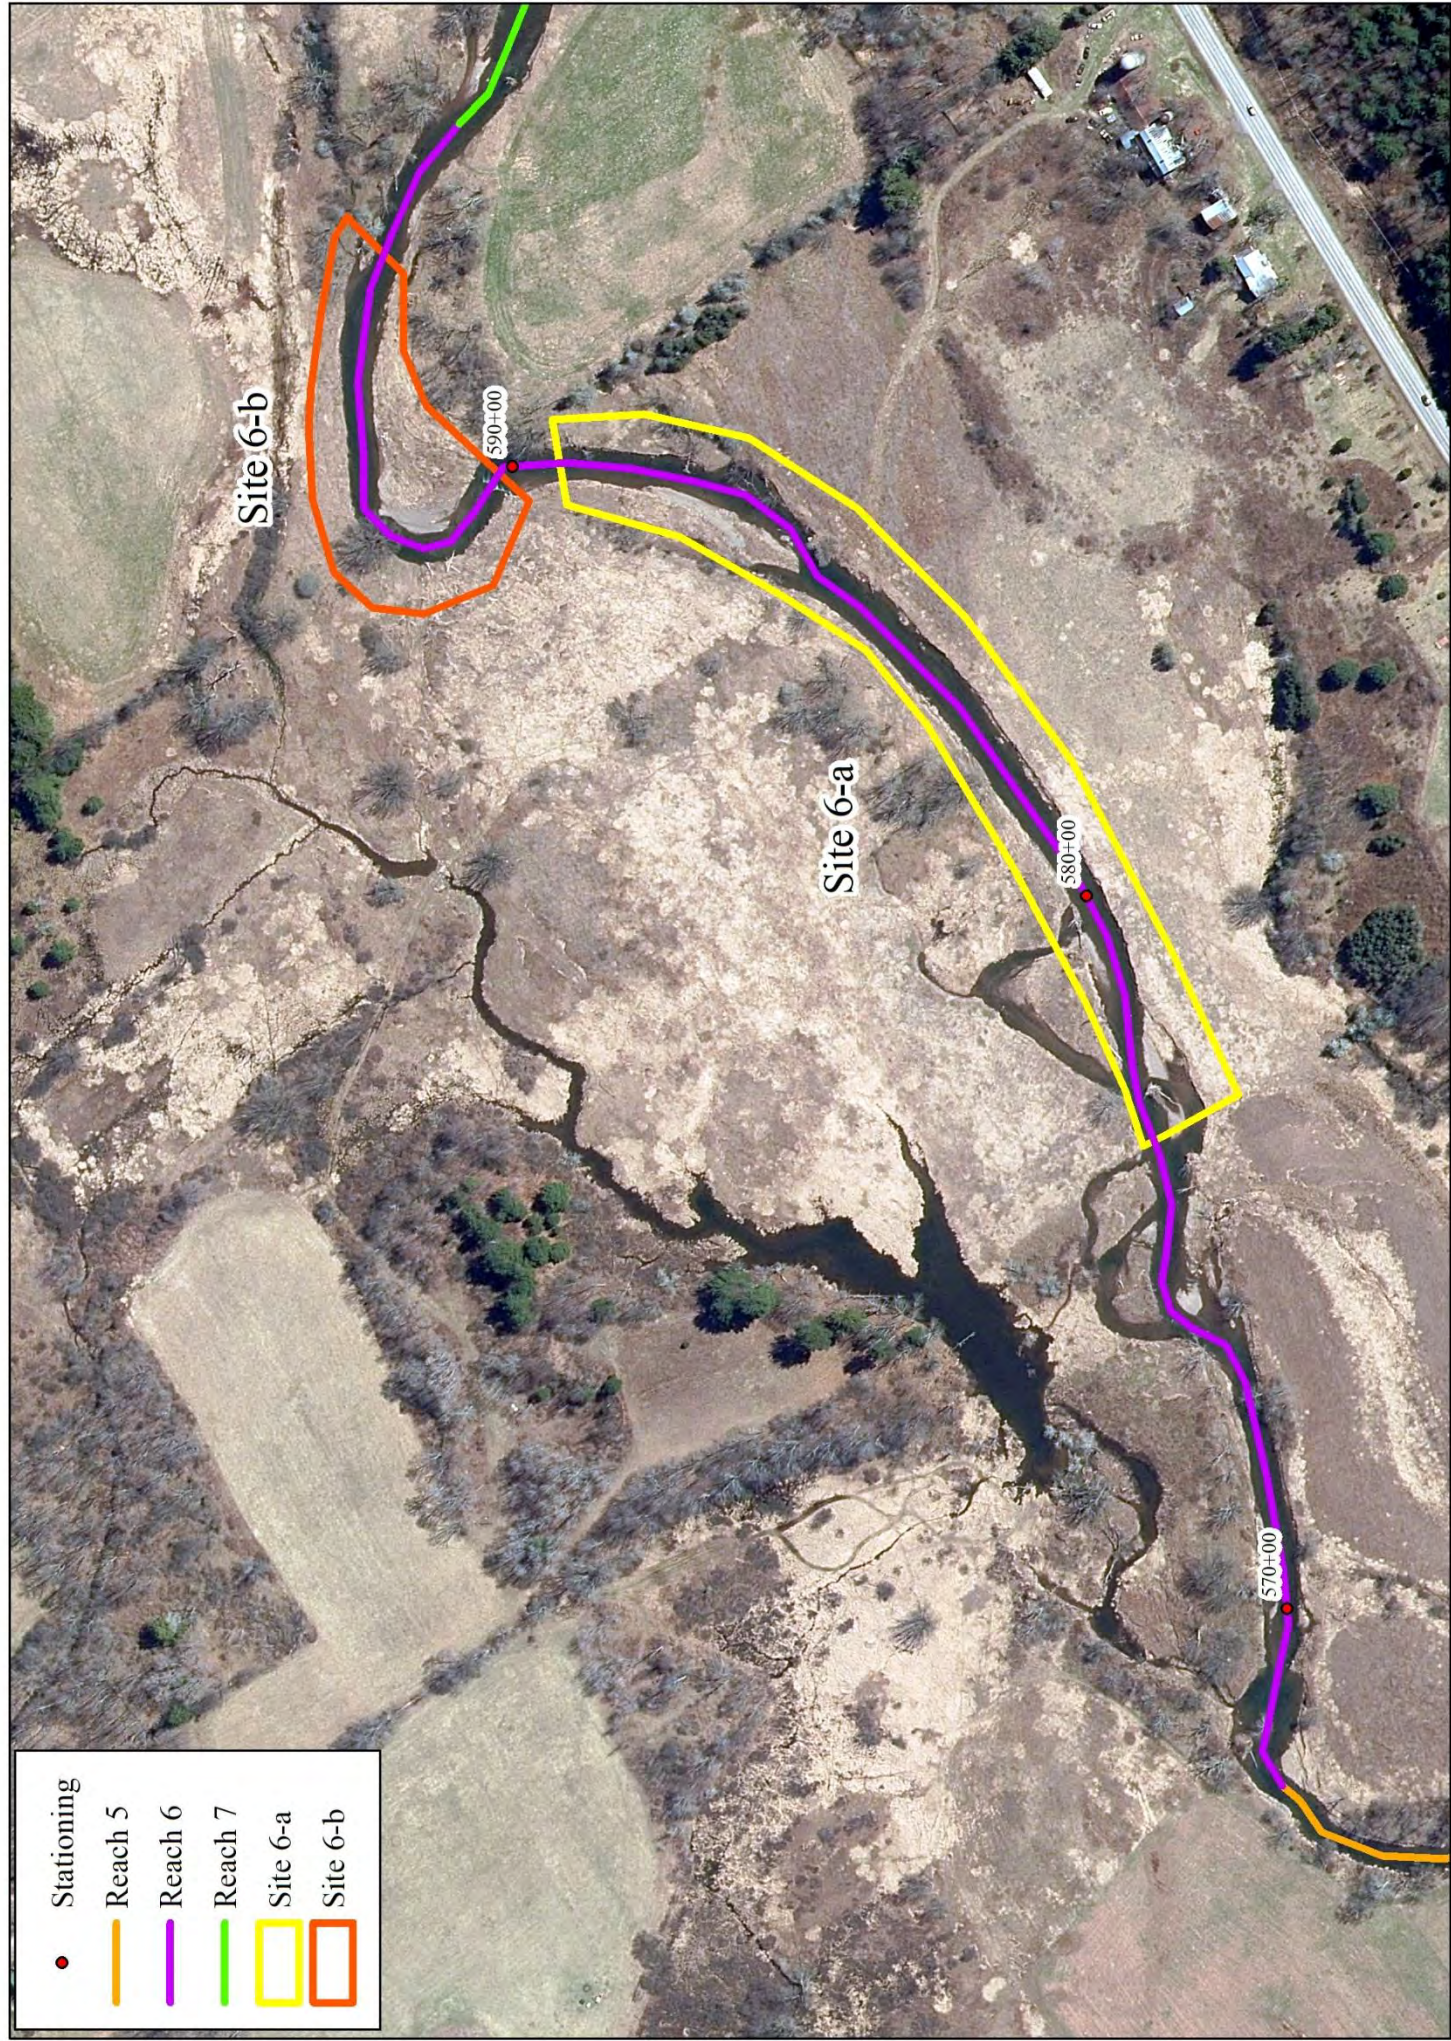
Figure 30: Reach 6 Map

In the reach, 44% of the banks were actively eroding and it is estimated that 500 yd<sup>3</sup> of sediment erodes annually from the reach. In addition, 1,100 lb of TN and 420 lb of TP are estimated to erode annually from the streambanks in the reach. This reach ranked 4th among reaches for the volume of eroded sediment, 4th for the mass of eroded TN, and 4th for the mass of eroded TP. The two sites of substantial erosion in the reach can be viewed on the reach map in **Figure 30**.

The second site of substantial erosion in Reach 6 was along the right bank from STA 590+00 ft to STA 595+50 ft. This erosion segment measured 597 ft in length with an average height of 5.0 ft. The erosion was along an old field with no riparian forest buffer. This erosion affected two land cover-soil categories which were Basher-field and Barbour-field. At this site, a sharp meander had formed in the channel and has been migrating downstream. At the downstream end of the erosion, there was a large boulder cross vane structure that bisects the channel. This structure is improperly sized and is likely contributing to the instability of channel as the stream could be shifting in order to try to flow at a less conflicting angle over the structure. There is also a large aggrading point bar across from the erosion. At its most severe extent, the erosion at this site scored a High BEHI rating and an Extreme NBS rating.

In the reach, there are two backwater oxbows that were cut off from the main flow of the channel. From historical orthoimagery, it can be seen that these backwater oxbows have historically been unstable as they have shifted frequently over time. They were previously receiving the majority of streamflow when the stream was eroding into the old field along the right bank. At the time of assessment, the backwater oxbows were not actively receiving flow from the stream channel as their upstream ends were blocked by depositional bars. However, they still have the potential to become reoccupied if the depositional bars are eroded or if the stream channel shifts.

Using historical orthoimagery, it is estimated that approximately 2 acres of field has eroded from Site 6-a and Site 6-b between 1997 and 2022, with a large amount of the erosion occurring when the two aforementioned backwater oxbows formed in the channel and eroded into the right bank. The reach also contained little riparian buffer between the old fields on the streambank and the stream channel.
