# **Ouleout Creek Geomorphic Assessment, Nutrient Load Estimation, and Remediation Recommendations**

**November 2023**

**Delaware County Soil and Water Conservation District**

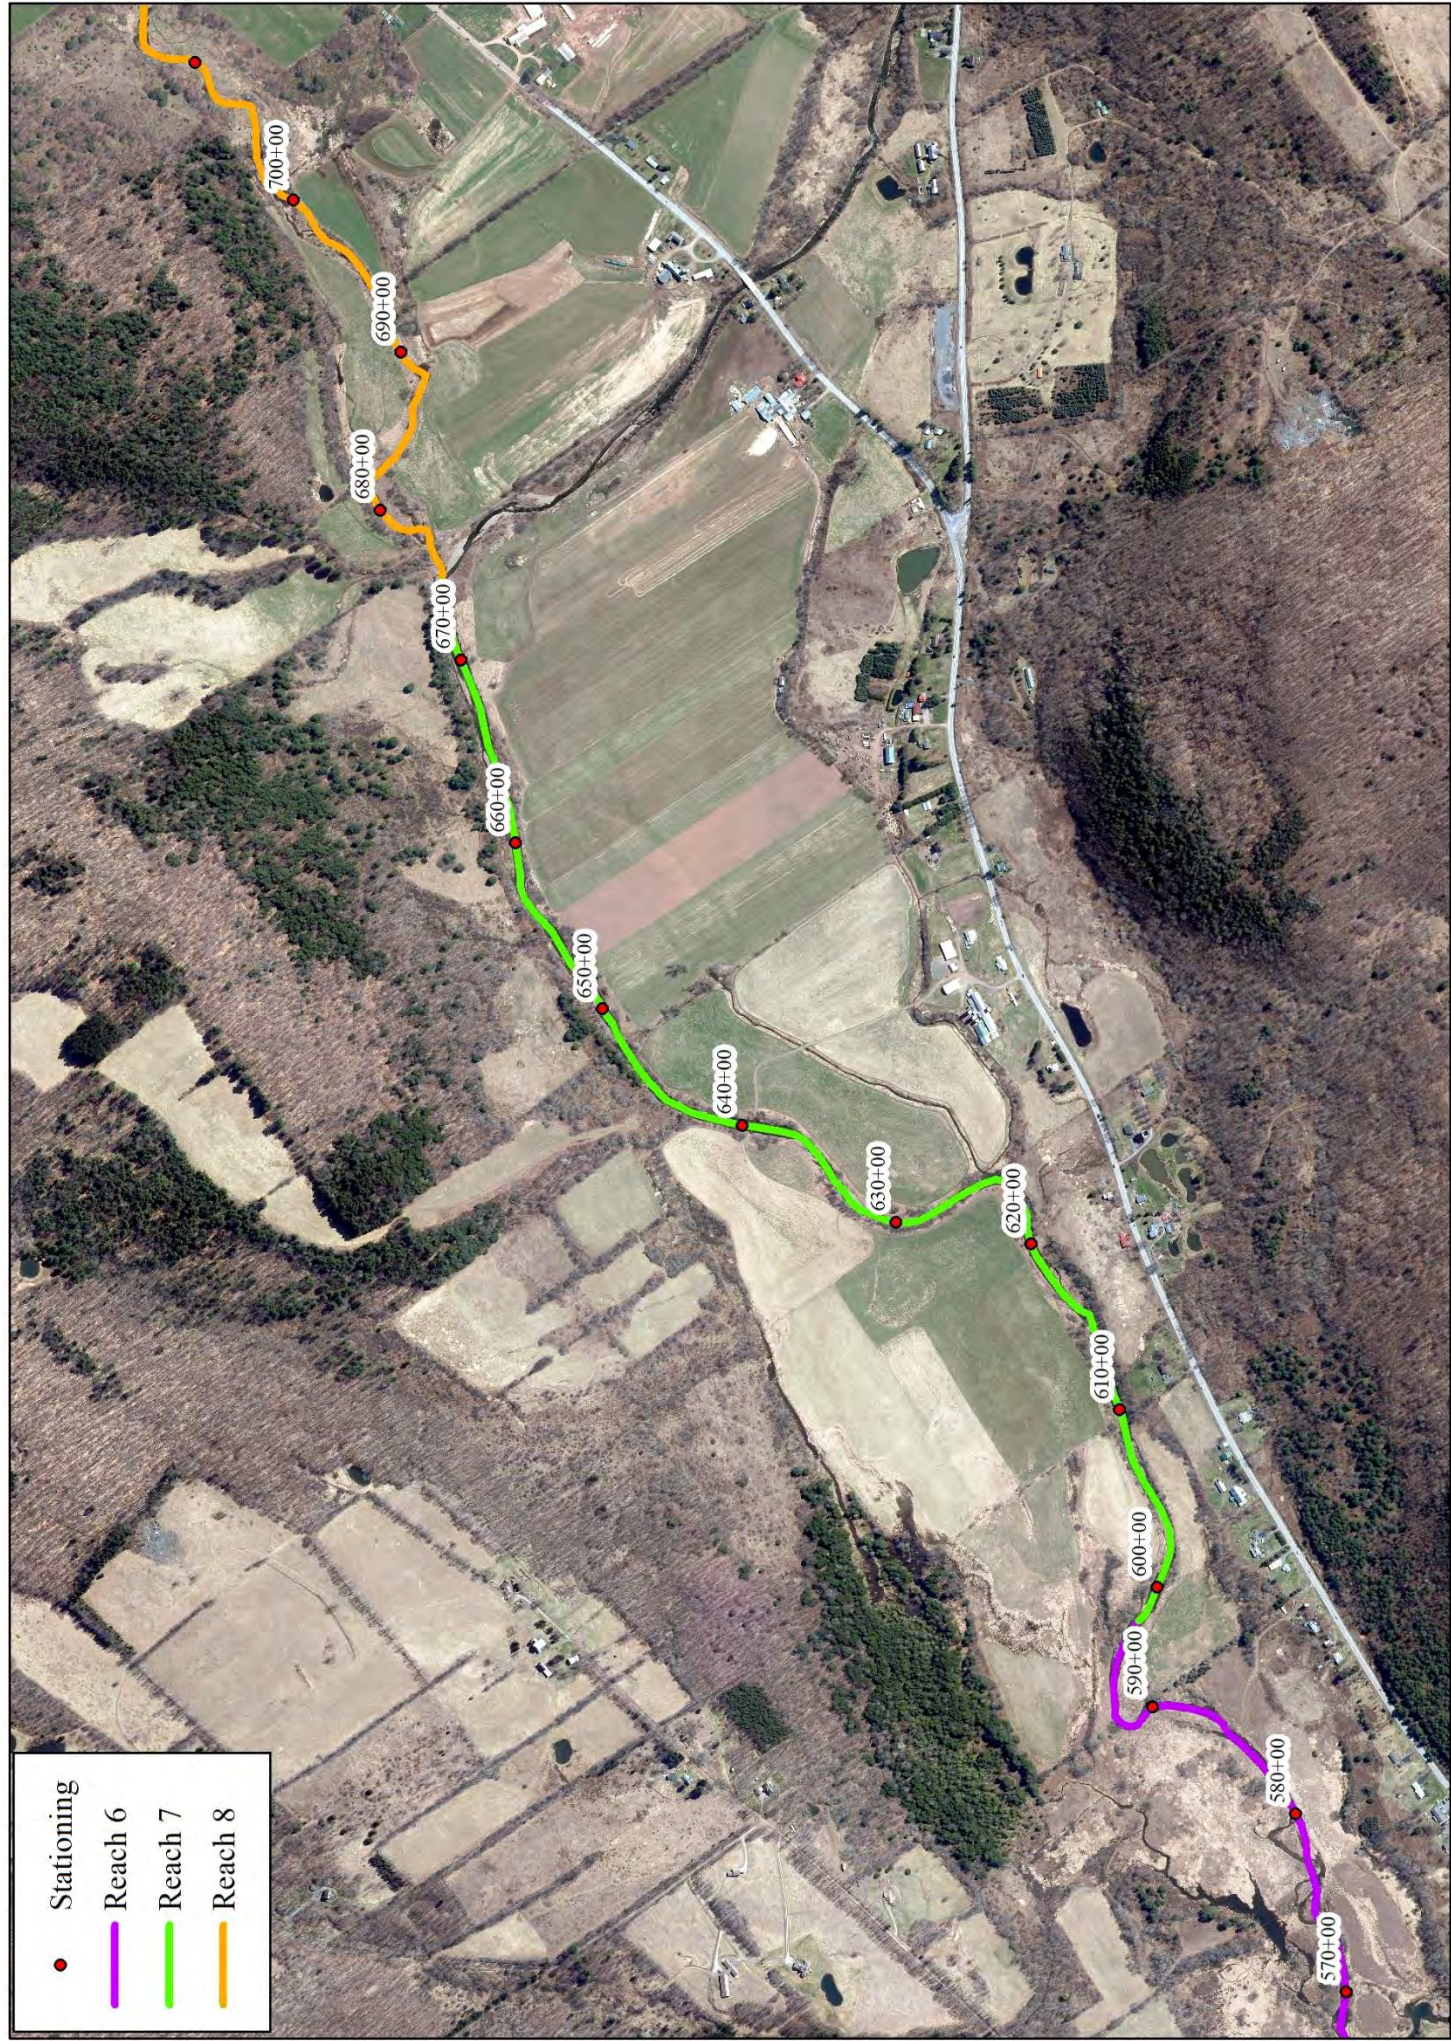
Figure 31: Reach 7 Map

There were no sites of substantial erosion in the reach, however, there were some notable erosion segments that have the potential to increase in severity. There were other noteworthy features in the reach as well. The reach's location can be viewed on the reach map in **Figure 31**.

There was a hillslope failure along the left bank from STA 621+00 ft to STA 623+00 ft. The failure measured 211 ft in length and had a maximum height of 22 ft. The hillslope failure had little toe protection along the majority of its extent, though a cantilevered block of soil with trees had slid down the hillslope near the upstream end of the erosion partially providing some toe protection for the upstream section of the failure. The failure was recently active at the time of assessment indicated by the fact that the bank face was bare and contained little vegetation growth. This failure should be monitored in the future to make sure that the erosion does not increase in severity or cause further instability within the stream channel.

Another area of note in the reach was Treadwell Creek's confluence with the Ouleout at STA 674+00 ft. The confluence of two streams is naturally a dynamic area where fluctuating sediment depositions are common. From recent orthoimagery it can be seen that Treadwell Creek has shifted frequently over the past 25 years. Additionally, it has previously eroded into the banks of the agricultural fields near its confluence with the Ouleout. Treadwell Creek also deposits large amounts of sediment at its confluence with the Ouleout. At the time of assessment, there were several excessive depositional features in the form of side channel bars and transverse bars upstream and downstream of the confluence. During times of low flow, Treadwell Creek sometimes flows subsurface along its downstream extent, indicating an excessive amount of gravel and cobble sized sediment at Treadwell's confluence with the Ouleout. The stream flowing subsurface is detrimental to aquatic organisms as they are unable to inhabit or pass through this section of Treadwell Creek. It would be useful to assess Treadwell Creek upstream of its confluence to determine possible instabilities causing the excess of sediment being delivered to the Ouleout.

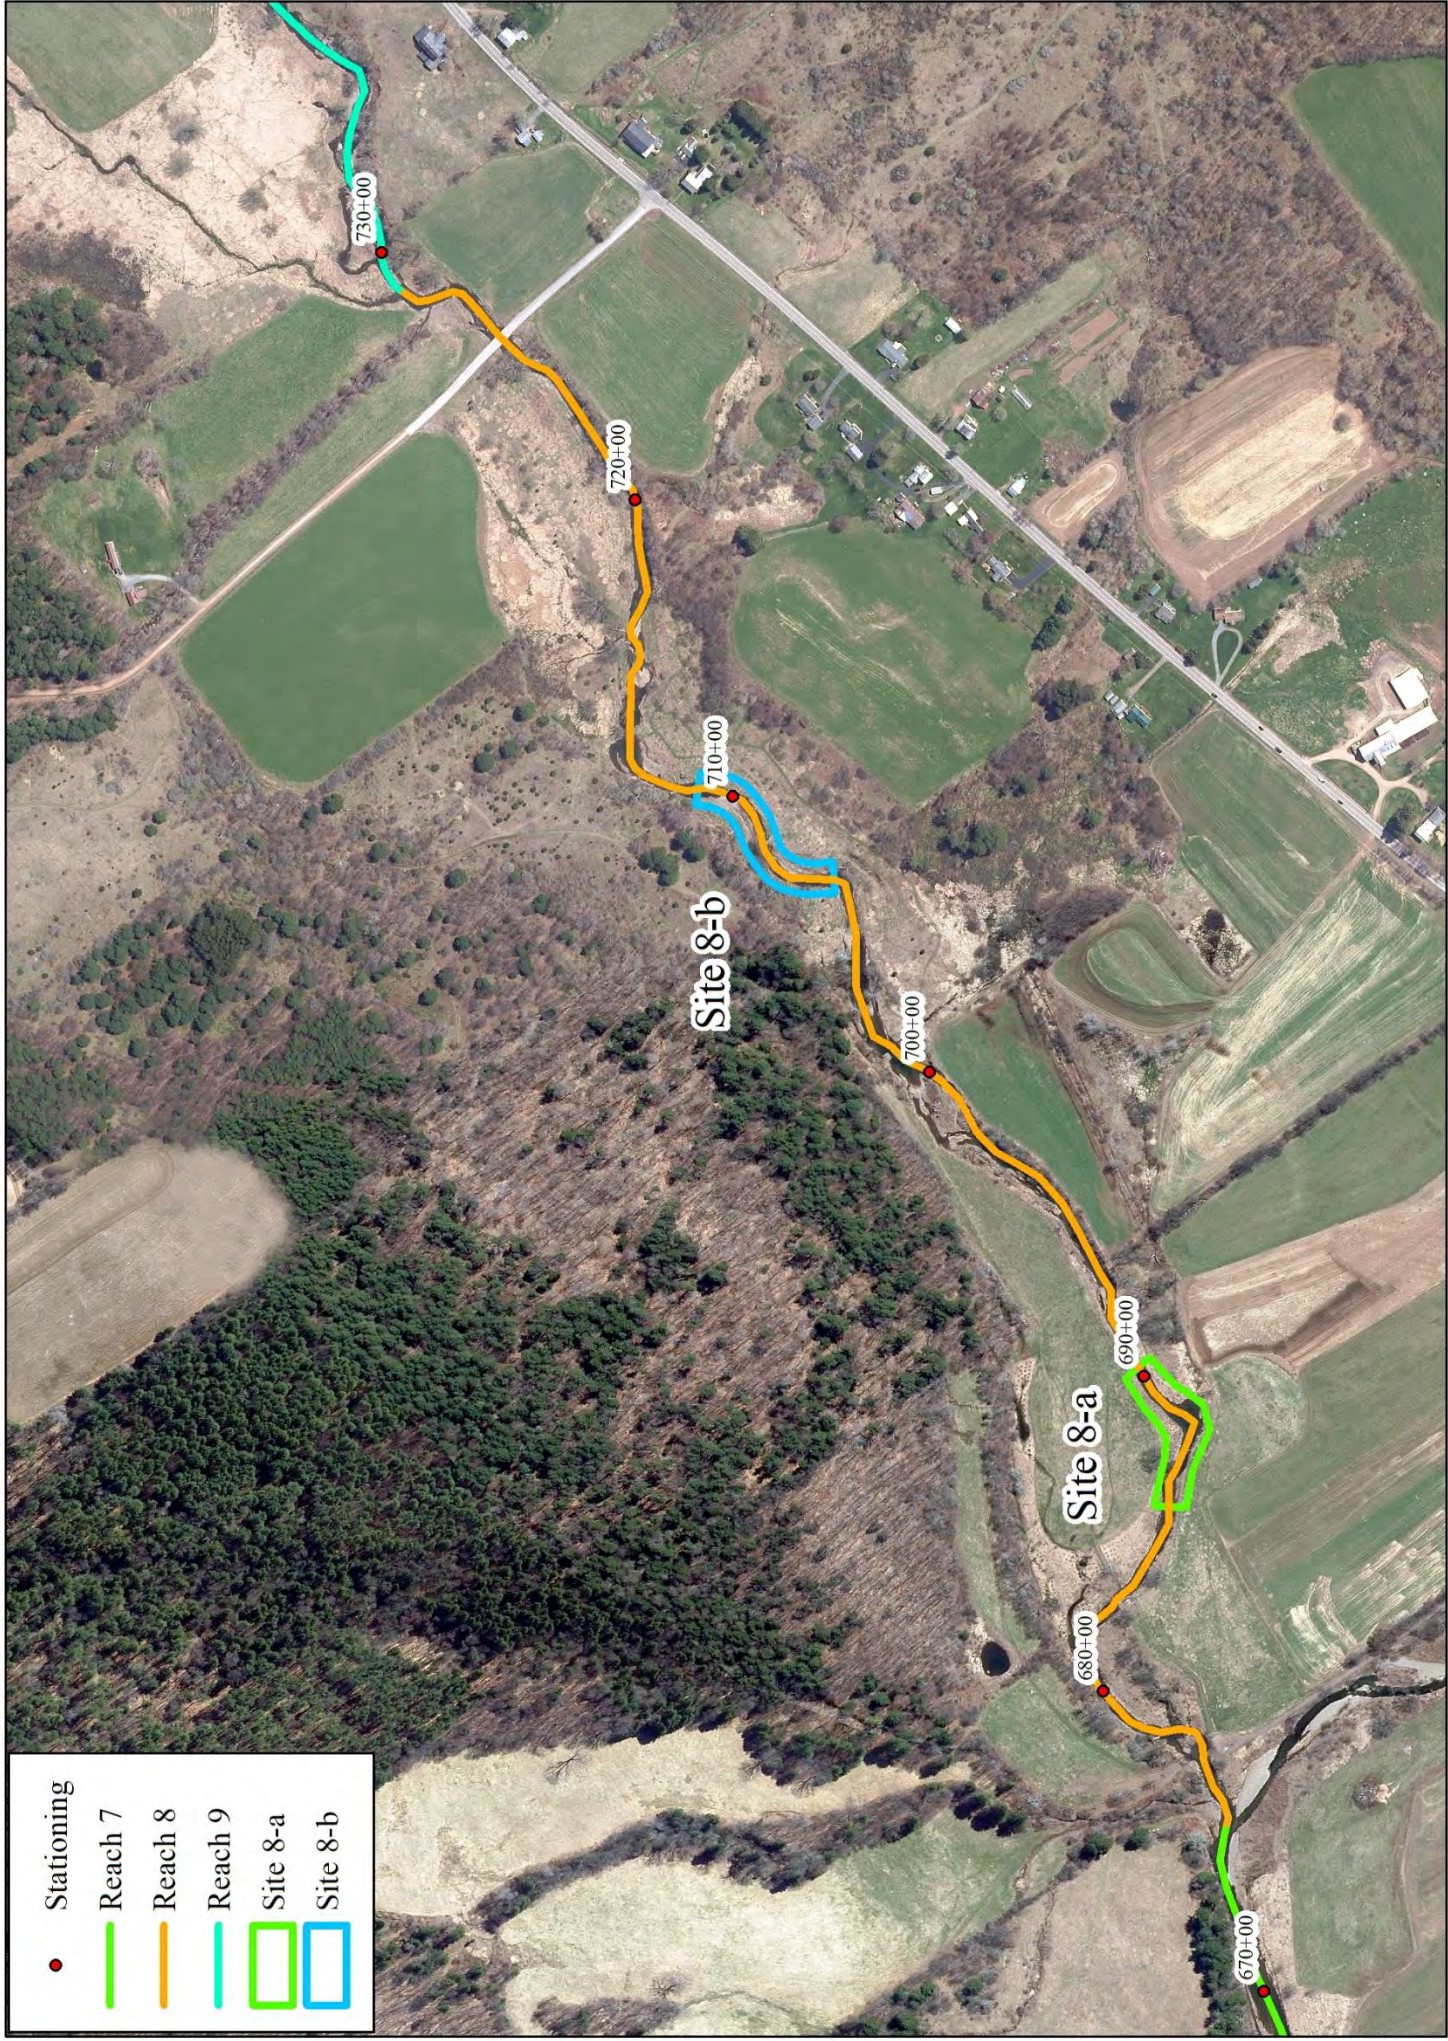
Figure 32: Reach 8 Map

In the reach, 28% of the banks were actively eroding and it is estimated that 280 yd<sup>3</sup> of sediment erodes annually from the reach. In addition, 590 lb of TN and 230 lb of TP are estimated to erode annually from the streambanks in the reach. This reach ranked 8th among reaches for the volume of eroded sediment, 7th for the mass of eroded TN, and 7th for the mass of eroded TP. The two sites of substantial erosion in the reach can be viewed on the reach map in **Figure 32**.

Another area of note was from STA 714+00 ft to STA 717+00 ft. In this area, the stream was eroding into both banks. The erosion segments totaled to 489 ft in length and had an average height of 3.6 ft. It is estimated that 19 yd<sup>3</sup> of sediment has eroded annually from the erosion segments. In addition to the erosion, the stream channel in this section contained several excessive depositional features including transverse bars. Several mature willow trees had also cantilevered into the channel at this location. The majority of the land cover in the surrounding area is old fields with herbaceous plants and shrubs covering the majority of the fields. At the time of assessment, the fields had recently been planted as part of a riparian forest buffer planting project. The erosion could be remediated naturally if the riparian forest buffer becomes established and protects the streambank from future erosion.

Another erosion segment of note was along the left bank from STA 726+50 ft to STA 727+50 ft. This erosion segment measured 101 ft in length, had an average height of 3.5 ft, and it is estimated that 3 yd<sup>3</sup> of sediment has eroded annually. Like the previous erosion segments mentioned above, this erosion segment was not substantial enough in the amount of eroded material to be ranked as a site of substantial erosion, but is still a cause for concern since it was along an agricultural field with no riparian buffer. The riparian buffer had previously been eroded away and all that remained between the agricultural field and the stream channel was a small strip of herbaceous plants. The erosion was more active in the mid-2010s when the riparian buffer was eroded away. Directly across the channel from the erosion is where an unnamed tributary enters the Ouleout from the right bank. At the tributary's confluence with the Ouleout was an aggrading bar along the right bank. This depositional bar is likely contributing to the erosion along the left bank by directing flow to the left side of the channel and into the streambank. This erosion could be remediated by armoring the left bank, grading and resizing the oversized bar to appropriate dimensions, and establishing a riparian forest buffer along the left bank.

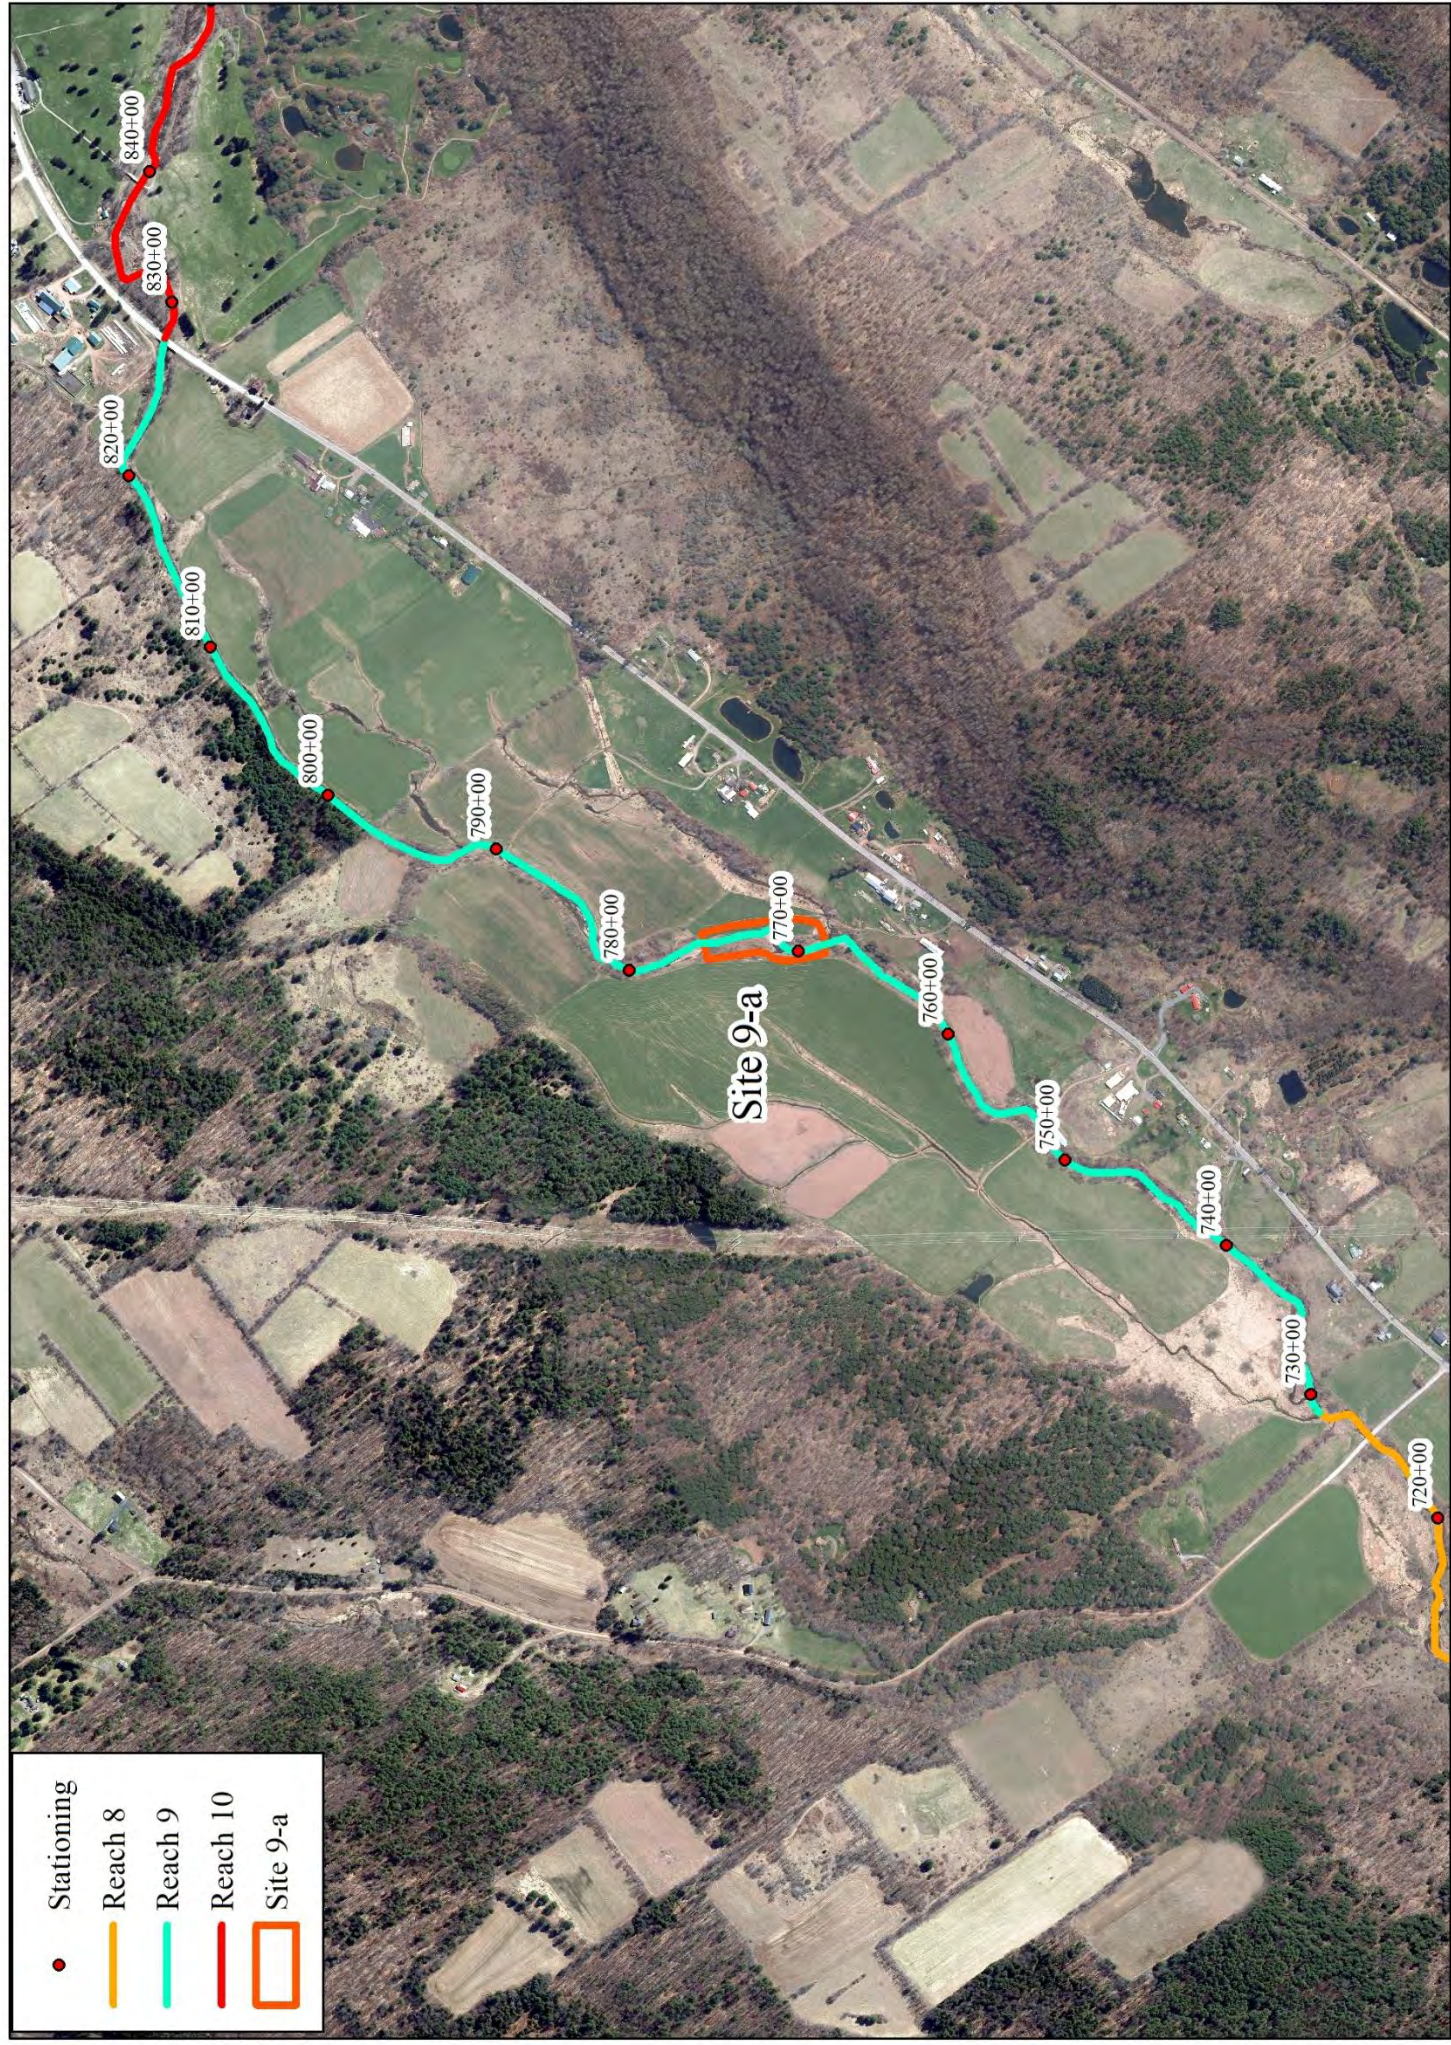
Figure 33: Reach 9 Map

In the reach, 17% of the banks were actively eroding and it is estimated that 220 yd<sup>3</sup> of sediment erodes annually from the reach. In addition, 470 lb of TN and 160 lb of TP are estimated to erode annually from the streambanks in the reach. This reach ranked 9th among reaches for the volume of eroded sediment, 9th for the mass of eroded TN, and 8th for the mass of eroded TP. The reach's location can be viewed on the reach map in **Figure 33**.

It is estimated that 480 yd<sup>3</sup> of sediment was eroding annually from Site 9-a. This eroded volume equated to 540 tons of sediment. It is estimated that 630 lb of TP and 1,400 lb of TN had eroded annually from the site. Due to the stabilization project remediating the erosion, this site was not included in sediment and nutrient calculations. It would be useful however, to continue to monitor this site and the condition of the stabilization project.

Another notable area in the reach was a hillslope failure along the left bank from STA 733+50 ft to STA 735+00 ft. This erosion segment measured 167 ft in length with a maximum height of 23 ft. Unlike the other hillslope failures along the Ouleout, that are composed primarily of glacial till, this failure was composed primarily of unconsolidated material. This unconsolidated sediment is much more susceptible to erosion due to its natural instability. The face of the hillslope was bare and contained little vegetation. There was also little toe protection at the foot of the bank and stream flow was impinging upon the base of the hillslope making the hillslope susceptible to further erosion. The hillslope was at a near vertical angle in some sections and will likely continue to contribute large amounts of sediment into the stream before it reaches an angle of repose.

In 2019, there was a stream stabilization project from STA 783+00 ft to STA 791+50 ft. Similar to the project that occurred at Site 9-a, the stream was eroding into an agricultural field along the left bank. The streambank was stabilized, grade control and revetment structures were installed, and a riparian forest buffer was planted along the streambank.

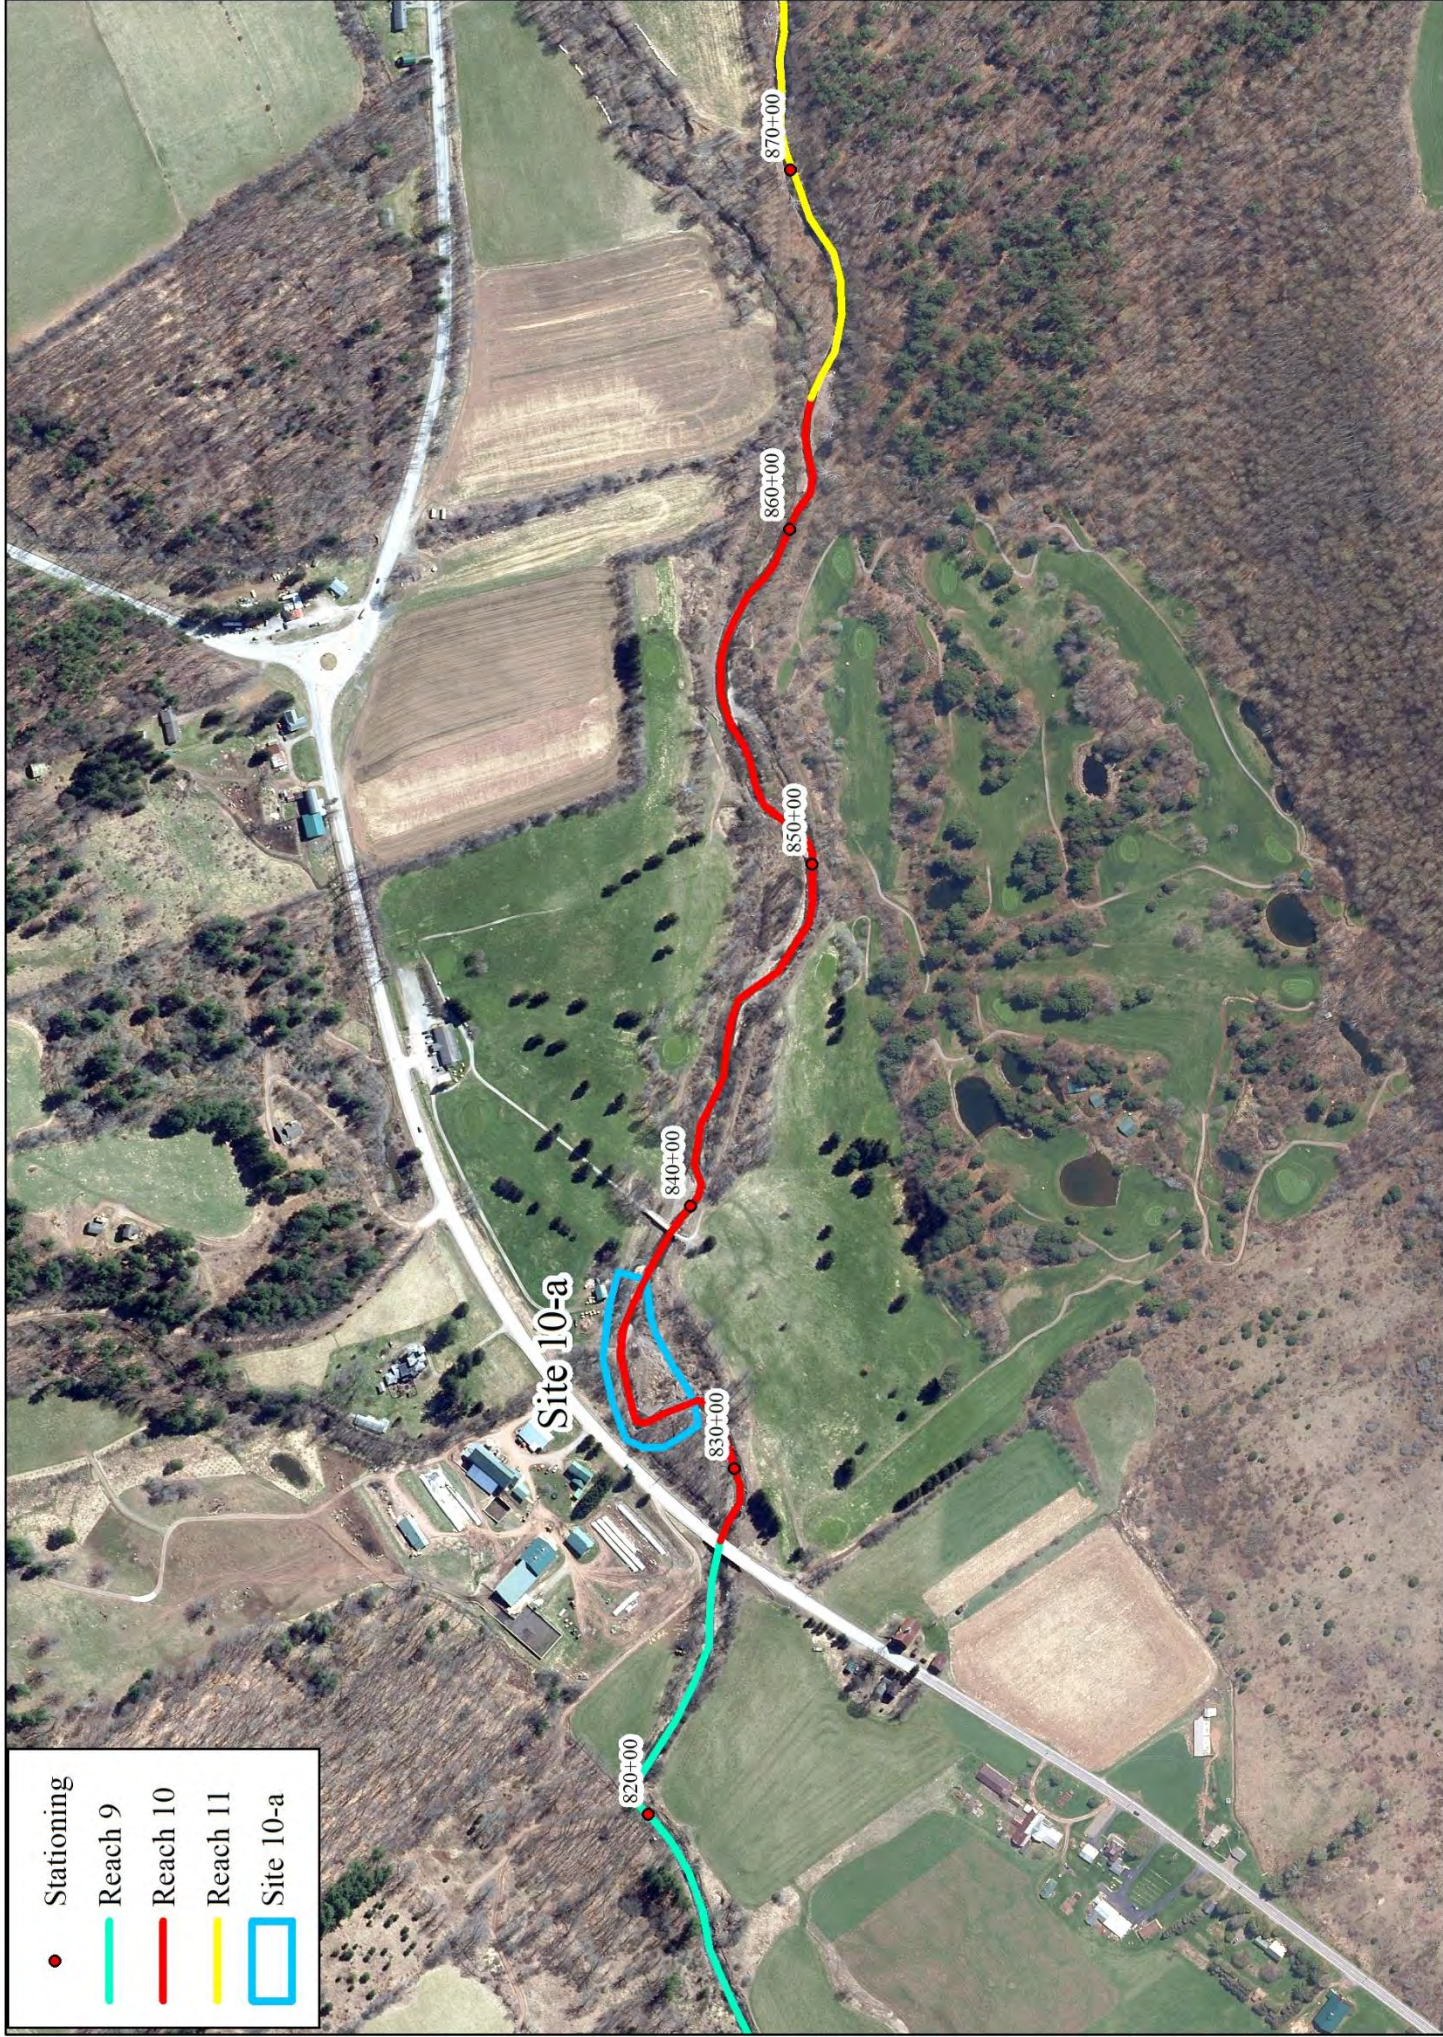
Figure 34: Reach 10 Map

Throughout this reach there were several natural and excessive depositional features indicating that this is primarily a reach where sediment is stored by the Ouleout system. During times of low flow, the stream flows subsurface in some sections of the reach as well. The one site of substantial erosion in the reach can be viewed on the reach map in **Figure 34**.

Though still active at the time of assessment, this site was eroding at a higher rate in the early 2010s. In addition to the eroding bank and the oversized point bar, there were several channel bridging trees that had cantilevered off the right bank and were causing an accumulation of debris in the channel and partially disrupting flow. These trees could potentially cause further blockages in the channel.

One erosion segment of note in the reach was along the left bank from STA 847+00 ft to STA 851+00 ft. This erosion was not great enough in terms of eroded material to be ranked as a site of substantial erosion but is still noteworthy and should be monitored. This erosion segment measured 404 ft in length, had an average height of 3.4 ft, and it is estimated that 53 yd<sup>3</sup> of sediment has eroded annually from the erosion segment. The erosion was along an area comprised of shrubs between the stream channel and a golf course. There was a large aggrading cobble bar opposite the erosion. The erosion could be remediated by stabilizing the left bank with revetment and establishing a riparian forest buffer along the left bank.

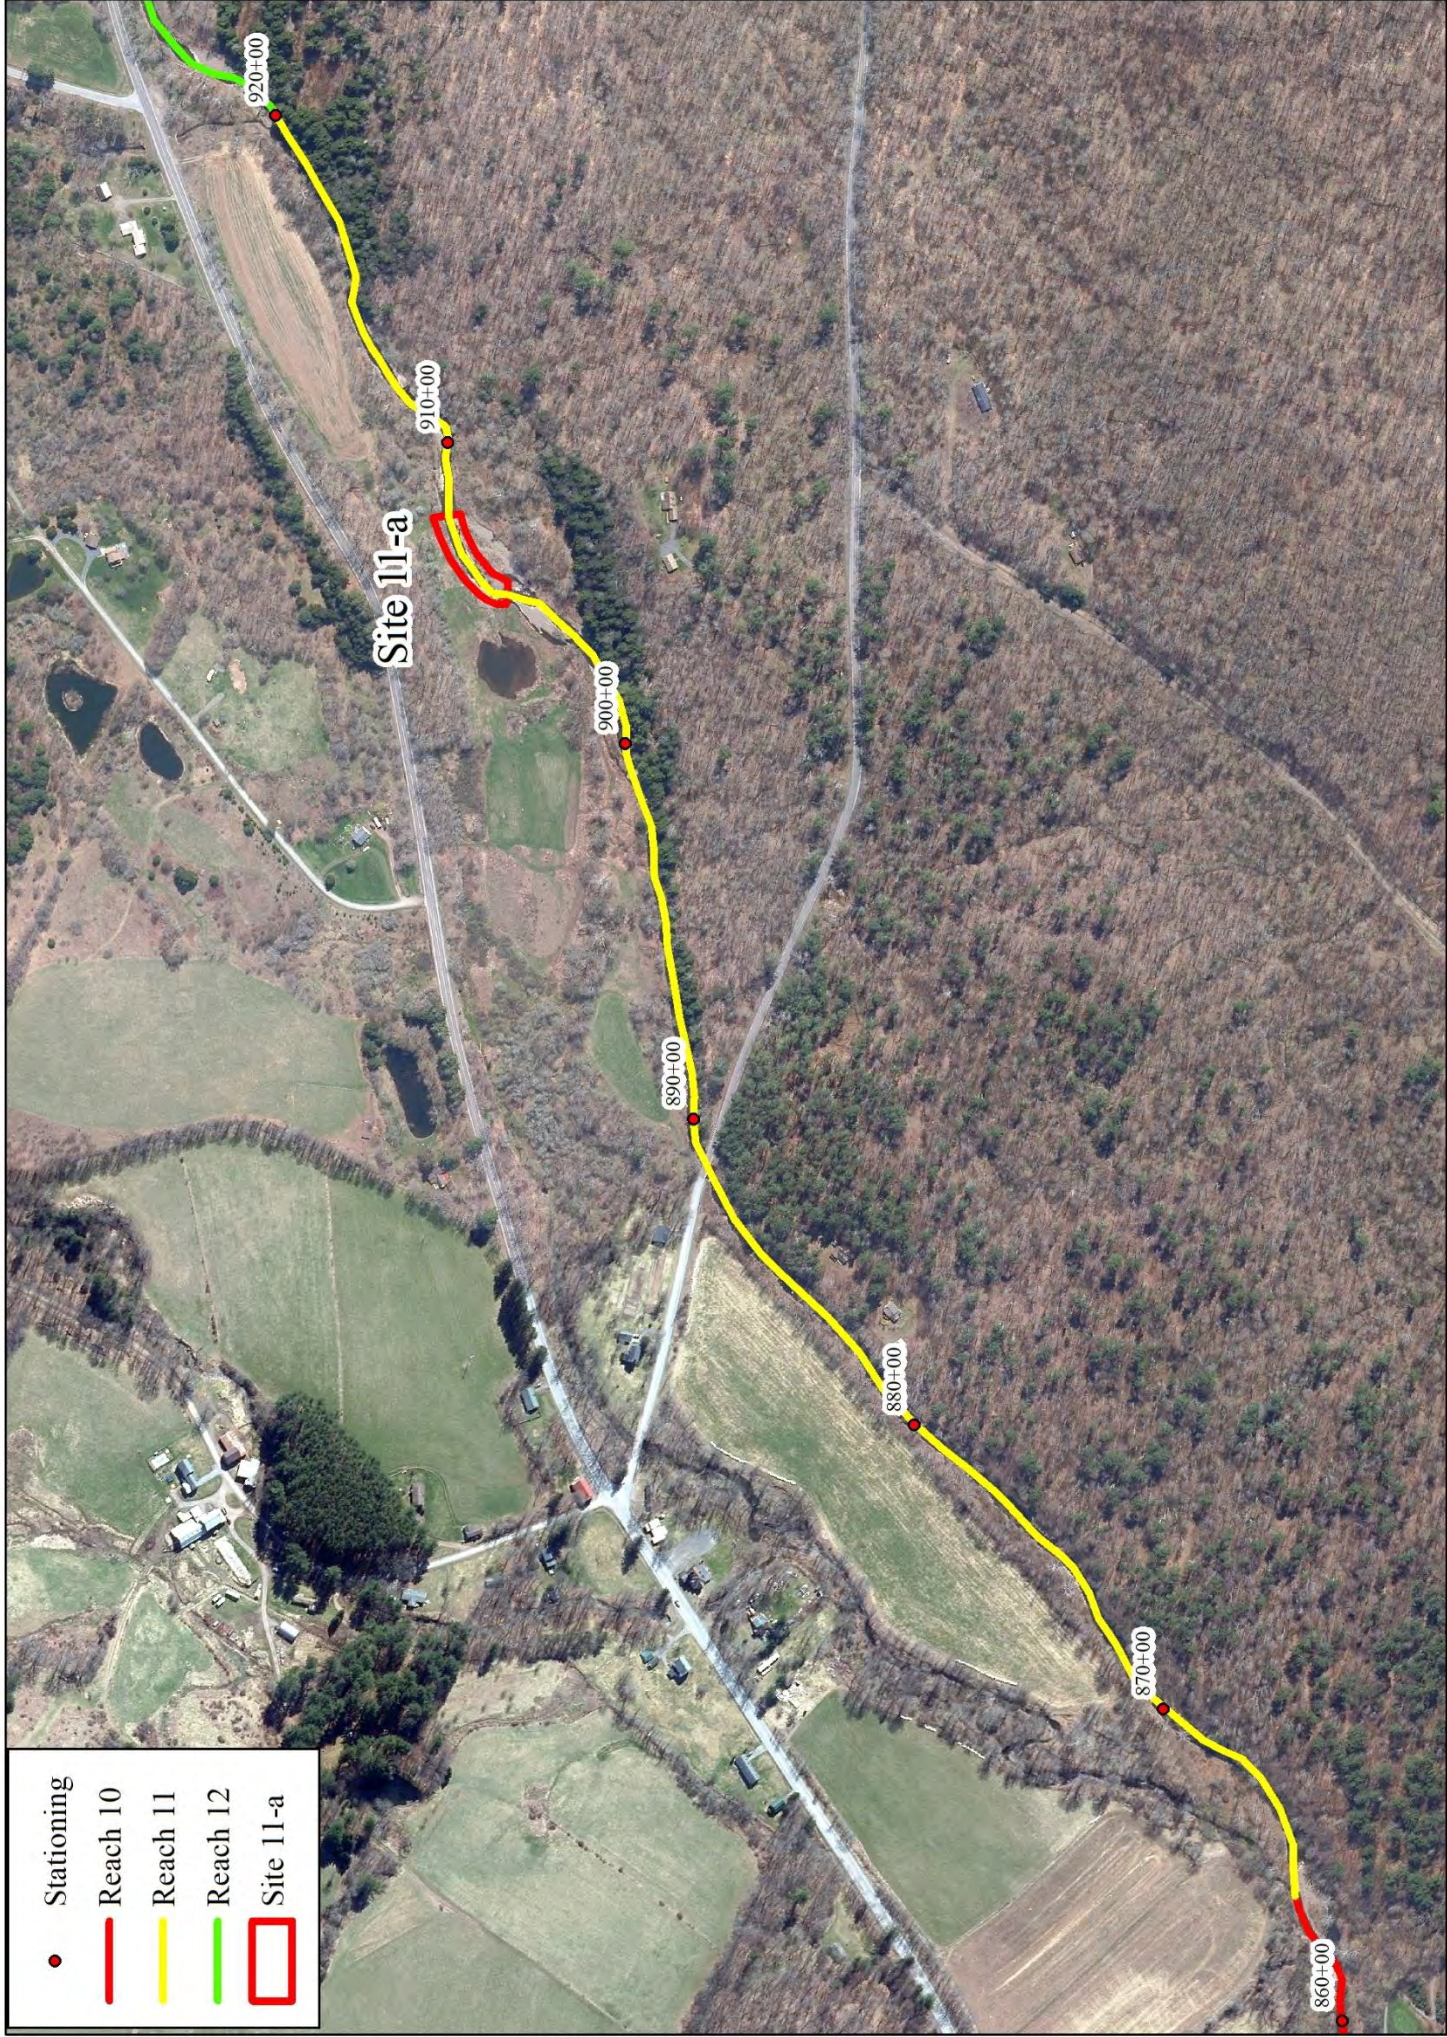
Figure 35: Reach 11 Map

One notable erosion segment in the reach was the hillslope failure along the left bank from STA 872+50 ft to STA 874+50 ft. This erosion segment measured 201 ft in length and had a maximum height of 28 ft. The hillslope failure contained some toe protection consisting of cantilevered soil blocks and trees resting along the base of the hillslope. Some sections of the failure were actively eroding and contained little vegetation at the time of assessment.

A second hillslope failure in the reach was located along the left bank from STA 919+50 ft to STA 921+00 ft. The failure measured 135 ft in length and had a maximum height of 22 ft. The hillslope failure had little toe protection though some boulders were resting intermittently along the base of the hillslope. The hillslope was composed primarily of glacial till which can be more resistant to erosion than a bank composed of unconsolidated sediment but can also be a source of fine sediment. The majority of the hillslope was bare, with a small amount of coltsfoot and other herbaceous vegetation growing on it. Across from this shallow slide, there was an oversized side channel bar with large woody debris deposited on it. This bar was centered around Gay Brook's confluence with the Ouleout. This bar is contributing to the erosion by causing flow to be directed towards the left hillslope. Like the previous hillslope failures, it would be wise to monitor this failure to make sure it does not increase in severity or cause instability within the stream channel.

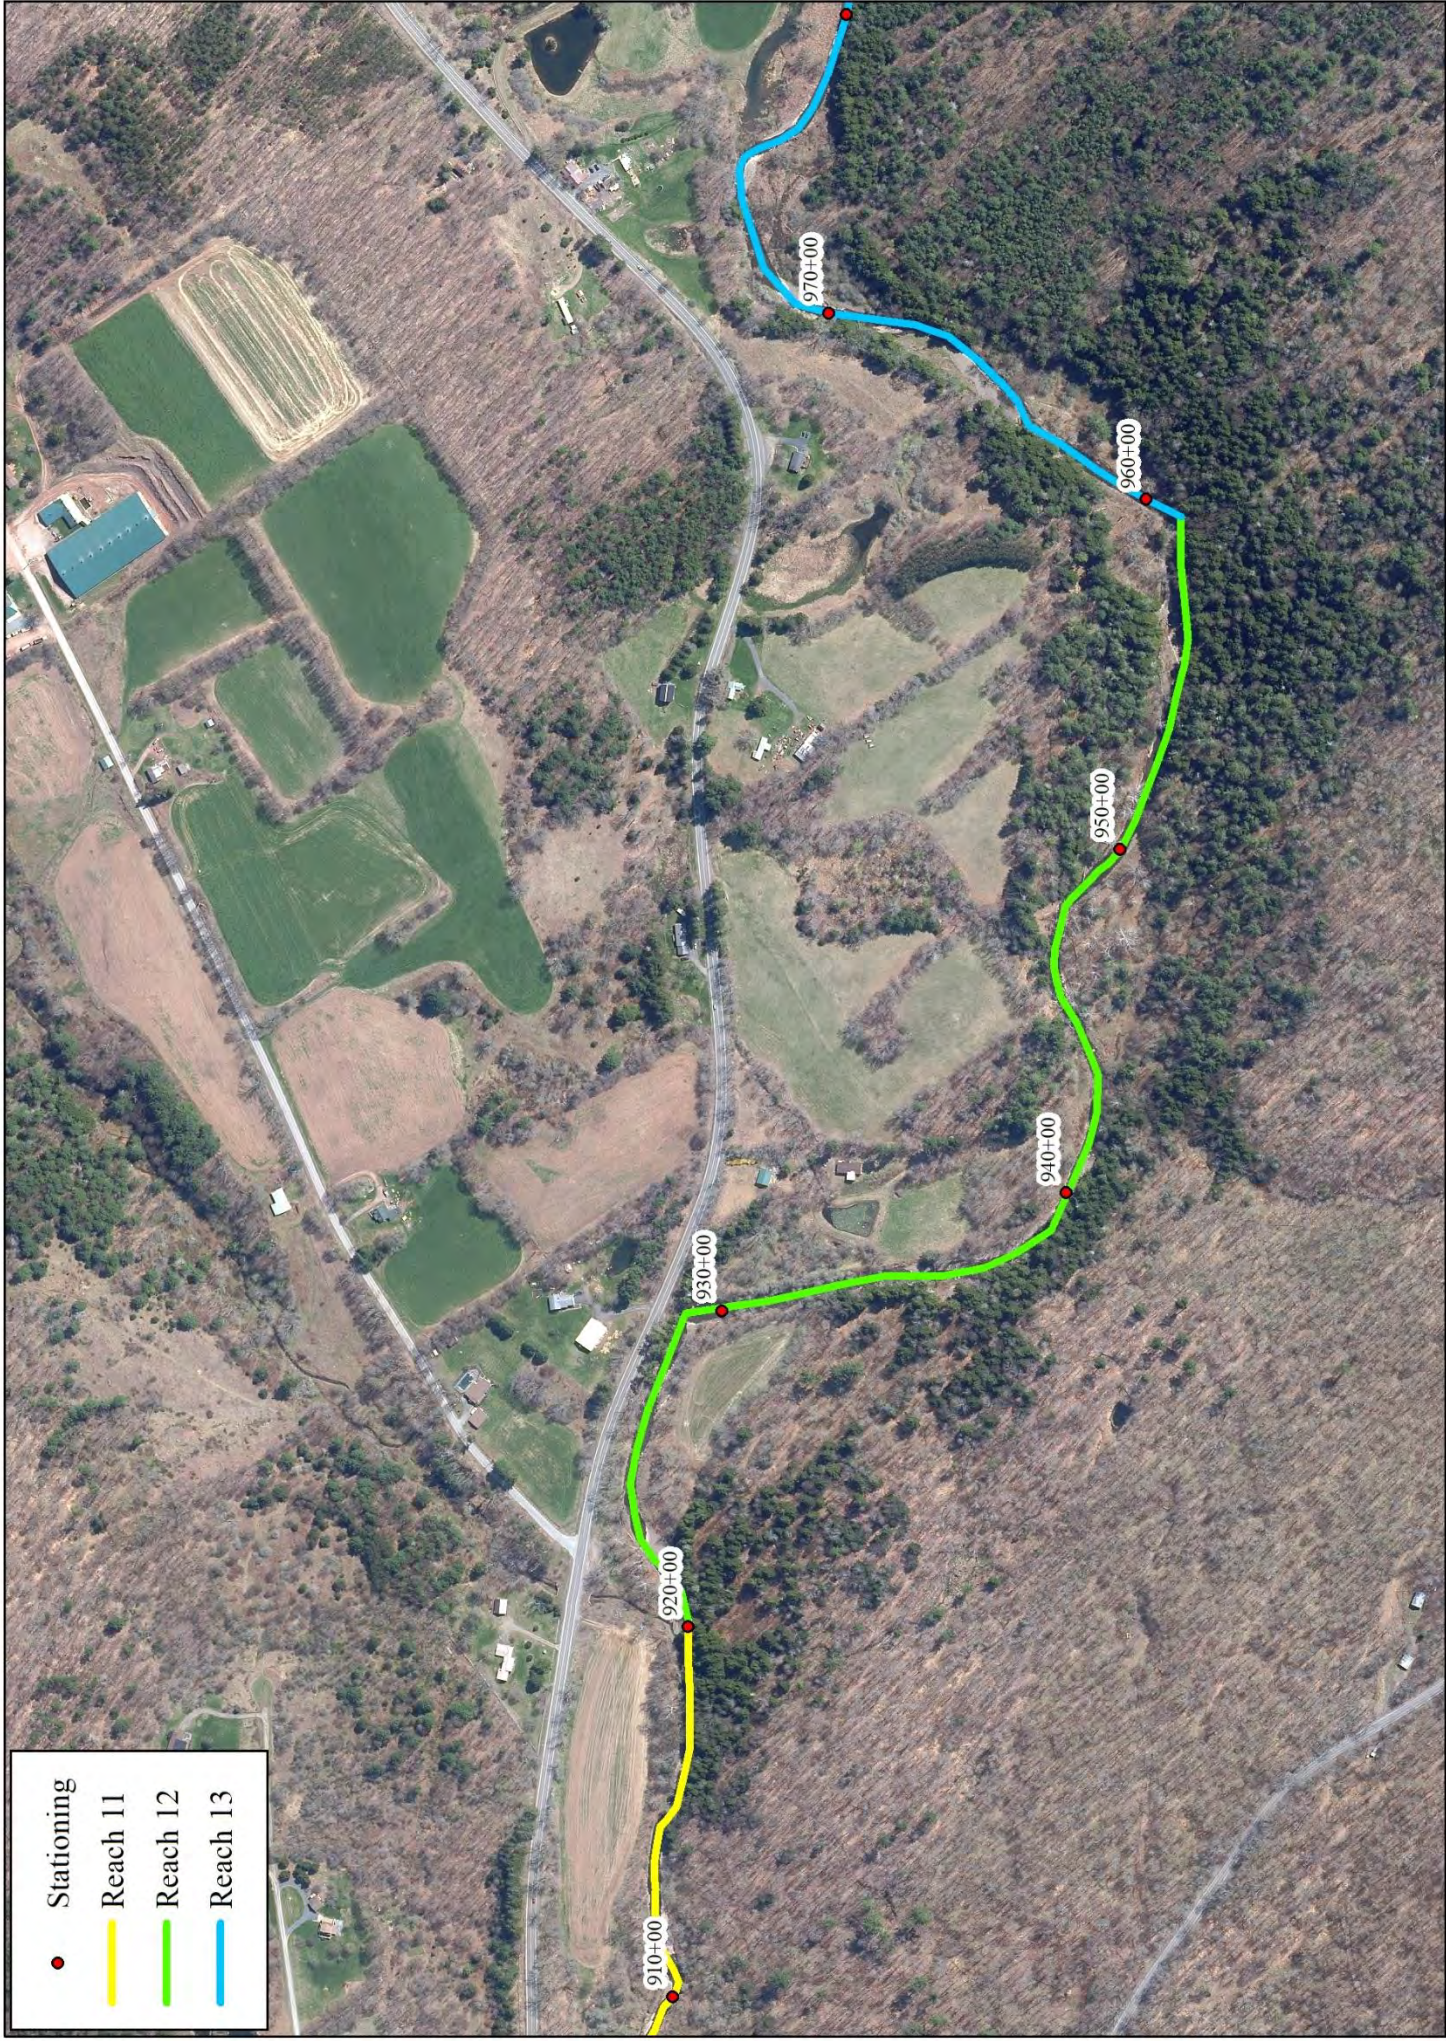
Figure 36: Reach 12 Map

One location of note was the inactive left hillslope failure from STA 935+00 ft to STA 936+00 ft. This failure was stable and contained young woody trees repopulating the hillslope. However, at the base of the hillslope there were two trees that had fallen across the channel. These trees were causing deposition along the right side of the channel forming a large side channel bar. This bar was causing the stream to flow along the left side of the channel near the base of the hillslope. The trees that were causing the deposition could cause a blockage if they collect other debris. These trees should be cut into sections to allow debris to pass downstream.

The second feature of note in the reach was from STA 946+00 ft to STA 948+50 ft. In this section there was a recently active hillslope failure and a dormant hillslope failure along the right bank. Both failures were composed primarily of glacial till. These failures had previously contributed large wood into the channel. Several trees, along with a few soil blocks, had slid down the active hillslope and into the channel. In addition, several trees were bridging the

channel at this location. The channel bridging trees could cause a blockage and prevent other debris from passing downstream. The hillslope where the majority of the large wood loading was occurring, was still unstable at the time of assessment and has the potential to contribute more large wood and sediment into the channel in the future. The hillslope was predominately bare at the time of assessment but did contain some toe protection, primarily being the aforementioned woody debris and soil blocks at the base of the hillslope. The channel bridging trees should be cut into sections to prevent blockages in the channel.

The most egregious site of large woody debris was from STA 955+00 ft to STA 957+00 ft. At this site there was a large accumulation of woody debris blocking the channel. There were approximately two dozen pieces of large woody debris that had accumulated in the channel. Some of the trees were hemlocks that had fallen off the left hillslope, others were pieces of large wood that had floated downstream and become stuck in the accumulation. The accumulation was also causing large amounts of deposition upstream and along the right side of the channel. At the time of assessment, streamflow was severely obstructed by the accumulation. During a high flow event, it is likely the channel becomes further blocked and the stream could avulse. The stream was also eroding the toe of the left hillslope adjacent to the large wood accumulation. This accumulation is in a forested area and is not located near any structures or roadways, as such, it does not pose a threat to any infrastructure but is a concern for channel stability and sediment transport. The trees in the accumulation should be cut into smaller pieces so that they do not obstruct flow and can be transported downstream.

The reach also contained bedrock control along certain sections. Notably, the right hillslope from STA 927+00 ft to STA 929+00 ft, the left hillslope from STA 939+00 ft to STA 941+00 ft, the streambed of the channel from STA 944+50 ft to STA 945+50 ft, the streambed from STA 952+50 ft to STA 956+00 ft, and the left hillslope and streambed from STA 957+00 ft to STA 959+00 ft were all composed of bedrock providing these sections of channel with stability as well as grade and planform control.
