# **Ouleout Creek Geomorphic Assessment, Nutrient Load Estimation, and Remediation Recommendations**

**November 2023**

**Delaware County Soil and Water Conservation District**

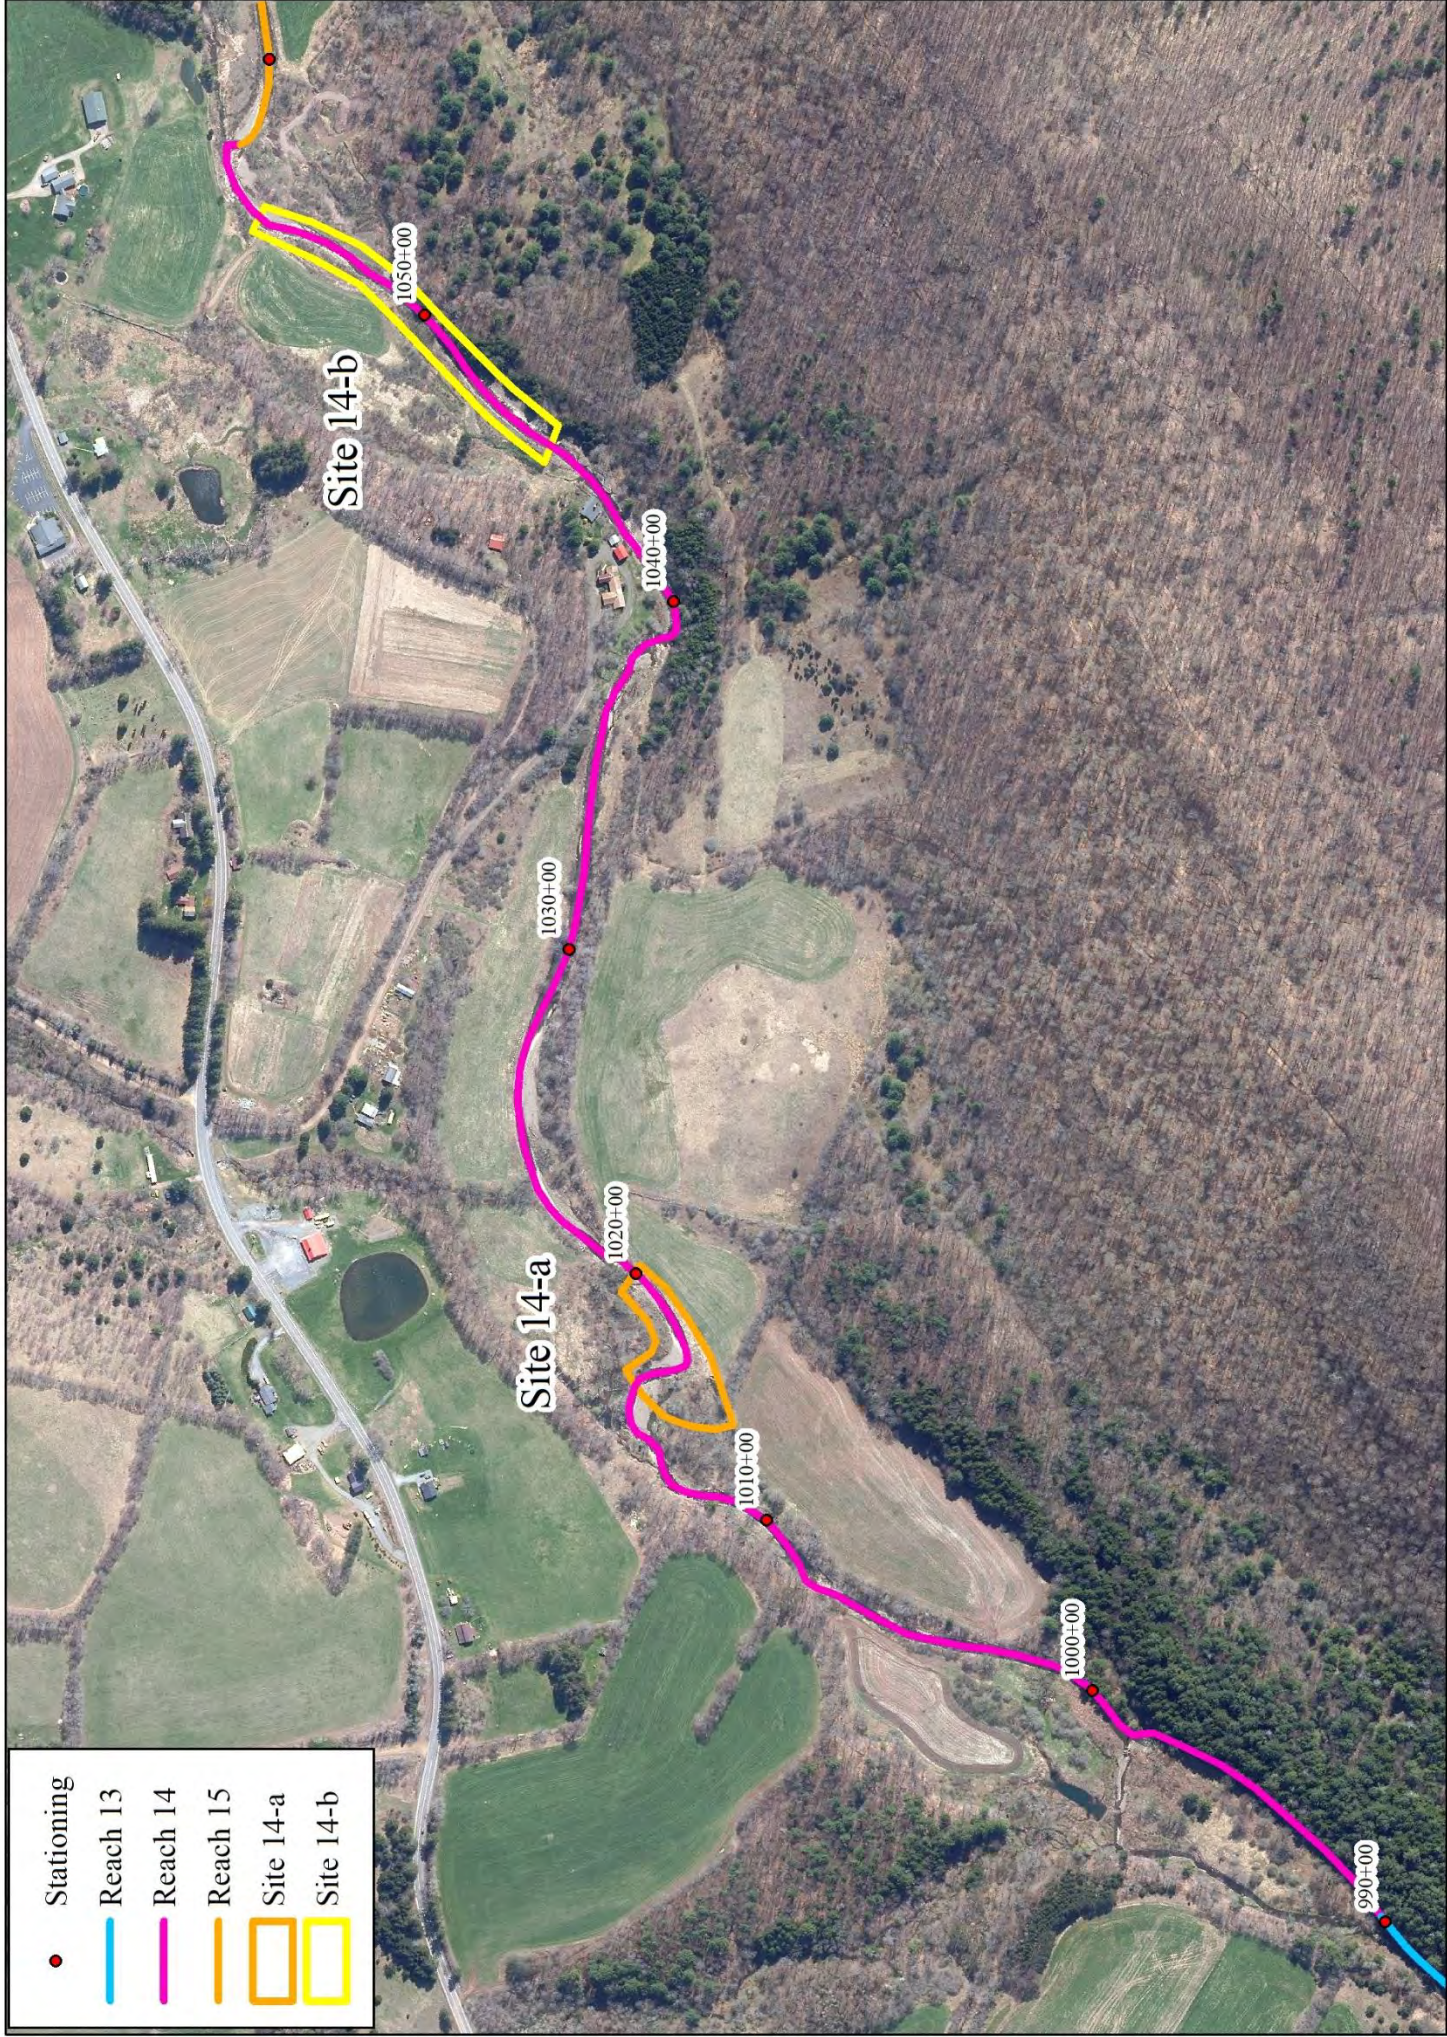
Figure 38: Reach 14 Map

In the reach, 27% of the banks were actively eroding and it is estimated that 550 yd<sup>3</sup> of sediment erodes annually from the reach. In addition, 1,200 lb of TN and 250 lb of TP are estimated to erode annually from the streambanks in the reach. This reach ranked 3rd among reaches for the volume of eroded sediment, 3rd for the mass of eroded TN, and 6th for the mass of eroded TP. The two sites of substantial erosion in the reach can be viewed on the reach map in **Figure 38**.

There was also a hillslope failure within the old channel from STA 1012+00 ft to STA 1012+50 ft. The failure measured 84 ft in length and had a maximum height of 21.4 ft. The hillslope was primarily bare and composed of glacial till. There is potential for more trees to cantilever off the hillslope and into the right channel as many trees at the top of the hillslope were severely undercut. The hillslope did contain toe protection in the form of boulders and will likely not continue to erode if the majority of streamflow remains in the avulsion channel and the old channel remains predominately inactive.

This section of the Ouleout is naturally unstable and would be complex to stabilize. Because of this, attempting to stabilize the channel in this section of stream would not be recommended. However, the right bank at the upstream end of the site along an agricultural field could potentially be armored with revetment such as large rock or root wads. A riparian forest buffer could also be established along that section of the right bank in order to protect the bank from future erosion.

The upstream section of the reach will likely experience further erosion in the future as just upstream of this reach is a meander eroding downstream located between STA 1057+50 ft and STA 1060+00 ft. This meander previously migrated through an agricultural field in Reach 15 but has since moved downstream and, at the time of assessment, was eroding into alluvial deposits in the depositional area at the downstream end of Reach 15. In addition to this meander,

there was an avulsion channel forming at STA 1059+00 ft which cuts through the left bank floodplain. This section of channel is further discussed in the Reach 15 section of the report.

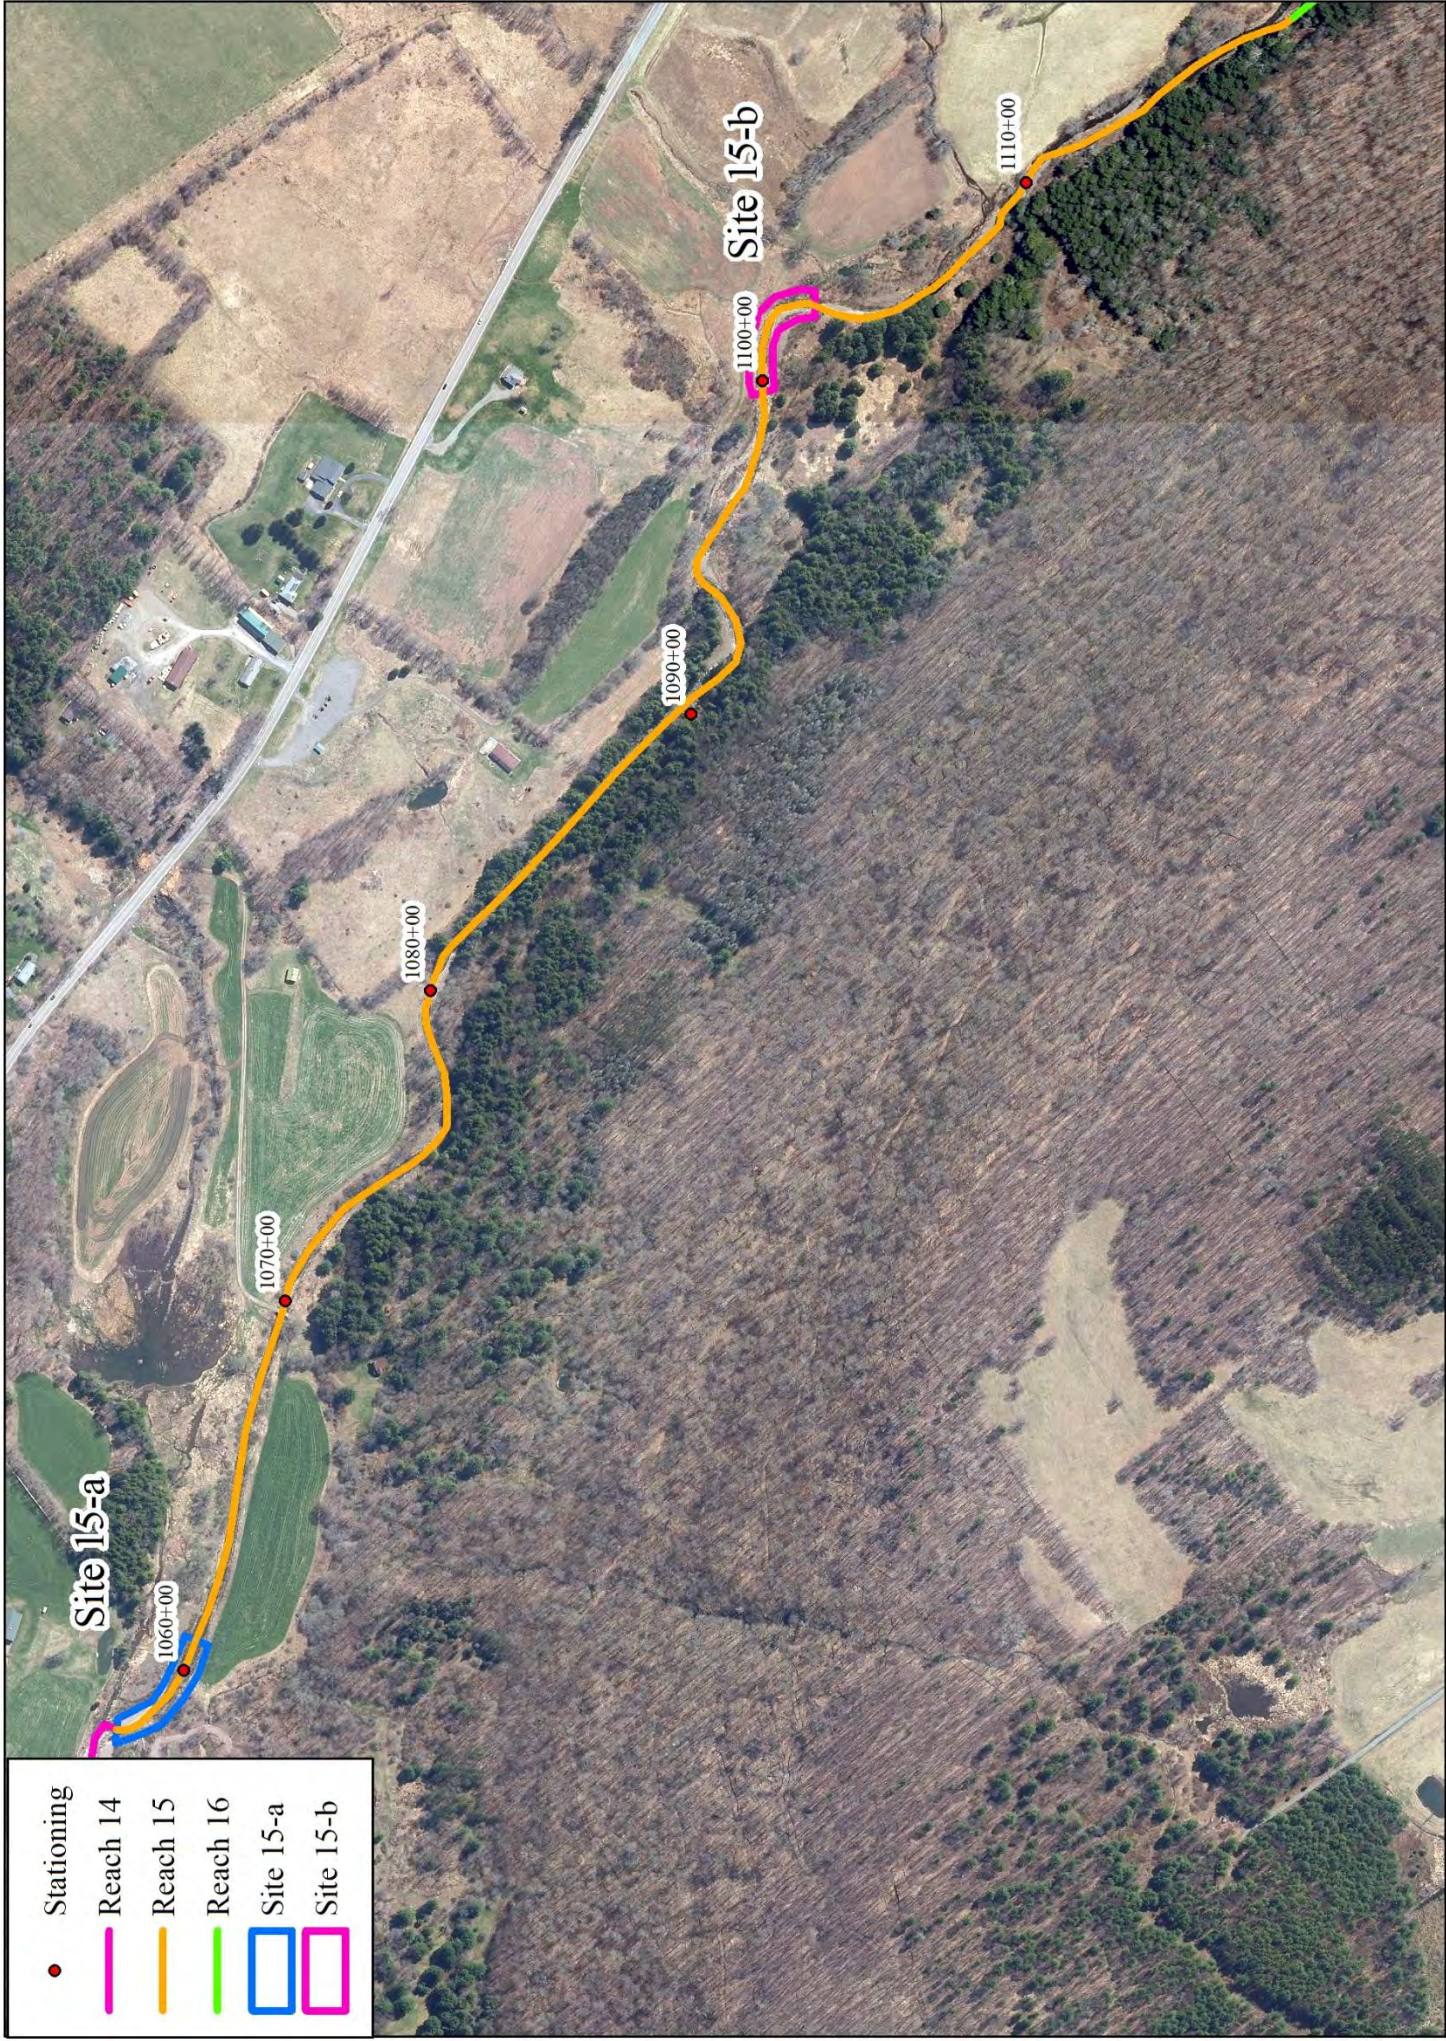
Figure 39: Reach 15 Map

In the reach, 25% of the banks were actively eroding and it is estimated that 300 yd<sup>3</sup> of sediment erodes annually from the reach. In addition, 590 lb of TN and 85 lb of TP are estimated to erode annually from the streambanks in the reach. This reach ranked 6th among reaches for the volume of eroded sediment, 8th for the mass of eroded TN, and 11th for the mass of eroded TP. The two sites of substantial erosion in the reach can be viewed on the reach map in **Figure 39**.

One area of note in the reach was a left hillslope failure from STA 1075+50 ft to STA 1077+50 ft. The failure measured 111 ft in length and had a maximum height of 35 ft. The

hillslope was primarily composed of glacial till and was sparsely vegetated with herbaceous plants such as coltsfoot. The base of the hillslope contained toe protection in the form of boulders. At the time of assessment, the downstream section of the failure appeared to be at an angle of repose and the erosion could likely become dormant in the future.

One notable location of large woody debris in the channel was at STA 1106+00 ft. At this location, a large pine tree that had cantilevered off the left bank and into the channel. This tree was bridging the entire active channel and has the potential to capture debris and cause a blockage in the channel at higher flow.

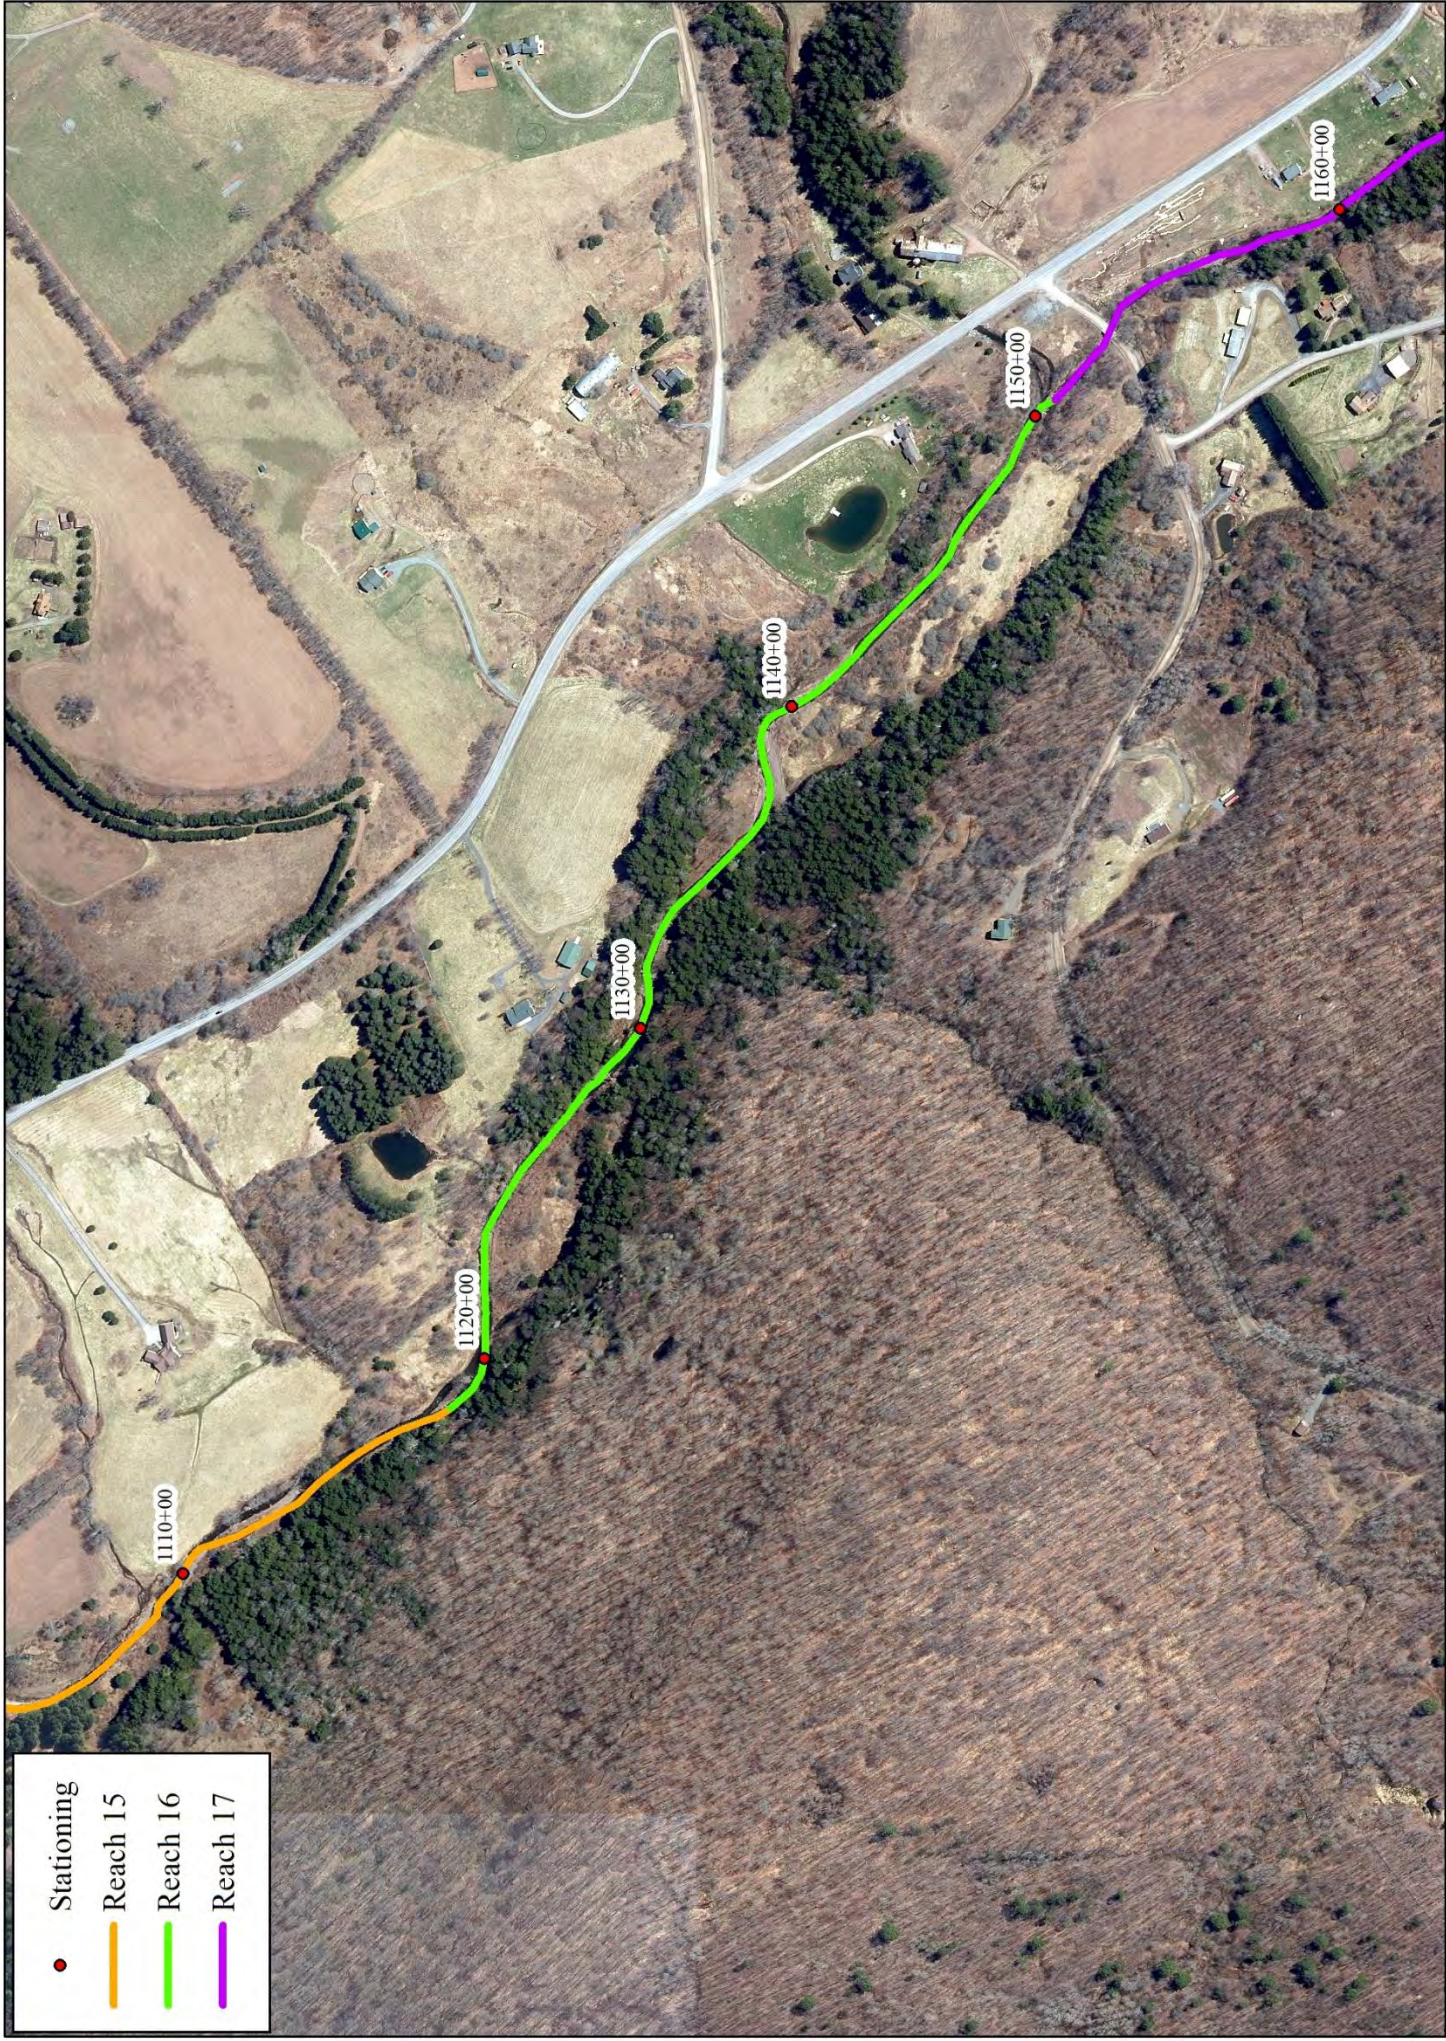
Figure 40: Reach 16 Map

In the reach, 24% of the banks were actively eroding and it is estimated that 60 yd<sup>3</sup> of sediment erodes annually from the reach. In addition, 120 lb of TN and 16 lb of TP are estimated to erode annually from the streambanks in the reach. This reach ranked 18th among reaches for the volume of eroded sediment, 18th for the mass of eroded TN, and 21st for the mass of eroded TP. The reach's location can be viewed on the reach map in **Figure 40**.

There were also several notable sites of large woody debris in the reach. There was a channel bridging tree that cantilevered off the right bank at STA 1126+50 ft. This tree could cause an accumulation within the channel during higher flow. Between STA 1131+00 ft and STA 1133+50 ft there were several trees that had cantilevered off the right hillslope and into the channel capturing debris within the channel. The right hillslope that the trees slid off of, was

composed primarily of glacial till and had previously eroded but appeared dormant at the time of assessment.

There was a right hillslope failure from STA 1138+50 ft to STA 1139+50 ft. The failure measured 136 ft in length and had a maximum height of 18 ft. The hillslope was composed primarily of glacial till. Cantilevered blocks of soil, root wads, and large woody debris had fallen into the channel at this site and blocked a large portion of the channel obstructing flow and causing an accumulation of debris. Just upstream of the failure was a transverse bar causing streamflow to impinge upon the base of the right hillslope. Across from the hillslope was a large floodplain along the left bank that the stream was eroding into at the time of assessment due to the channel being blocked by the aforementioned debris.

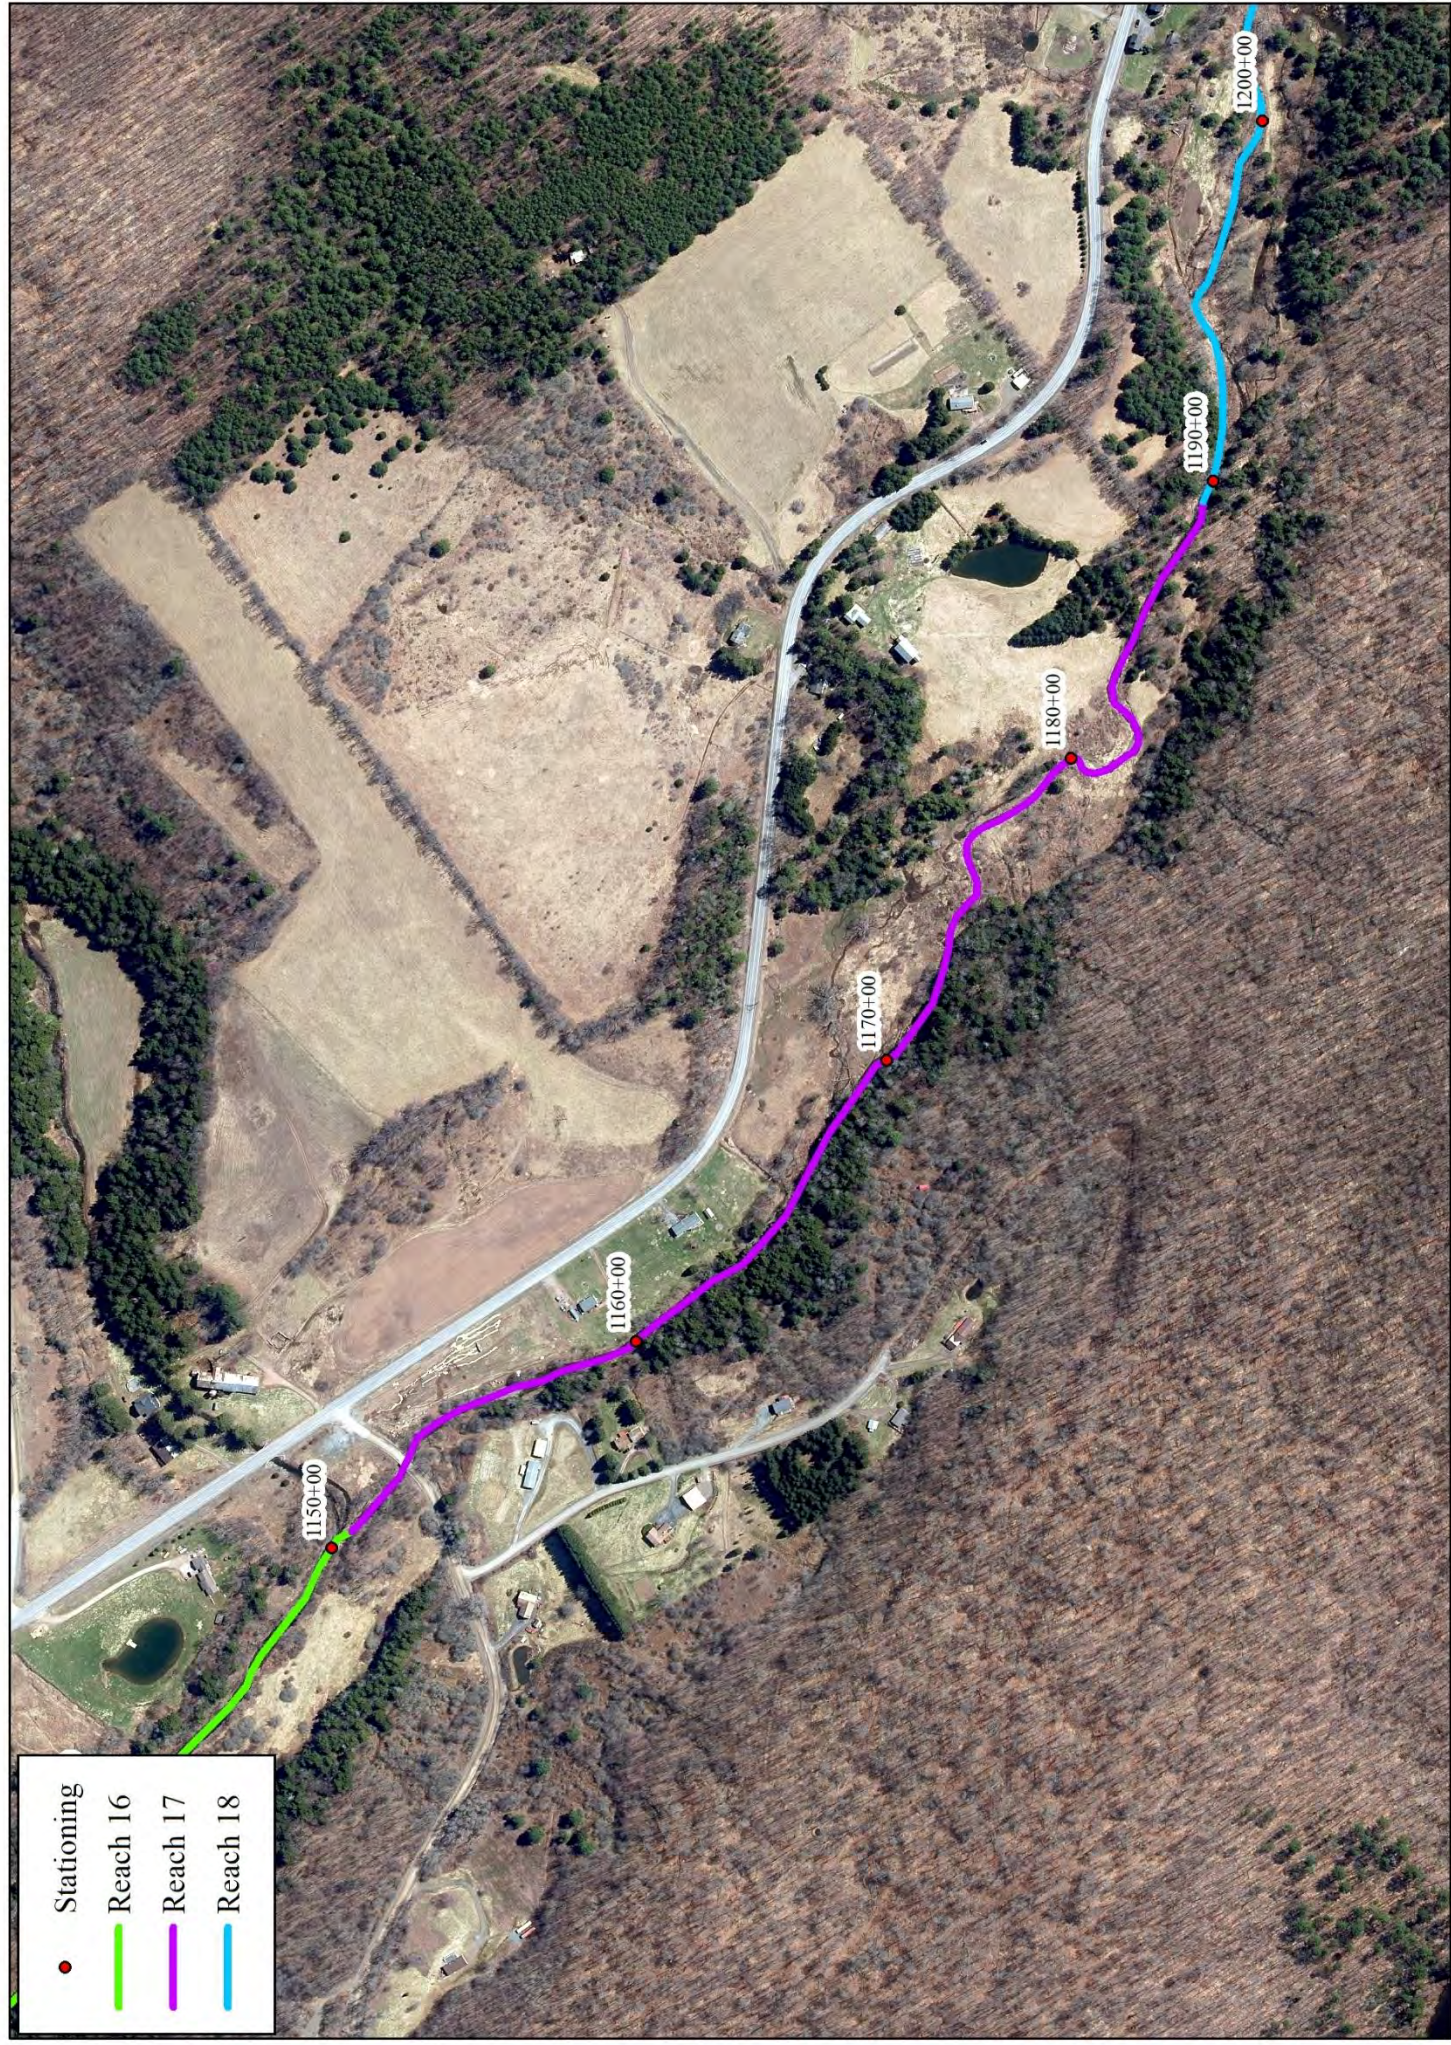
Figure 41: Reach 17 Map

In the reach, 24% of the banks were actively eroding and it is estimated that 59 yd<sup>3</sup> of sediment erodes annually from the reach. In addition, 120 lb of TN and 29 lb of TP are estimated to erode annually from the streambanks in the reach. This reach ranked 19th among reaches for the volume of eroded sediment, 19th for the mass of eroded TN, and 16th for the mass of eroded TP. There were no sites of substantial erosion in the reach. The reach's location can be viewed on the reach map in **Figure 41**.

One location of large woody debris in the channel was at STA 1173+50 ft where several large willows had cantilevered off the right bank and into the channel. These willows were causing an accumulation of debris upstream and scour within the bed of the channel. The willows could cause a blockage if further debris accumulates at the site.

The most concerning accumulation of large woody debris was from STA 1171+00 ft to STA 1171+50 ft. At this location, there were multiple trees that slid off a previously eroding left bank hillslope failure. The hillslope, for the most part, had recovered and was revegetated with young birch trees and other vegetation. However, there were approximately two dozen pieces of large woody debris that accumulated in the channel at the site. This accumulation nearly blocks the whole channel, obstructs flow, and prevents debris from passing downstream. There was also a large depositional bar upstream of the accumulation indicating that the accumulation is affecting sediment transport. Further accumulation of debris at the site would likely block the channel and could cause the stream to avulse.

1177+00 ft and converge at STA 1168+00 ft. At the time of assessment, only the channel along the left hillslope was receiving flow. Between STA 1166+00 ft and STA 1168+00 ft, there is an old berm along the right bank. This berm prevents the stream from accessing its floodplain during high flow events.

One erosion segment of note in the reach was along the left bank from STA 1180+00 ft to STA 1183+00 ft. This erosion was not large enough in terms of eroded material to be ranked as a site of substantial erosion but is still noteworthy and should be monitored. This erosion segment measured 210 ft in length and had an average height of 2.2 ft. It is estimated that 28 yd<sup>3</sup> of sediment has eroded annually from the erosion segment. The erosion was along a large bend in the stream channel opposite an aggrading point bar on the right bank. From 2016 to 2022, the stream had eroded approximately 30 ft laterally into a field along the left bank. To the southwest of the eroding bank, there is a tributary channel that runs along the base of the left hillslope. A field along the left bank of the Ouleout separates the Ouleout channel from the tributary channel. Within this field, there is an avulsion channel from the Ouleout to the tributary channel near STA 1182+00 ft. The avulsion channel contains a headcut which was approximately 30 ft from the main channel of the Ouleout at the time of assessment. When the headcut reaches the Ouleout, it will likely direct the flow of the Ouleout into the tributary channel that runs along the base of the left hillslope. The tributary channel converges with the Ouleout at STA 1173+50 ft.

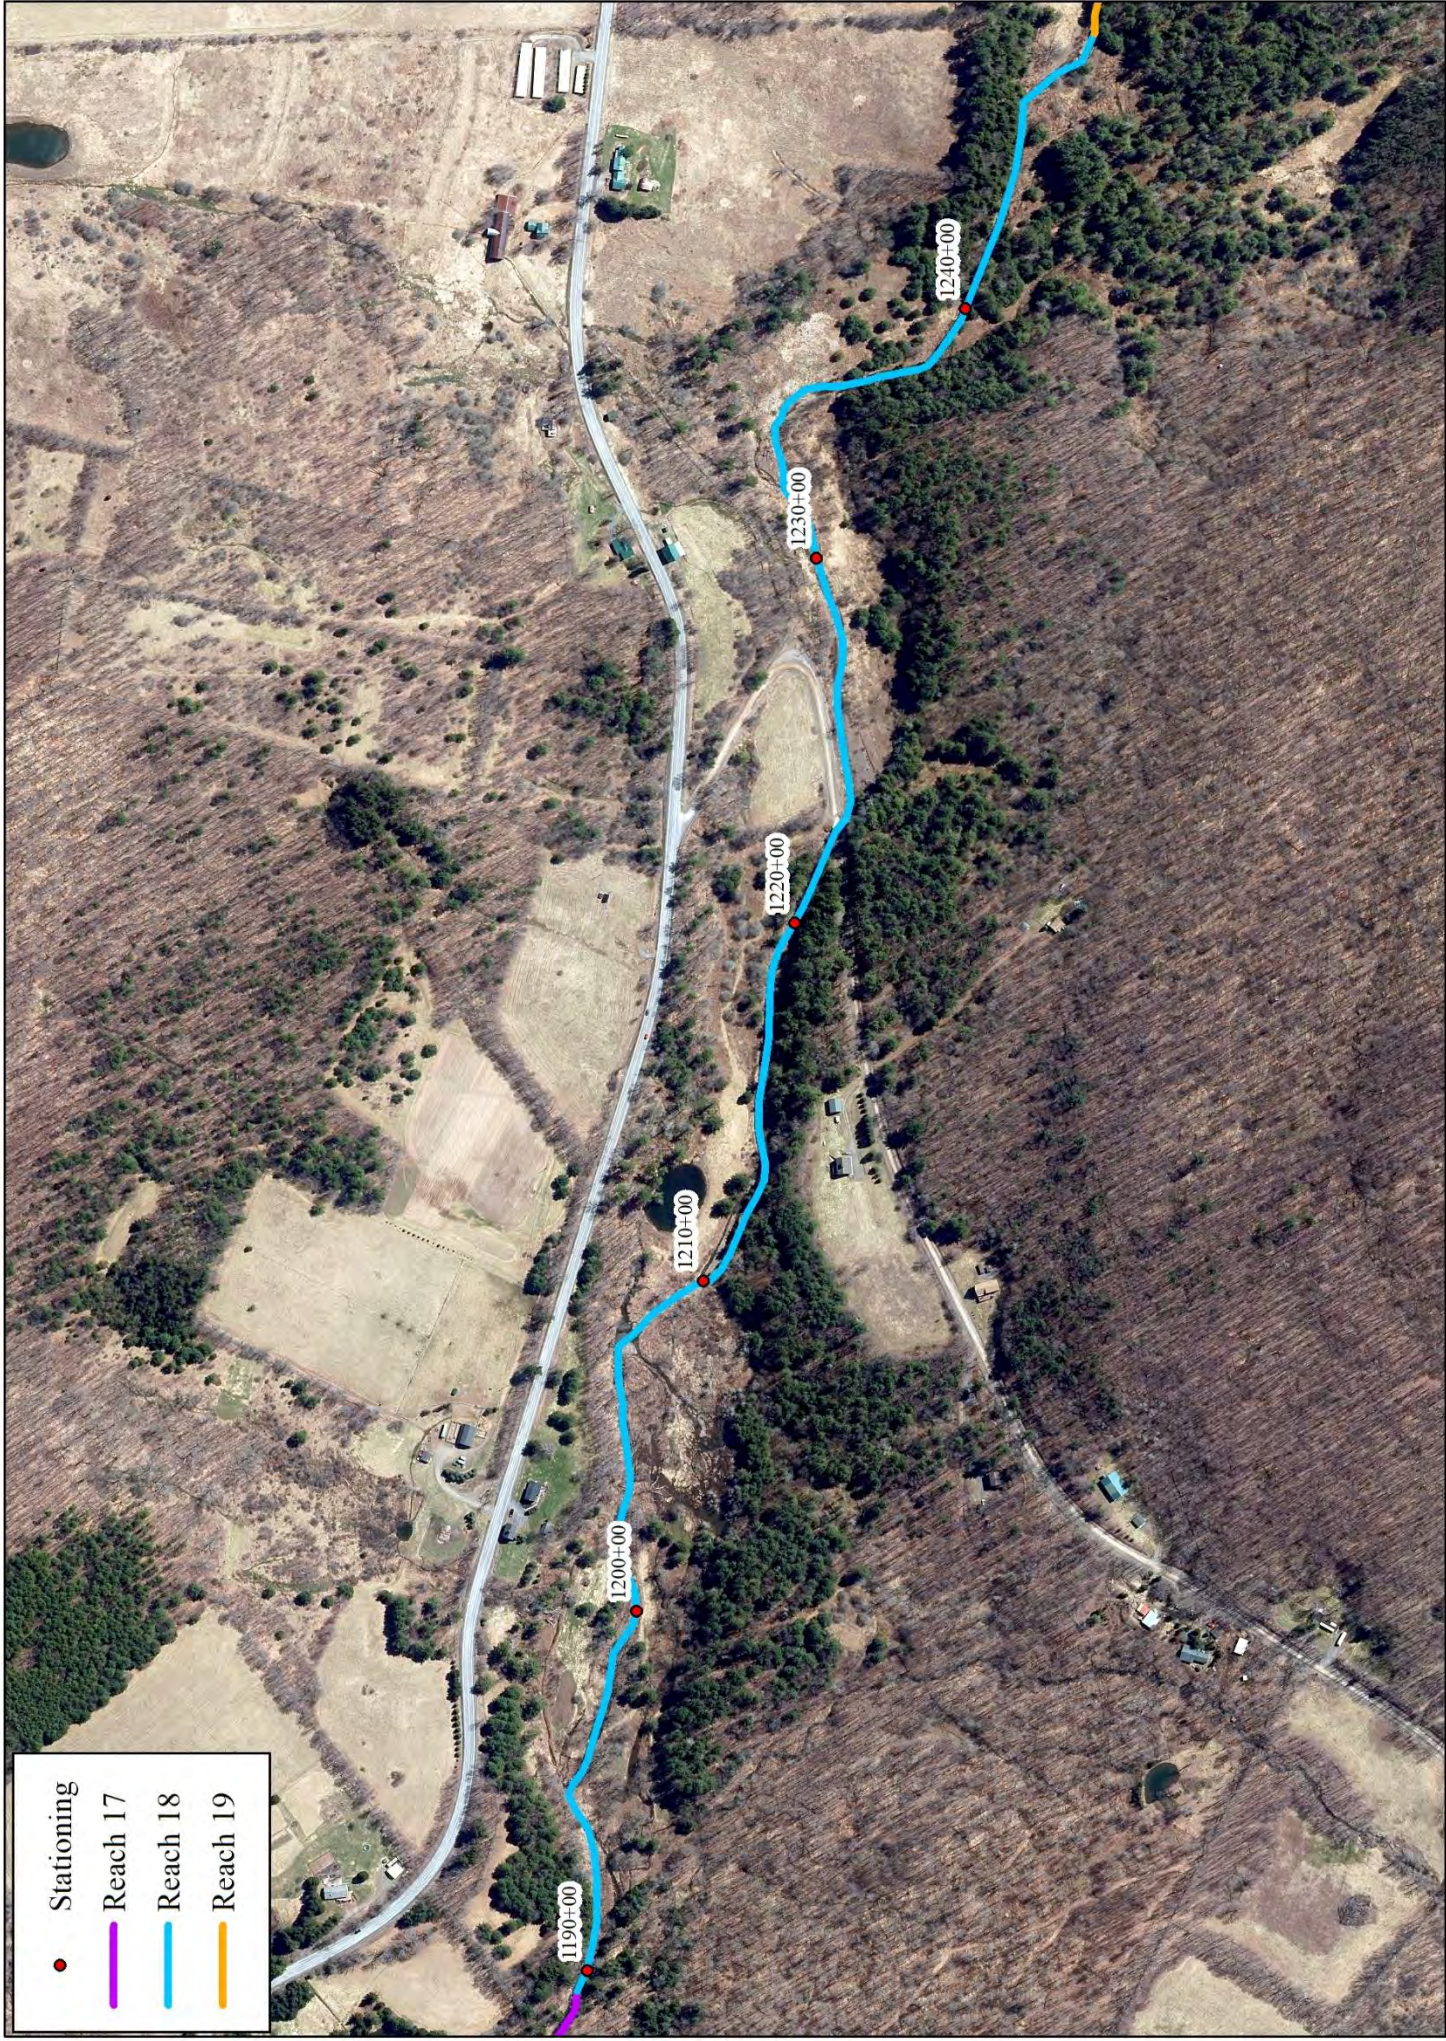
Figure 42: Reach 18 Map

In the reach, 17% of the banks were actively eroding and it is estimated that 97 yd<sup>3</sup> of sediment erodes annually from the reach. In addition, 190 lb of TN and 47 lb of TP are estimated to erode annually from the streambanks in the reach. This reach ranked 15th among reaches for the volume of eroded sediment, 16th for the mass of eroded TN, and 14th for the mass of eroded TP. The reach's location can be viewed on the reach map in **Figure 42**.

There were three headcuts in the reach. The first headcut was located at STA 1190+00 ft and had a depth of 1.5 ft. Immediately downstream of the headcut, the left bank was actively eroding at the time of assessment. In addition, several trees had cantilevered off the left bank and into the channel. The second headcut was located in the right channel at STA 1199+00 ft and had a depth of 1.2 ft. The third headcut was located at STA 1232+00 ft and had a depth of 0.5 ft. The threat these headcuts posed was to bed and bank stability as they were located in forested areas and not in close proximity to any infrastructure.

As with the previous reaches that were heavily forested, this reach contained large woody debris within the stream channel. Trees that had fallen across the channel were located at STA 1190+00 ft and STA 1191+00 ft. These trees were retaining debris and could further disrupt flow. Within the left channel at STA 1193+00 ft and STA 1194+00 ft there were two pine trees that had cantilevered off the left bank and into the channel. These trees were partially obstructing flow and causing scour within the streambed. The pine trees also have the potential of further blocking the channel in a high flow event. At STA 1246+50 ft, a tree had cantilevered off the eroding left bank and into the channel and was capturing debris. The eroding bank that this tree cantilevered off of measured 206 ft in length, had an average height of 2.7 ft, and it is estimated that 29 yd<sup>3</sup> of sediment erodes annually from the erosion segment. The erosion was along an old field that was primarily comprised of herbaceous plants and shrubs. The erosion at this location could be remediated by establishing an adequate riparian forest buffer.

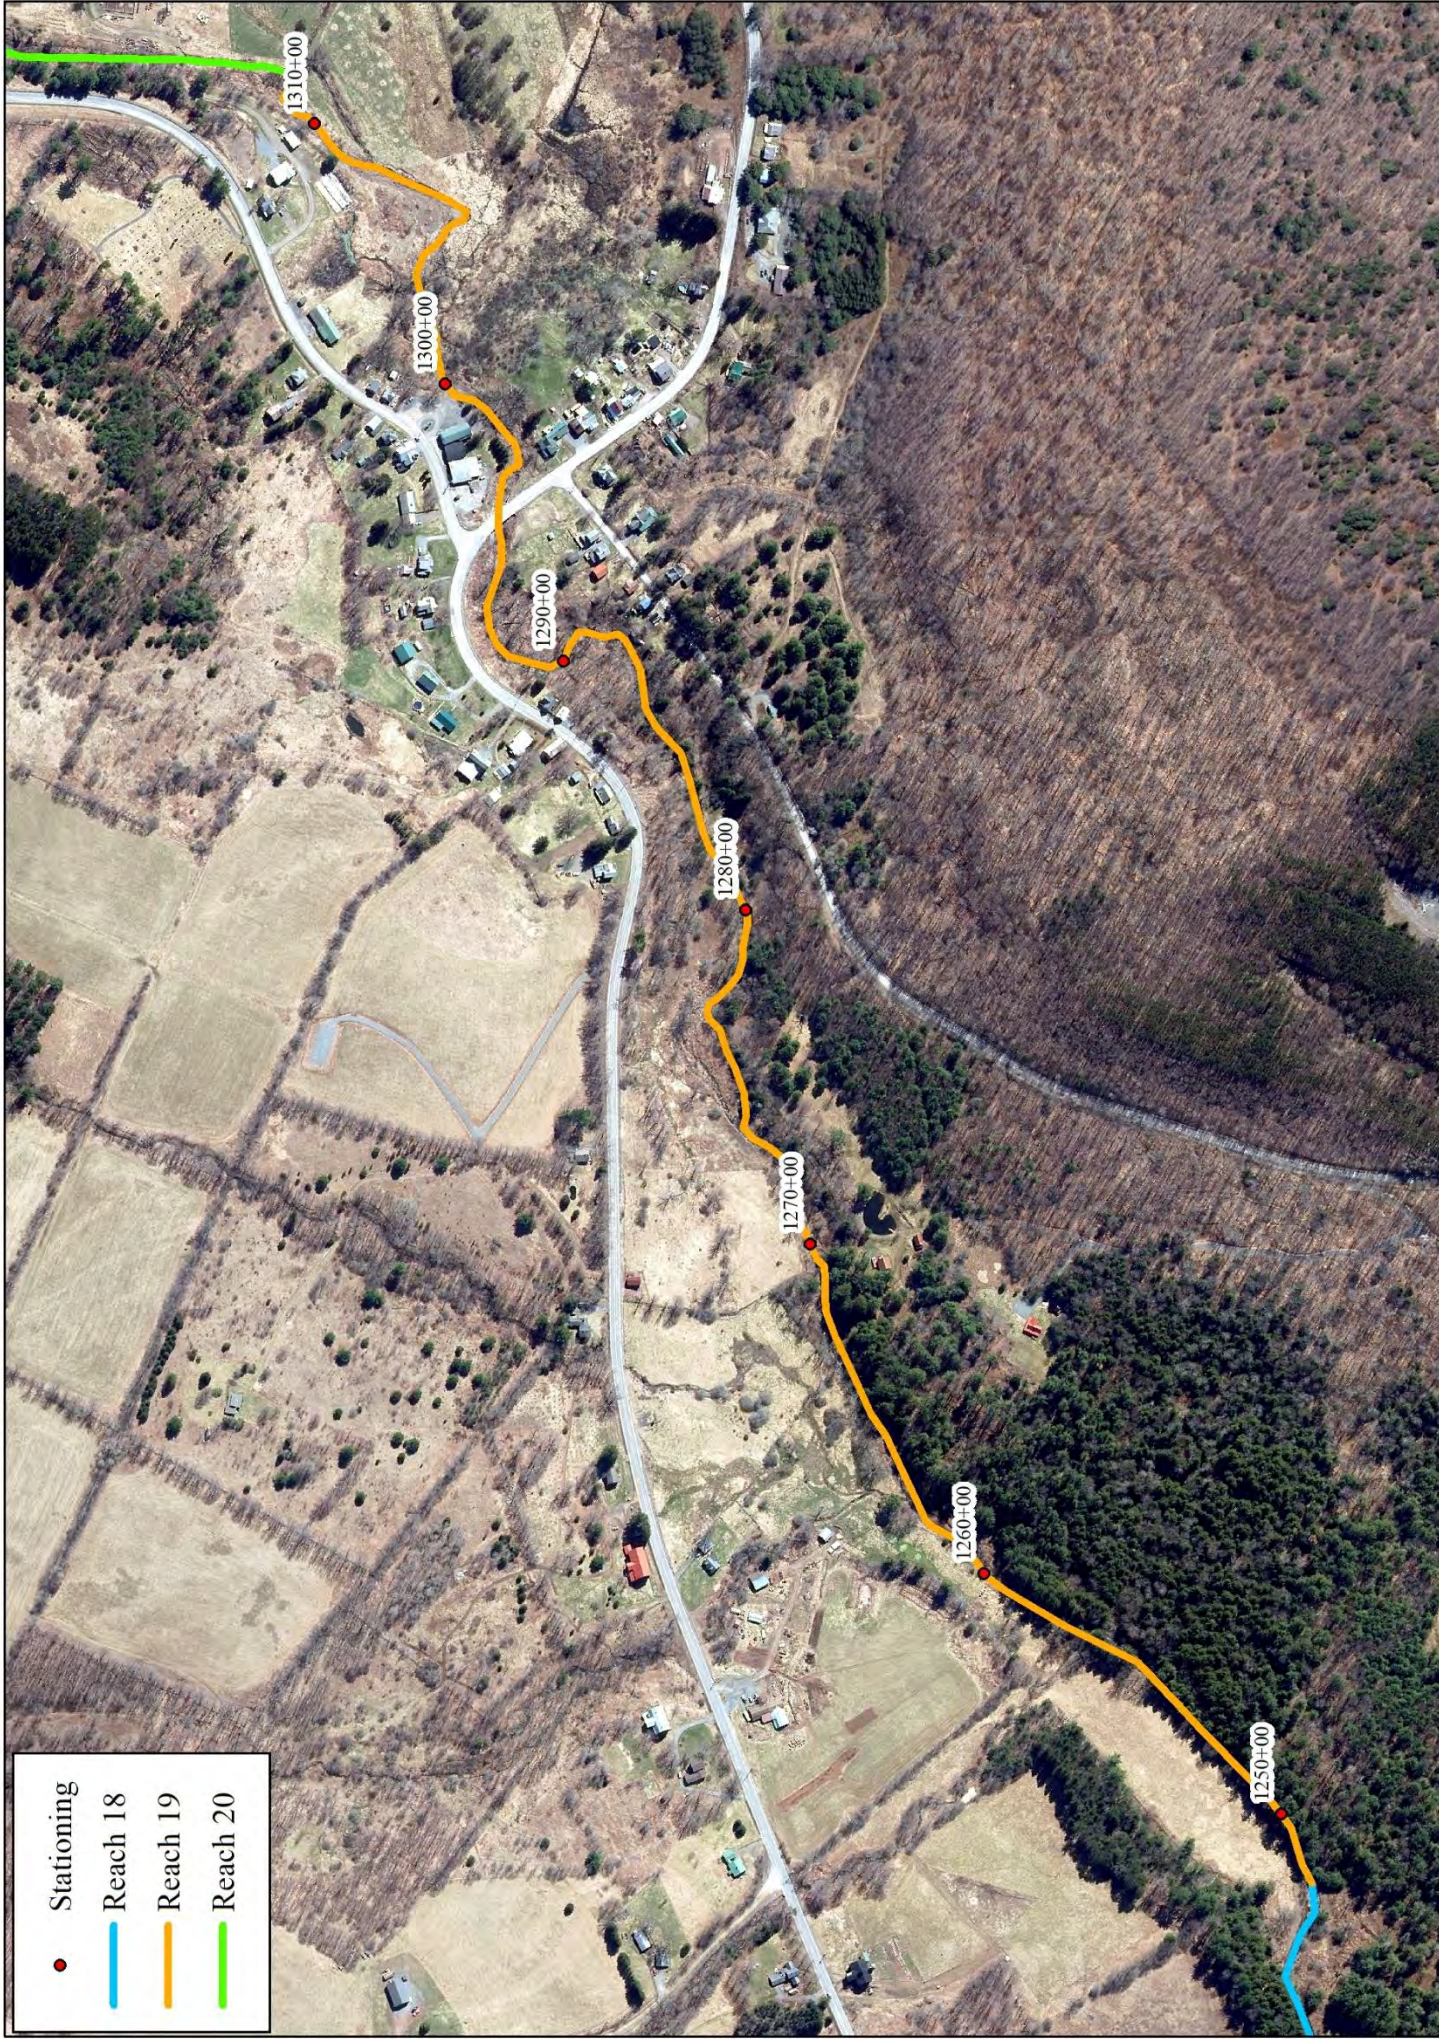
Throughout the reach, there were accumulations of large woody debris in the stream channel that could be of concern. There were several trees from STA 1282+00 ft to STA 1285+50 ft that had fallen into the channel and were causing accumulations of debris. There was also an accumulation of large woody debris at STA 1289+00 ft. Large woody debris was accumulating at this site due to a sharp bend in the channel caused by an old stacked rock revetment wall which redirects flow. The revetment also narrowed the channel and prevented the aforementioned large woody debris from passing downstream. At STA 1293+00 ft, several willows had cantilevered into the channel causing scour within the bed of the channel and constricting streamflow.

The stream was previously eroding into the left bank from STA 1304+50 ft to STA 1307+00 ft. Between 2006 and 2022, the stream eroded approximately 150 ft laterally into the left bank. However, at the time of assessment, the left bank was not actively eroding and was partially inundated by the pool caused by the large beaver impoundment immediately downstream.

In the upstream section of Reach 19, the stream flows along a pasture with an intermittent riparian buffer. At the time of assessment, the stream was eroding into the pasture along the left bank from STA 1311+00 ft to STA 1312+00 ft. This erosion segment measured 95 ft in length, had an average height of 2.4 ft, and it is estimated that 10 yd<sup>3</sup> of sediment has eroded annually.
