# **Ouleout Creek Geomorphic Assessment, Nutrient Load Estimation, and Remediation Recommendations**

**November 2023**

**Delaware County Soil and Water Conservation District**

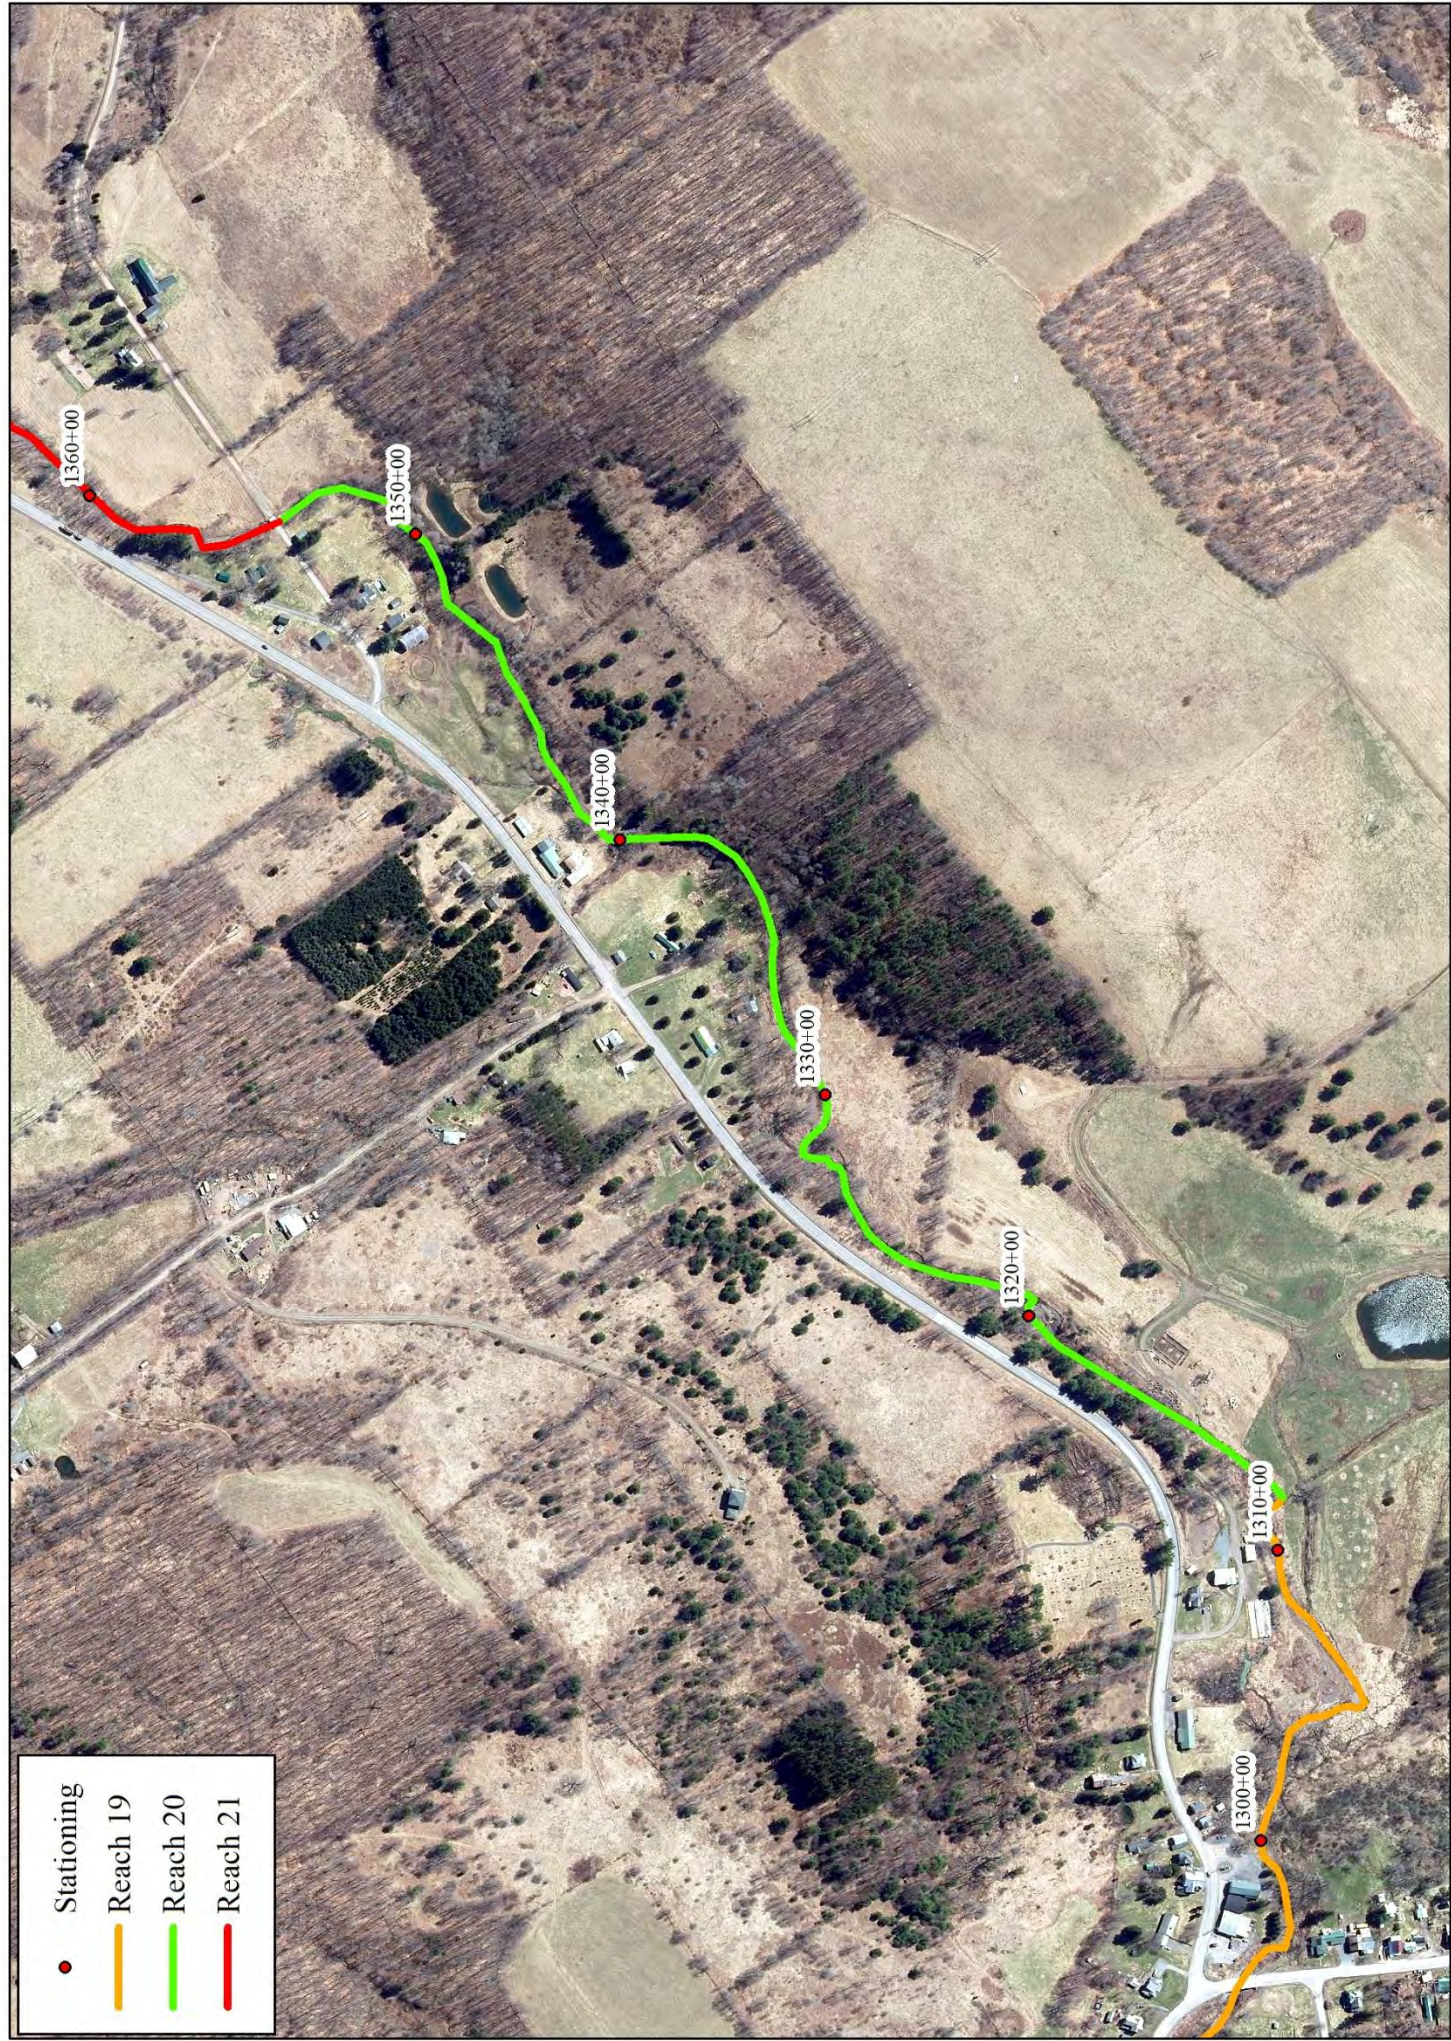
Figure 44: Reach 20 Map

In the reach, 19% of the banks were actively eroding and it is estimated that 80 yd<sup>3</sup> of sediment erodes annually from the reach. In addition, 230 lb of TN and 41 lb of TP are estimated to erode annually from the streambanks in the reach. This reach ranked 16th among reaches for the volume of eroded sediment, 15th for the mass of eroded TN, and 15th for the mass of eroded TP. There were no substantial sites of erosion in Reach 20, however, there were other noteworthy features in the reach. The reach's location can be viewed on the reach map in **Figure 44**.

Similar to several of the previously discussed reaches, there were several locations of large woody debris within the channel in the reach. Some of these sites of large woody debris could be of concern. At approximately STA 1328+00 ft, there were several trees that had cantilevered off the eroding right bank and had fallen into the channel. These trees were retaining large amounts of debris and preventing the debris from passing downstream. The large woody debris was also causing scour in the channel downstream of the accumulation.

A private bridge is located at STA 1334+50 ft. This bridge is approximately 30 ft in length and has 1 pier in the middle. At the time of assessment, the bridge and its corresponding revetment were in poor condition. The stream approached the sheet piling revetment at a near perpendicular angle causing streamflow to impinge upon the left bank revetment and also scour behind the revetment. The bridge itself was structurally unsound as the wood boards it is composed of were in various stages of disrepair and decay. The wood supports of the bridge along the left bank had been undercut by the stream causing the bridge to lean at an angle. If the bridge were to fail, it could partially block the stream channel and disrupt streamflow.

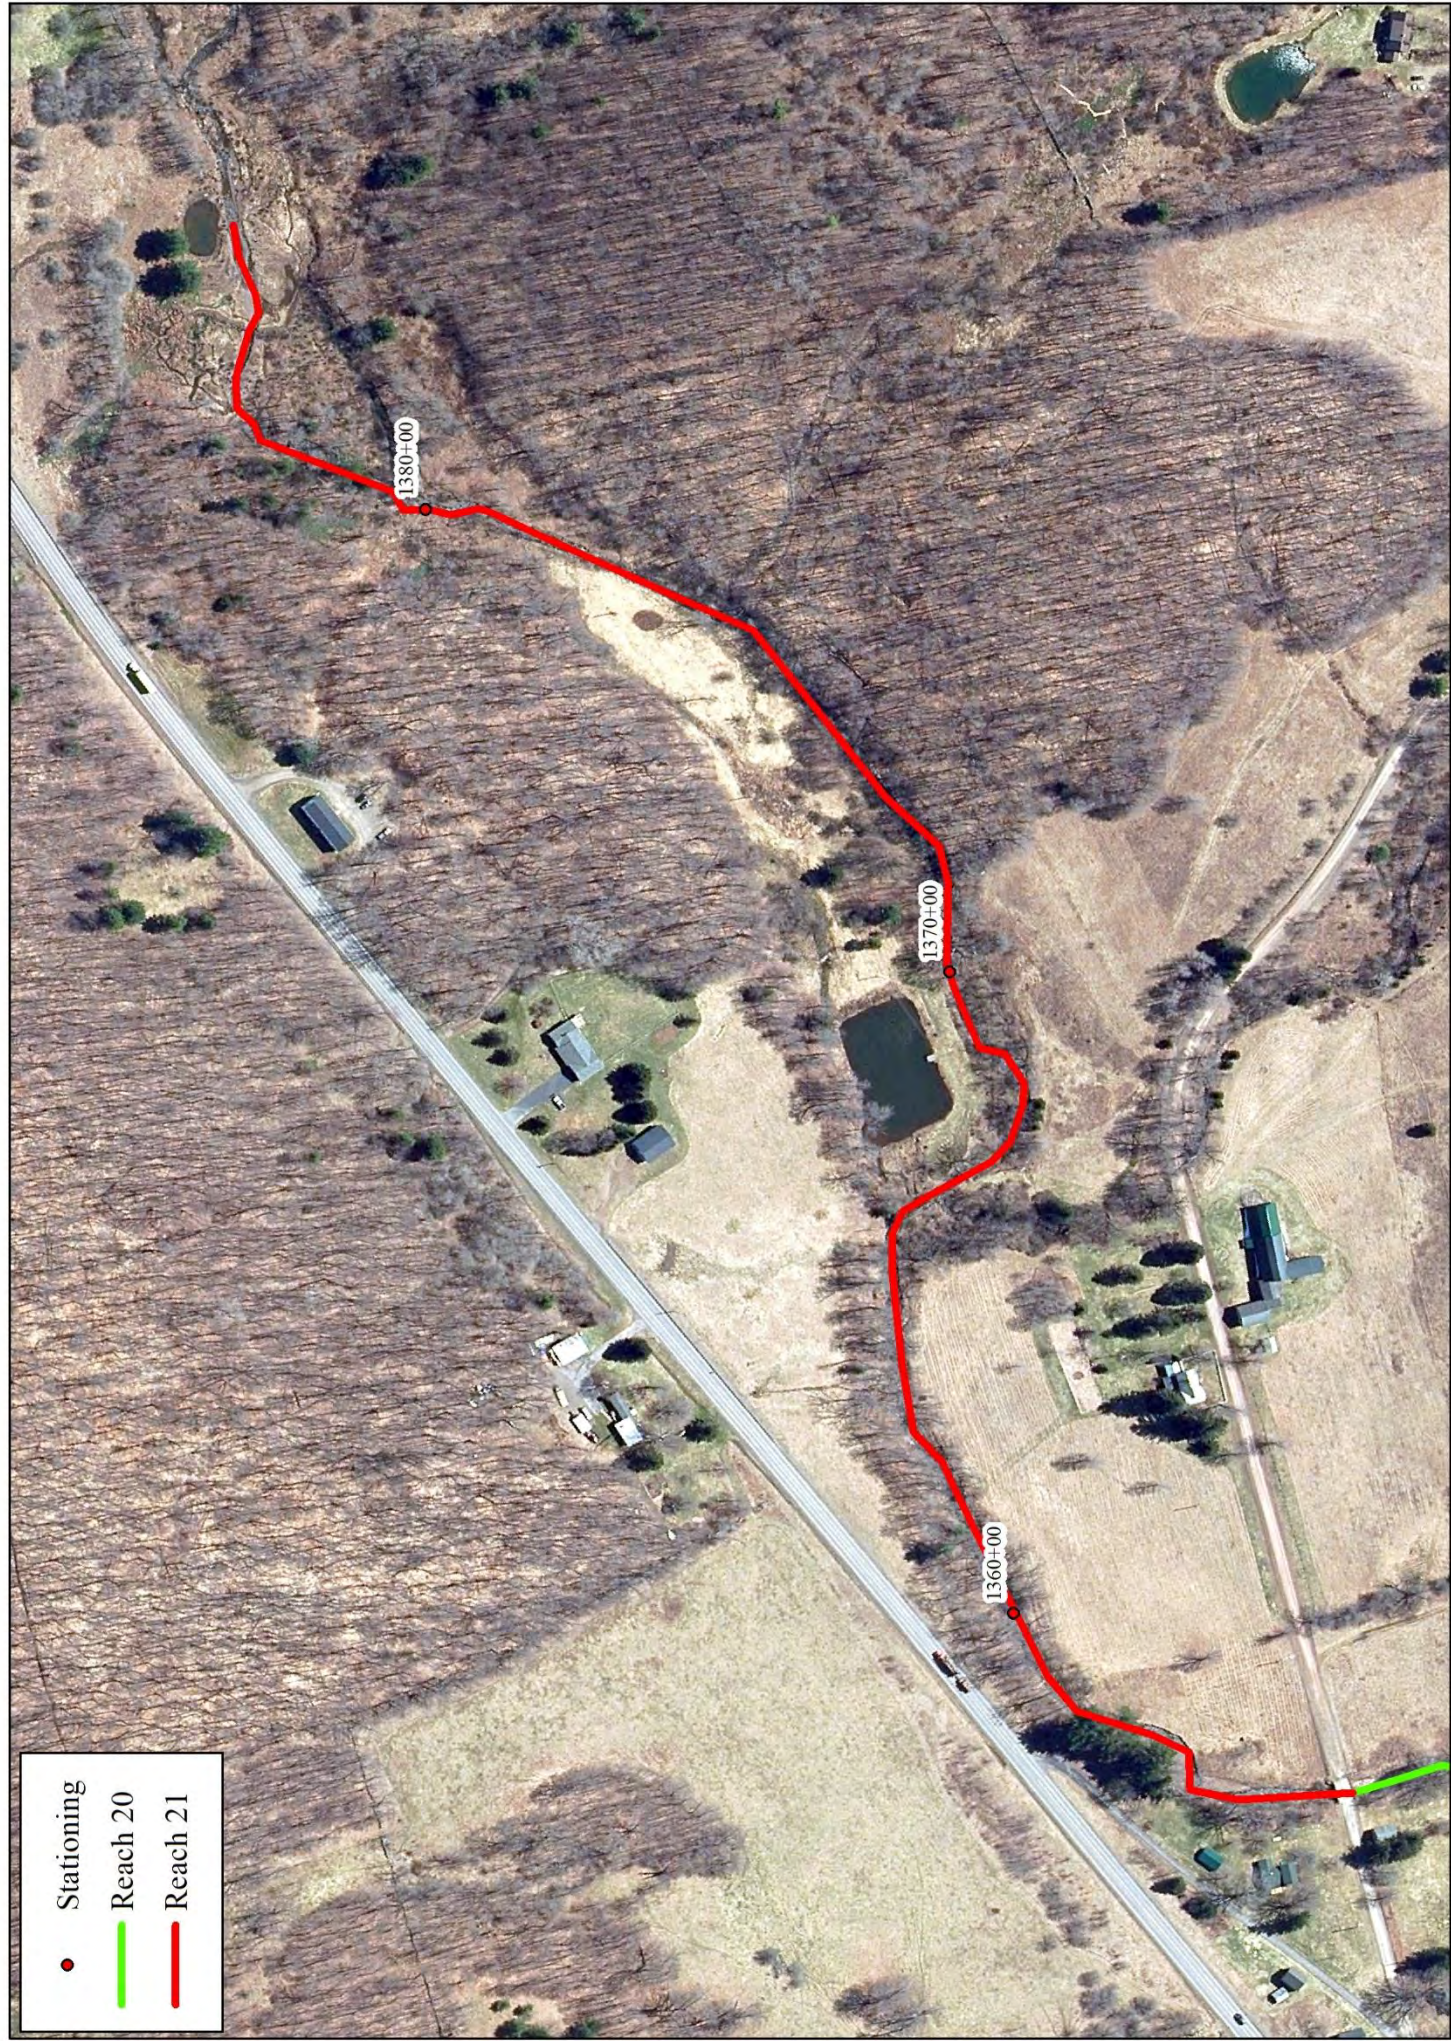
Figure 45: Reach 21 Map

In the reach, 15% of the banks were actively eroding and it is estimated that 65 yd<sup>3</sup> of sediment erodes annually from the reach. In addition, 150 lb of TN and 26 lb of TP are estimated to erode annually from the streambanks in the reach. This reach ranked 17th among reaches for the volume of eroded sediment, 17th for the mass of eroded TN, and 17th for the mass of eroded TP. There were no sites of substantial erosion identified in the reach, however, there were still several noteworthy features recorded. The reach's location can be viewed on the reach map in **Figure 45**.

Another feature of note was an eroding hillslope along the right bank from STA 1358+00 ft to STA 1360+00 ft. This erosion segment measured 220 ft in length, had a maximum height of 17 ft, and it is estimated that 16 yd<sup>3</sup> of sediment erodes annually from the hillslope. Another right hillslope failure was located from STA 1362+50 ft to STA 1363+50 ft. This erosion segment measured 105 ft in length, with a maximum height of 20 ft, and it is estimated that 7.0 yd<sup>3</sup> of sediment erodes annually from the right hillslope. Across from the upstream end of the hillslope

failures was an old berm along the left bank. This berm prevents the stream from accessing its floodplain and likely causes the flow to be directed into the right hillslope contributing to the hillslope failures. At the top of the hillslope is County Highway 10. Drainage from the road may be contributing to the instability of this particular hillslope.

There were two headcuts located in the reach. The first headcut was located at STA 1368+00 ft. The headcut had a depth of 0.5 ft and was along a bend in the stream channel. Downstream of the headcut, there was erosion along both banks. The threat this headcut posed was to bed and bank stability as it was not located near any infrastructure. The second headcut was located at STA 1381+50 ft. This headcut had a depth of 2.0 ft and, at the time of assessment was, held in place by several large boulders within the stream channel. The threat this headcut posed was to bed and bank stability as it was not located near any infrastructure.

At the upstream end of the reach is an area with several large beaver impoundments between STA 1383+00 ft and STA 1400+00 ft. The SFI was concluded at this location.
